Building Information - Valley View Local (48744) - Valley View High

GENERAL DESCRIPTION

Valley View High School, which is not on the National Register of Historic Buildings, and originally constructed in 1968, is a 2 story, 96,535 square foot brick school building located in a rural agricultural setting. The existing facility features a conventionally partitioned design, and does utilize a modular building. The structure of the overall facility is a brick veneer on a masonry bearing wall system type exterior wall construction, with concrete masonry unit and demountable partition type wall construction in the interior. The ground floor system consists of concrete slab on grade. The Intermediate floor consists of a cast-in-place concrete system. The roof structure is a combination of metal deck, tectum, wood deck and cast in place concrete on steel joist. The roofing system of the overall facility is EPDM fully adhered membrane, installed in 1995, 1996, 1997, 1998, and 2000. The ventilation system in the 1968 Original Construction is inadequate to meet the needs of the users. The ventilation system in the 2000 Addition is adequate to meet the needs of the users. The Classrooms are

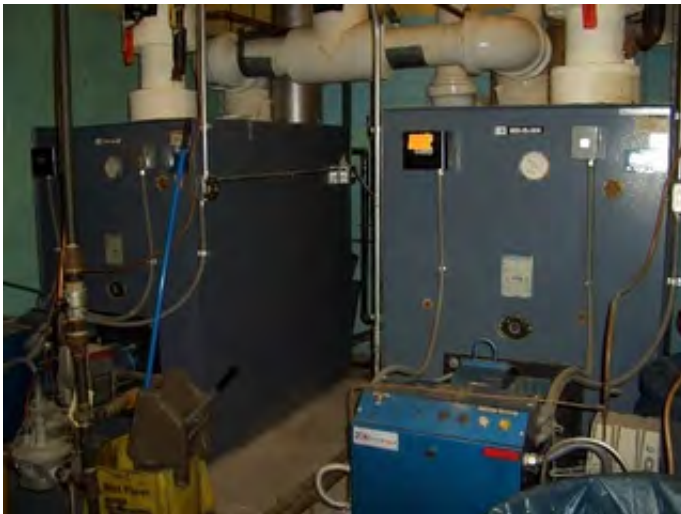
Description: The existing system for the 1968 Original Construction is a natural gas fired heating water system, installed in 1968 and upgraded in 1996, and is in fair overall condition. The existing system for the 2000 Addition Student Dining Area is a heating water system, fed from the 1968 Original Construction, installed in 2000, and is in good condition. The existing system for the remainder of the 2000 Addition is a natural gas fired packaged rooftop HVAC system, installed in 2000, and is in good condition. The heating and chilled water system in the 1968 Original Construction and 2000 Addition Student Dining Area is a 2-pipe system, without a capacity for simultaneous heating and cooling operation, which is not compliant with the OSDM requirements for basic system type. 2-pipe vs. 4-pipe designations are not applicable in the remainder of the 2000 Addition due to the utilization of a packaged HVAC unit with natural gas heat and DX cooling. The two heating water boilers, manufactured by Weil-McClain, were installed in 1996 and are in good condition. Heating water is distributed to terminal units consisting of unit ventilators, cabinet heaters, and air handlers. The terminal equipment in the 1968 Original Construction was installed in 1968, and is in fair condition. The terminal equipment in the 2000 Addition was installed in 2000, and is in good condition. The system in the 1968 Original Construction does not comply with the 15 CFM per person fresh air requirements of the Ohio Building Code mechanical code and Ohio School Design Manual. The system in the 2000 Addition does comply with the 15 CFM per person fresh air requirements of the Ohio Building Code mechanical code and Ohio School Design Manual. The pneumatic and DDC type system temperature controls were installed in 1968, with the DDC controls added to control the boilers and chillers in 1996, and are in fair condition. The system does feature individual temperature controls in all spaces required by the OSDM. The overall system does not feature any central energy recovery systems. The 1968 Original Construction is equipped with louvered interior doors to facilitate Corridor utilization as return air plenums. The existing system in the 1968 Original Construction is not ducted, and floor to ceiling heights will not accommodate the installation of a ducted system. The overall heating system is evaluated as being in safe but inefficient working order, and long term life expectancy of the existing system is anticipated. The 2000 Addition is not equipped with louvered interior doors to facilitate Corridor utilization as return air plenums. The existing system is ducted in the 2000 Addition, with the exception of the 2000 Addition Student Dining Area, but the ductwork cannot be integrated into a possible future system due to arrangement, air volume, and routing of existing ductwork. The overall heating system is evaluated as being in safe but inefficient working order, though long term life expectancy of the existing system is not anticipated due to the utilization of a rooftop HVAC unit. The structure is equipped with central air conditioning. The site does not contain underground fuel tanks.

Rating: 3 Needs Replacement

Heating Water Boilers

Recommendations: Provide new overall heating, ventilating, and air conditioning system to achieve compliance with Ohio Building Code and Ohio School Design Manual standards. Convert to ducted system to facilitate efficient exchange of conditioned air. Replace existing ductwork in the 2000 Addition to facilitate efficient exchange of conditioned air. Provide architectural soffits in the 1968 Original Construction to accommodate the installation of ductwork, with funding provided by convert to ducted system replacement.

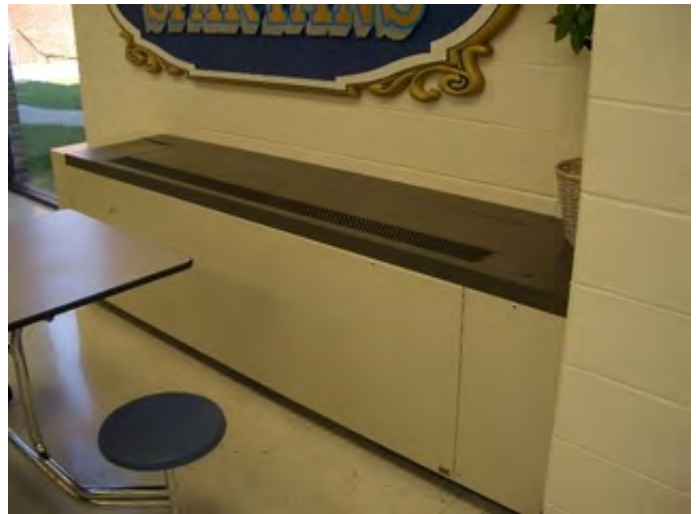
Unit Ventilator in the 2000 Addition

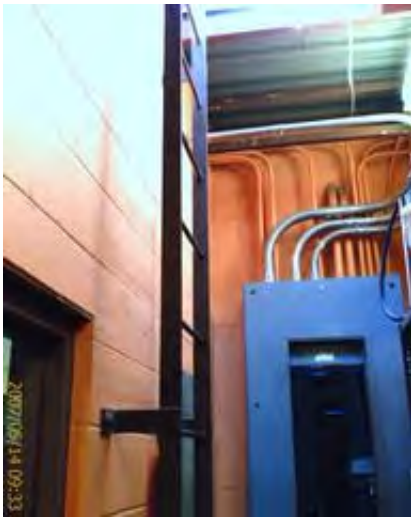
Description: The roof over the 1968 Original Construction is an EPDM adhered system that was installed in 1995, 1996, 1997, and 1998, and is in fair condition. The roof over the 2000 Addition is an EPDM adhered system that was installed in 2000, and is in good condition. There are no District reports of current leaking. Signs of past leaking were observed in the 1968 Original Construction during the physical assessment. Access to the roof was gained by roof hatch and ladders that are in good condition but are not provided with the required fall protection cage. There were observations of standing water on the roof. Metal cap flashings and copings in the 1968 Original Construction are in poor condition. Metal cap flashings and copings in the 2000 Addition are in good condition. Roof storm drainage is addressed through a system of roof drains, which are properly located, and in good condition. No problems requiring attention were encountered with any roof penetrations. There are not any covered walkways attached to this structure.

Rating: 3 Needs Replacement

Typical Access Ladder

Recommendations: The roof over the overall facility requires replacement to meet Ohio School Design Manual guidelines for age of system. Metal cap flashings and coping replacement is included in the roofing replacement cost. Provide fall protection cage to roof access ladders. POST-ASSESSMENT NOTE Rii 9-24-15 - Remove / replace 15 existing drains and sump. Provide 15 overflow roof drains & piping.

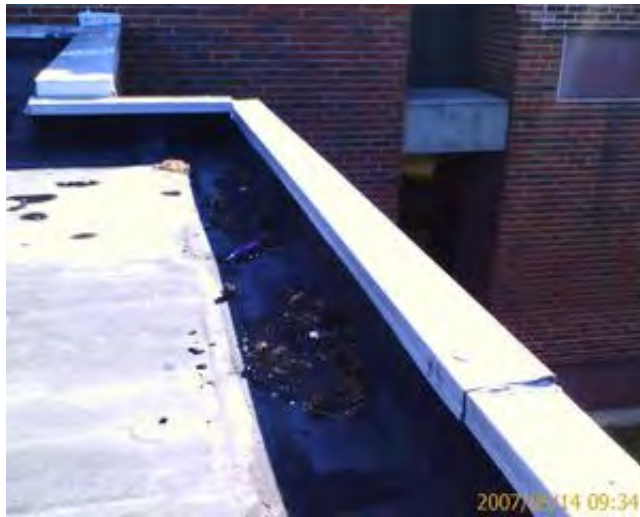
Typical Coping Condition

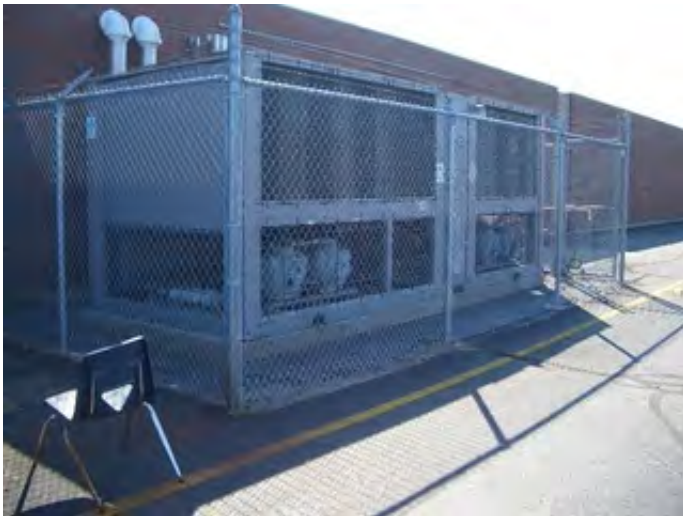
Description: The 1968 Original Construction and 2000 Addition Student Dining Area are equipped with a chilled water type central air conditioning system, which is in fair condition. In the 1968 Original Construction, chilled water is distributed from two air cooled chillers by a 2-pipe system to air handling units and unit ventilators. The chillers were installed in 1996, and are in fair condition. The unit ventilators and air handling units in the 1968 Original Construction were installed in 1968, and are in fair condition. The unit ventilators in the 2000 Addition Student Dining Area were installed in 2000, and are in good condition. The remainder of the 2000 Addition is equipped with a packaged rooftop type central air conditioning system, which is in fair to good condition. Cooling air is distributed from a single packaged rooftop HVAC unit by a ducted system with VAV terminal units to regulate the airflow to individual spaces. The system was installed in 2000, and is in good condition. Window units are provided in the former Weight Room, but are no longer in use. The ventilation system in the 1968 Original Construction consists of unit ventilators, installed in 1968 and in fair condition, providing fresh air to Classrooms, and air handlers, installed in 1968 and in fair condition, providing fresh air to other miscellaneous spaces. Relief air venting is provided by louvered interior doors and Corridor plenums. The ventilation system in the 2000 Addition Student Dining Area consists of unit ventilators, installed in 2000 and in good condition. Relief air venting is ducted directly outdoors by relief hoods on the roof of the 2000 Addition. The ventilation system in the remainder of the 2000 Addition consists of a rooftop packaged HVAC unit, installed in 2000 and in good condition, providing fresh air to Classrooms and other miscellaneous spaces. Relief air venting is provided by ceiling plenums transferring air back to the rooftop HVAC unit. The ventilation system in the 1968 Original Construction does not meet the Ohio Building Code 15 CFM per occupant fresh air requirement. The ventilation system in the 2000 Addition meets the Ohio Building Code 15 CFM per occupant fresh air requirement. The overall system is not compliant with Ohio Building Code and Ohio School Design Manual requirements. Dust collection systems are required in this facility and existing equipment is adequate. Exhaust systems for the overall facility are inadequately placed, and in fair to poor condition. The Art program is equipped with two kilns, which are not currently being utilized, and not properly vented.

Rating: 2 Needs Repair

Air Cooled Chiller

Recommendations: Provide an air conditioning system to meet with Ohio Building Code and Ohio School Design Manual requirements. Pricing included in Item A. Replace the overall exhaust systems in the facility due to inadequate placement, age, and condition. Provide a heat removal hood for the Art program kilns. POST-ASSESSMENT NOTE Rii 9-24-15 - Replace dust collection system.

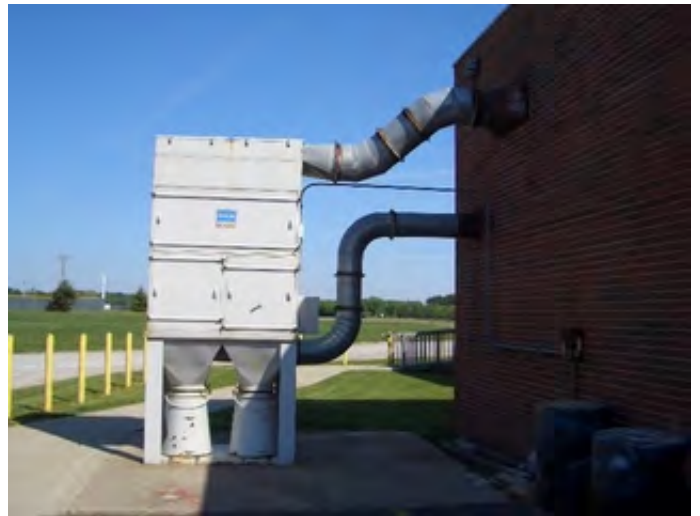
Dust Collection System

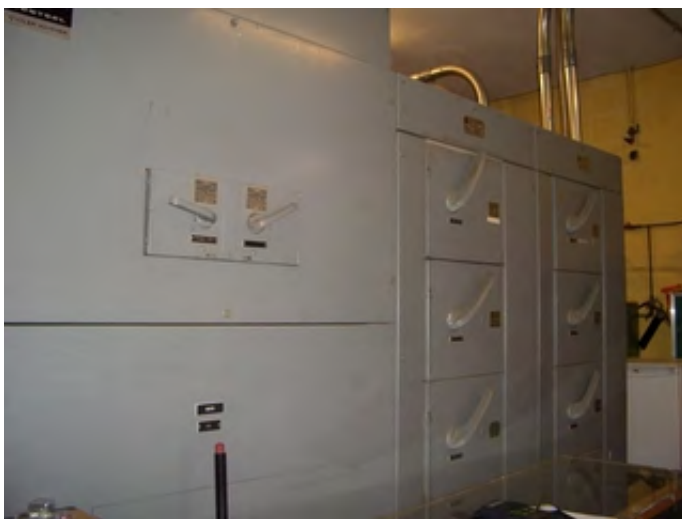
Description: The electrical system provided to the 1968 Original Construction is a 480 volt, 2000 amp, three phase, four wire system installed in 1968, and is in fair condition. The electrical system in the 2000 Addition is an extension of that found in the 1968 Original Construction. Power is provided to the school by a single utility owned, pad-mounted transformer located outside the Electrical Room, and in fair condition. The panel system in the 1968 Original Construction, installed in 1968, is in fair condition, and cannot be expanded to add additional capacity. The panel system in the 2000 Addition, installed in 2000, is in good condition, and can be expanded to add additional capacity. The Classrooms in the 1968 Original Construction are not equipped with adequate electrical outlets. The typical Classroom contains four general purpose outlets and one dedicated outlet for each Classroom television. Some Classrooms are equipped with as many as six general purpose outlets. The Classrooms in the 2000 Addition are not equipped with adequate electrical outlets. The typical Classroom contains 12 general purpose outlets and no dedicated outlets for Classroom computers or a television. There are not any spaces that have no electrical outlets. The Corridors in the 1968 Original Construction are not equipped with adequate electrical outlets for servicing. The Corridors in the 2000 Addition are equipped with adequate electrical outlets for servicing. Adequate GFI protected exterior outlets are not provided around the perimeter of the 1968 Original Construction. Adequate GFI protected exterior outlets are provided around the perimeter of the 2000 Addition. The facility is not equipped with an emergency generator. Adequate lightning protection safeguards are not provided. Stage lighting power system including control panel, breakers, and dimmers is inadequately provided, in fair condition and does not meet OSDM requirements. The overall electrical system does not meet Ohio School Design Manual requirements in supporting the current needs of the school, and will be inadequate to meet the facility's future needs.

Rating: 3 Needs Replacement

Main Distribution Panel

Recommendations: The entire electrical system in the 1968 Original Construction requires replacement to meet Ohio School Design Manual guidelines for Classroom capacity, and due to condition and age. Provide a dedicated circuit and two additional dedicated receptacles for the Classroom computers in the three 2000 Addition Classrooms. Provide adequate lightning protection safeguards in the 1968 Original Construction, including associated grounding system, with funding included in the electrical system replacement. Provide adequate lightning protection safeguards in the 2000 Addition, including associated grounding system. Provide an emergency generator, costs included in electrical system replacement. Provide control panel, dimmers and breakers to support the Stage lighting system.

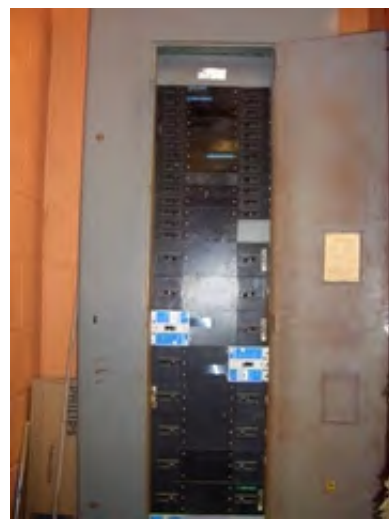
Electrical Sub Panel

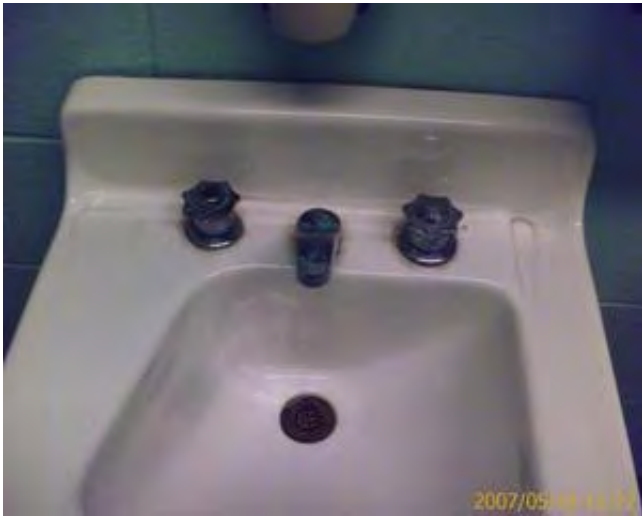
Description: The service entrance is not equipped with a reduced pressure backflow preventer. A water treatment system is provided to serve the boiler make up water and the domestic hot water system. The domestic water supply piping in the 1968 Original Construction is galvanized, was installed in 1968, and is in fair condition. The waste piping in the 1968 Original Construction is cast iron, was installed in 1968, and is in good condition. There is no water supply piping or waste piping in the 2000 Addition. The facility is equipped with an A.O. Smith Brand gas water heater with two separate 115 gallon storage tanks in good condition. The school contains 3 Large Group Restrooms for boys, 3 Large Group Restrooms for girls, 1 Locker Room Restroom for boys, 1 Locker Room Restroom for girls, no Restrooms associated with specialty Classrooms, and 4 Restrooms for staff. Boys' Large Group Restrooms contain 1 ADA and 5 non-ADA wall mounted flush valve toilets, 1 ADA and 11 non-ADA wall mounted flush valve urinals, and 1 ADA and 8 non-ADA wall mounted lavatories. Girls' Large Group Restrooms contain 1 ADA and 11 non-ADA wall mounted flush valve toilets, as well as 1 ADA and 8 non-ADA wall mounted lavatories. Boys' Locker Room Restroom contains 1 non-ADA wall mounted flush valve toilet, 1 non-ADA wall mounted flush valve urinal, 1 non-ADA wall mounted lavatory, and 9 non-ADA showers. Girls' Locker Room Restroom contains 1 non-ADA wall mounted flush valve toilets, 2 non-ADA wall mounted lavatories, and 9 non-ADA showers. Staff Restrooms contain 4 non-ADA wall mounted flush valve toilets, and 4 non-ADA wall mounted lavatories. Condition of fixtures is good. The facility is equipped with 2 ADA and 9 non-ADA electric water coolers, in fair condition. Special Education Classroom is not equipped with the required Restroom facilities. Kitchen is equipped with the required Restroom, and fixtures are in good condition. Heath Clinic is equipped with the required Restroom, and fixtures are in good condition. Due to existing grade configuration, there are no Kindergarten / Pre-K Classrooms. Kitchen fixtures consist of 1 single and 2 double sinks, as well as 1 garbage disposal unit, all of which are in good condition. The Kitchen is not equipped with a grease interceptor. The Kitchen is provided the required 140 degree hot water supply via a 16 gallon electric water heater, which is in good condition. The school does not meet the OBC requirements for fixtures. ADA requirements are not met for fixtures and drinking fountains (see Item O). Science Classrooms / Project Laboratories / Career Tech Laboratories are equipped with required utility sink, safety shower / eyewash in good condition, but are not equipped with required gas and compressed air connections. Adequate exterior wall hydrants are not provided.

Rating: 3 Needs Replacement

Typical Lavatory Faucet Condition

Recommendations: Provide 5 new lavatories, 3 new electric water coolers (2 double), 3 gas connections, and 1 air connection to facilitate the school's compliance with OBC and OSFC requirements. Replace 21 faucets and valves due to condition and to facilitate the school's compliance with OBC and OSFC requirements. Replace galvanized water supply piping in the 1968 Original Construction with copper piping due to condition. Provide a reduced pressure back flow preventer. Provide three additional exterior wall hydrants. Provide a grease interceptor for the Kitchen. See Item O for replacement of fixtures related to ADA requirements. See Item J for provisions on kitchen related equipment. POST-ASSESSMENT NOTE Rii 9-24-15 - Replace water softener treatment system. Replace Sanitary Waste Piping. Replace Domestic Water Heater. Provide Acid Waste System for Science Classroom.

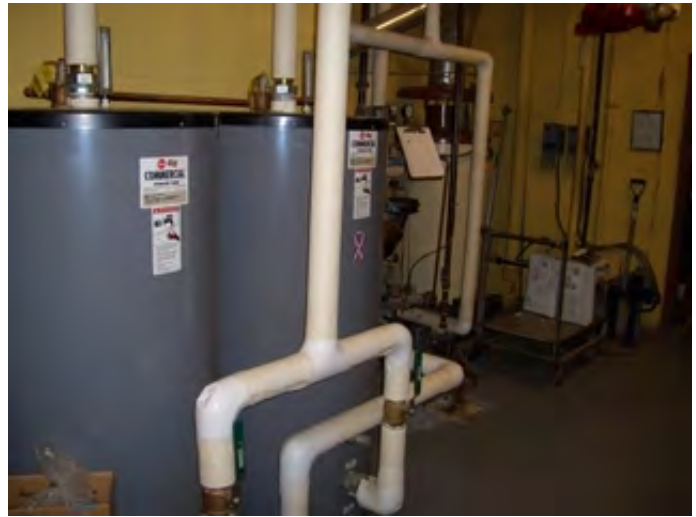
Domestic Water Heating System

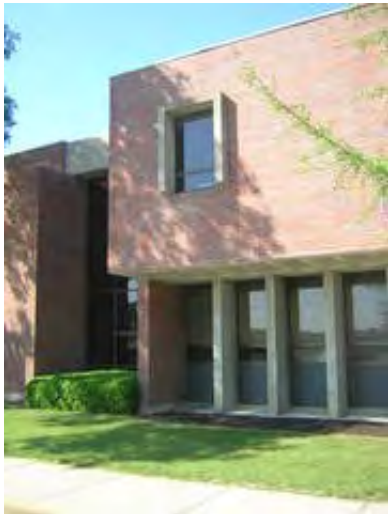
Description: The 1968 Original Construction is equipped with non-thermally broken aluminum frame windows with single glazed type window system, which was installed in 1968, and is in fair condition. The window system features surface mounted blinds, which are in fair condition. The 2000 Additions are equipped with thermally broken aluminum frame windows with double glazed insulated type window system, which were installed in 2000, and are in good condition. Aluminum frame curtain wall systems are found in the 1968 Original Construction and are in fair condition. Curtain wall systems are equipped with non-thermally broken aluminum frames and single glazed type window system, which was installed in 1968. This facility does not feature any glass block windows. The exterior doors in the 1968 Original Construction are equipped with non-thermally broken aluminum and hollow metal frame sidelights and transoms with single pane glazing, in fair condition. The exterior doors in the 2000 Additions are equipped with thermally broken aluminum frame sidelights and transoms with double glazed insulated glazing, and are in good condition. The school does not contain skylights. Exterior door transoms and sidelights are single pane safety type glazing in fair condition.

Rating: 3 Needs Replacement

1968 Original Construction Windows

Recommendations: Provide a new insulated window system with integral blinds to meet with Ohio School Design Manual requirements in the 1968 Original Construction. Replace curtain wall system in the 1968 Original Construction with thermally broken aluminum frame and double glazed insulated type system. Replace windows, transoms & sidelights in exterior doors of the 1968 Original Construction with approved double glazed safety glass. POST-ASSESSMENT NOTE Rii 9-24-15 - Per SHP, Replace skylights in poor condition in Boys and Girls Locker Rooms.

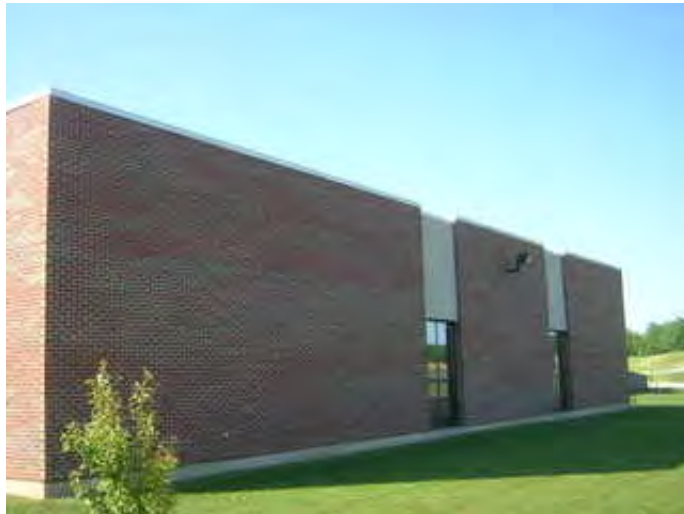
2000 Music Addition Windows

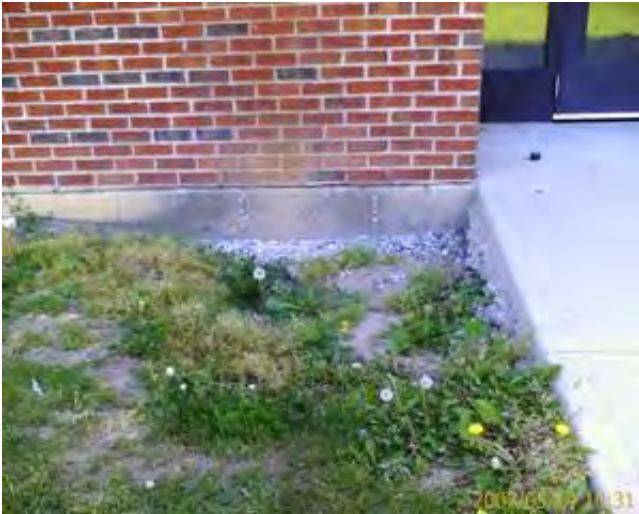
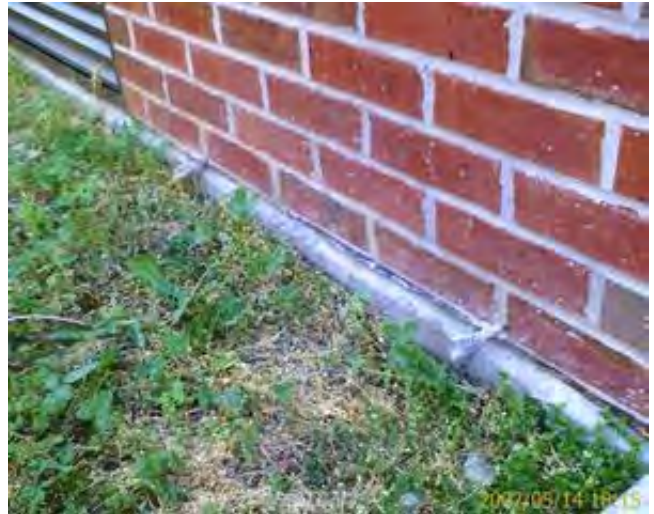
Description: The overall facility is equipped with cast-in-place concrete foundation walls on concrete footings, which displayed no locations of significant differential settlement, cracking, or leaking, and are in good condition. The District reports that there has been no past leaking. No grading or site drainage deficiencies were noted around the perimeter of the structure that are or could contribute to foundation / wall structural deterioration.

Typical Cast-in-Place Concrete Foundation Wall

Recommendations: Existing conditions require no renovation or replacement at the present time.

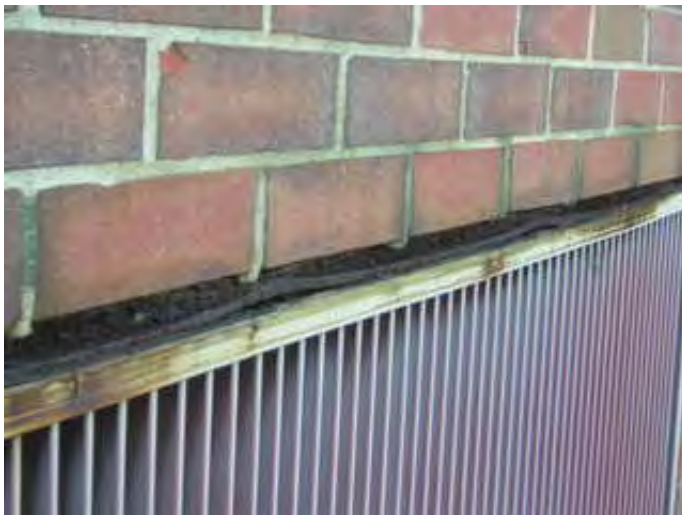
Description: The 1968 Original Construction has brick veneer on a masonry bearing wall system which displayed locations of deterioration at exterior mechanical louver penetrations, and is in fair condition. The 2000 Addition has a brick veneer on a masonry bearing wall system which displayed no locations of deterioration, and is in good condition. The exterior masonry in the 1968 Original Construction does not have sufficient control joints. Existing caulked control joints in the 1968 Original Construction are in poor condition. The exterior masonry in the 2000 Addition has appropriately spaced control joints which are in good condition. The exterior masonry for the overall facility has not been cleaned and sealed in recent years. Interior walls are concrete masonry units and metal demountable partitions and are in good condition. Interior masonry appears to have adequately spaced and caulked control joints in good condition. Exterior soffits in the 1968 Original Construction are in fair condition. The window sills are brick, concrete and an element of the aluminum window system, and are in good condition. The exterior lintels for masonry veneer at mechanical grille locations in the 1968 Original Construction are steel, are rusting and are in poor condition. There are no chimneys in the overall facility.

Rating: 2 Needs Repair

Deteriorated Lintel Above Wall Grille

Recommendations: Provide tuckpointing in all areas of mortar deterioration as required in the 1968 Original Construction. Provide masonry cleaning and sealing for the overall facility. Saw cut and caulk new appropriately spaced control joints in existing masonry in the 1968 Original Construction. Recaulk existing control joints in the 1968 Original Construction. Replace steel lintels and repair masonry at mechanical louver locations in the 1968 Original Construction. Repair concrete soffits as required in the 1968 Original Construction. Repair brick veneer as required in the 1968 Original Construction. POST-ASSESSMENT NOTE Rii 9-24-15 - Added 2100 SF of tuckpointing scope and funding.

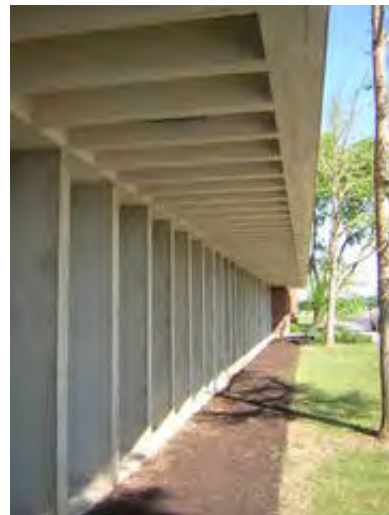
Exposed Concrete Soffit

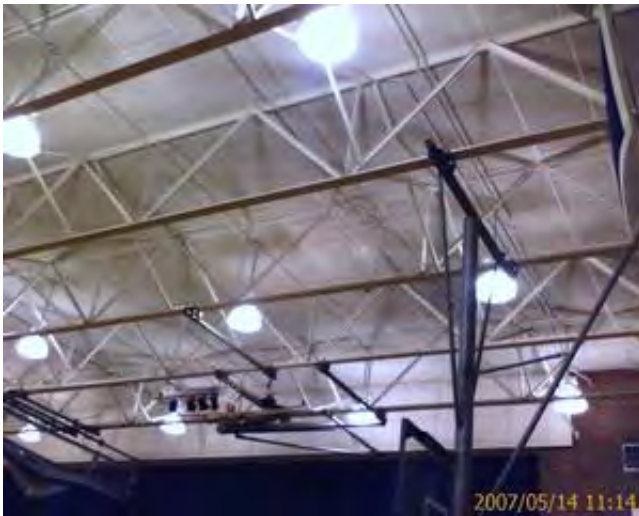
Description: The floor construction of the base floor of the overall facility is concrete slab-on-grade type construction and is in good condition. There is no crawl space. The floor construction of the intermediate floors of the 1968 Original Construction is cast-in-place concrete and is in good condition. Ceiling to structural deck spaces are insufficient to accommodate HVAC, electrical, and plumbing scopes of work in required renovations. Floor to ceiling heights will not accommodate dropping the ceiling as a remedy in Corridors. The roof construction of the 1968 Original Construction is a combination of metal deck, tectum, wood and cast-in-place concrete on steel joist type construction, and is in good condition. The roof construction of the 2000 Addition is metal deck on steel joist type construction, and is in good condition.

Rating: 2 Needs Repair

Typical Tectum Deck System

Recommendations: Replace wood roof decking in the 1968 Original Construction. Funding for issues related to floor to ceiling heights are addressed in Item A.

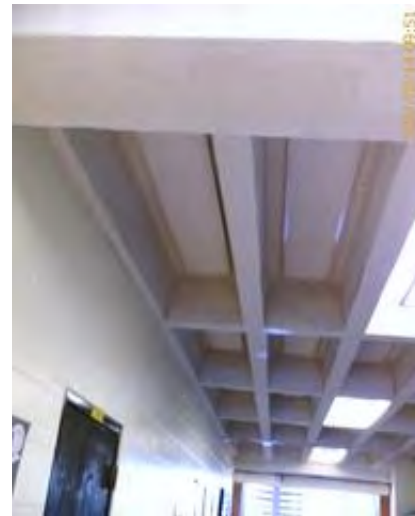
Typical Cast in Place Concrete Intermediate Floor

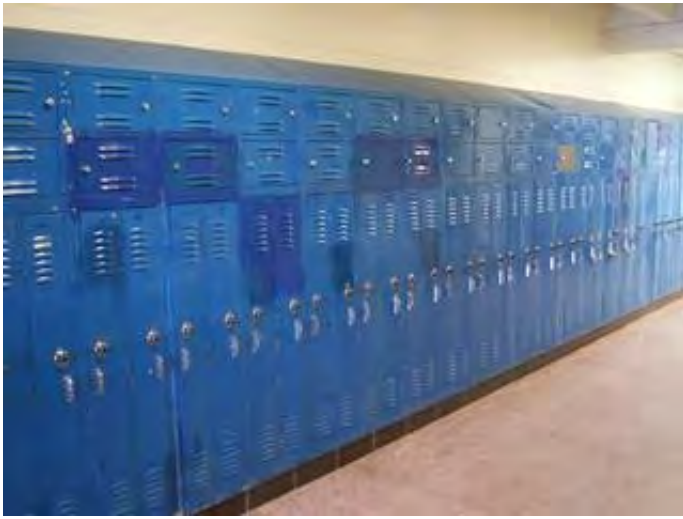
Description: The 1968 Original Construction features conventionally partitioned Classrooms with VAT and carpet flooring, lay-in ceilings, as well as painted block and wood paneled wall finishes, and they are in fair/poor condition. Corridors have terrazzo flooring, cast-in-place concrete deck with ACM plaster coating type ceilings, as well as painted block and brick wall finishes, and they are in fair/poor condition. Restrooms have ceramic tile flooring, drywall ceilings, as well as painted block wall finishes, and they are in fair/poor condition. Toilet partitions are plastic and metal type construction, in good to poor condition. Classroom casework is wood type construction with plastic laminate tops, is inadequately provided, and in fair/poor condition. The Classroom casework provided ranges from 4 feet to 12 feet. Classrooms are provided with adequate chalkboards, markerboards, and tackboards, which range from good to poor condition. The lockers, located in the Corridors, are adequately provided, and in poor condition. This portion of the facility is equipped with wood louvered interior doors that are recessed without proper ADA hardware and clearances, and are in poor condition. The 2000 Addition features conventionally partitioned Classrooms with carpet flooring, lay-in ceilings, as well as painted block wall finishes, in good condition. Corridors have carpet flooring, lay-in ceilings, as well as painted block wall finishes, in good condition. No Restrooms are located in the 2000 Addition. Classroom casework consists of miscellaneous wood and metal shelving units, in poor condition. Classrooms are provided with adequate markerboards and tackboards, which are in good condition. There are no lockers located in this addition. This portion of the facility is equipped with wood louvered interior doors that are recessed with proper ADA hardware and clearances, and are in good condition. The Gymnasium space has wood flooring, exposed bar joist and tectum ceilings, as well as painted block wall finishes, and they are in fair condition. Gymnasium telescoping stands are metal type construction in fair/poor condition. Gymnasium basketball backboards are fixed and electrically operated, and are in good condition. The Media Center, located in the 1968 Original Construction features carpet type flooring, cast-in-place concrete deck with ACM plaster coating type ceilings, as well as painted block wall finishes, and they are in fair condition. Student Dining, located in the 1968 Original Construction has VAT flooring, lay-in ceilings, as well as painted block wall finishes, and they are in fair/poor condition. A portion of the Student Dining space was added in 2000, which has VCT flooring, lay-in ceilings, as well as painted block and brick type wall finishes, which are in good condition. OSDM-required fixed equipment for the Stage is inadequately provided, and in fair condition. The existing Kitchen is full service and the existing Kitchen equipment, installed in 1968, is in fair condition. The Kitchen hood is in fair condition, and is equipped with a compliant UL300 wet chemical fire suppression system. The hood is non-compliant due to inadequate extension beyond cooking surfaces. The cooking equipment is interlocked to shut down in the event of a discharge of the fire suppression system. Walk-in coolers and freezers are located within the Kitchen spaces, and are in fair condition.

Rating: 3 Needs Replacement

Typical Corridor with Lockers in Poor Condition

Recommendations: Provide complete replacement of finishes and casework throughout the facility due to installation of systems outlined in Items A, C, D, E, I, K, L, M, N, T, and U, and due to condition. Provide for replacement of wood framed partition walls, and partition walls in poor condition. Provide for replacement of wood floors at the Gymnasium due to age and condition. Provide for replacement of bleachers in the Gymnasium due to condition. Provide for replacement of toilet partitions due to work outlined in Item O, and due to condition. Provide for replacement of toilet accessories due to condition. Provide for replacement of Kitchen equipment due to age and condition of equipment. Provide for replacement of Kitchen hood due to condition. Funding for replacement of interior doors is provided in Item O, including doors here noted as being in poor condition. Provide for replacement of Science Lab table tops due to work outlined in Item T. POST-ASSESSMENT NOTE Rii 9-24-15 - Provide Gymnasium Divider Curtain. Provide Stage Curtain, Valance, & Rigging. Provide Volleyball Equipment. Provide six (6) Basketball Goals (electric). Funding for Gymnasium Floor Replacement amended, with Add Other deleted and funding provided under "Resilient wood / synthetic flooring" line item, which means it is now covered by Complete Replacement of Finishes and Casework. Replace Walk-In Cooler & Freezer. Provide Sound Attenuation Acoustical Surface Treatments in Gymnasium, Student Dining, Media Center, and Music Room.

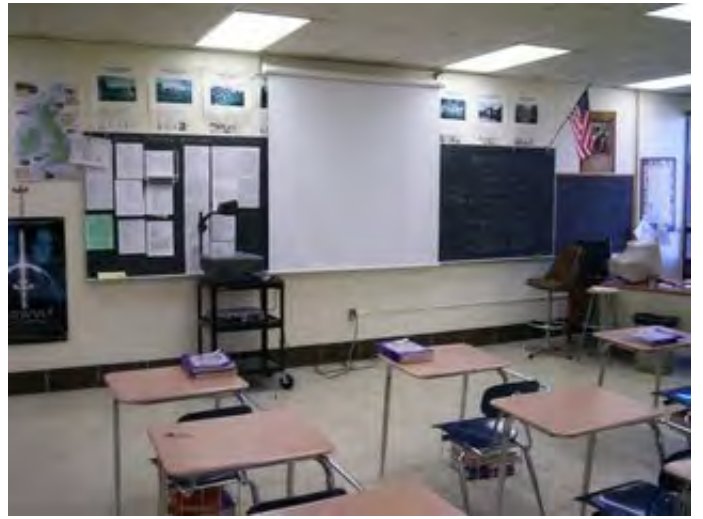
Typical Classroom Finishes

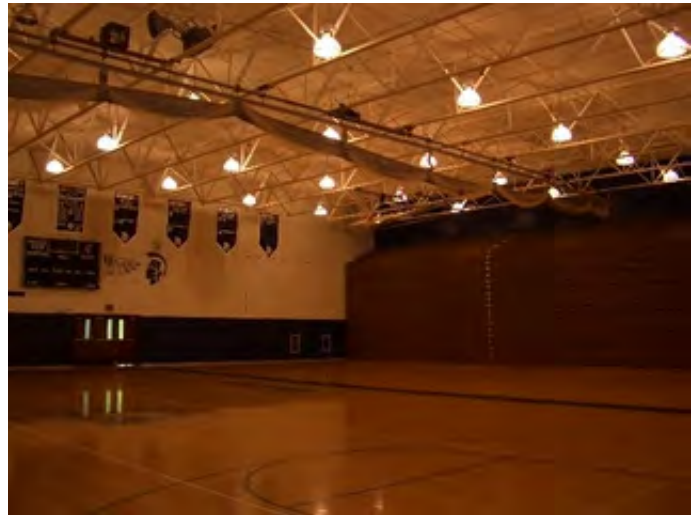
Gymnasium Lighting

Provide complete replacement of lighting system including Stage lighting due to condition, lighting levels, utilization of incandescent fixtures, lack of multilevel switching, and installation of systems outlined in Items A, C, J, and U.

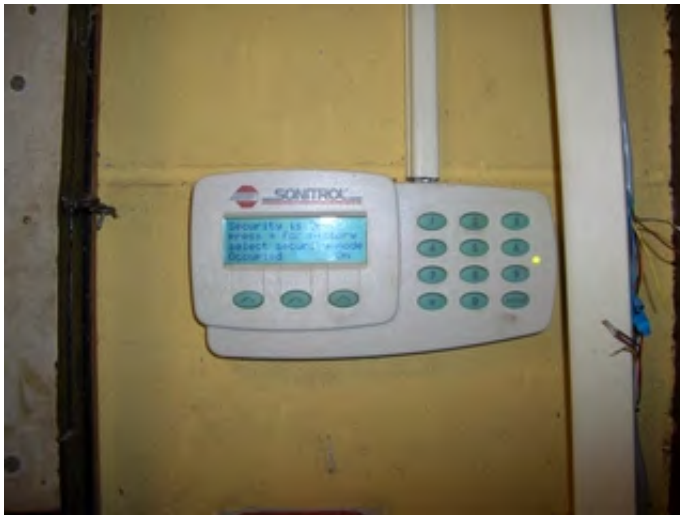
Rating: 3 Needs Replacement

Security System Keypad

Recommendations: Provide complete replacement of security system to meet Ohio School Design Manual guidelines. Provide complete replacement of exterior site lighting system to meet Ohio School Design Manual guidelines. POST-ASSESSMENT NOTE Rii 9-24-15 - Provide secure main entrance vestibule, including foundation, doors, access control, ceiling, & HVAC.

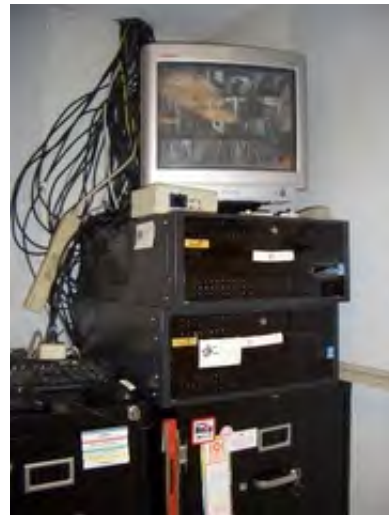
CCTV Monitor

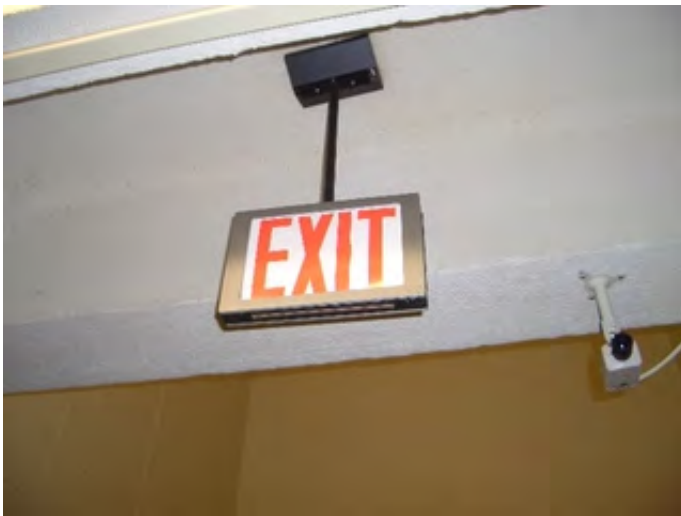
Rating: 3 Needs Replacement

Lighted Exit Sign

Recommendations: Provide complete replacement of emergency / egress lighting system to meet Ohio School Design Manual guidelines and to accommodate the scope of work outlined in Items A, C, J, and U.

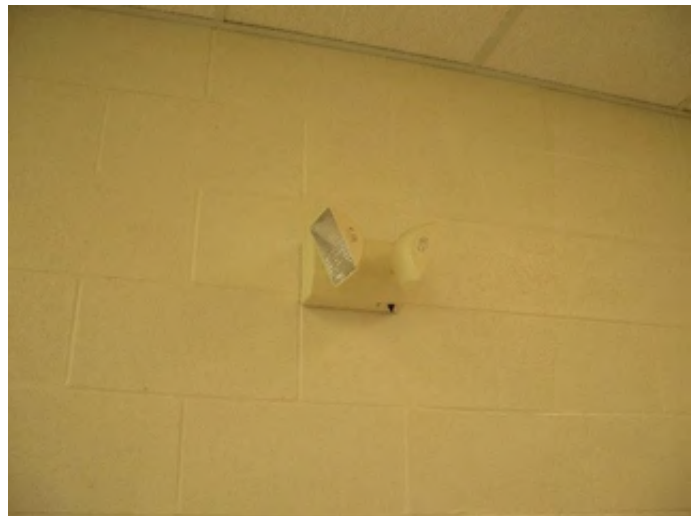
Emergency Light Fixture

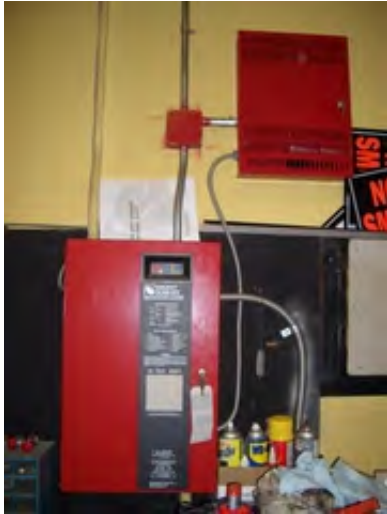
Fire Alarm Control Panel

Recommendations: Provide complete replacement of fire alarm system to meet NFPA and Ohio School Design Manual guidelines.

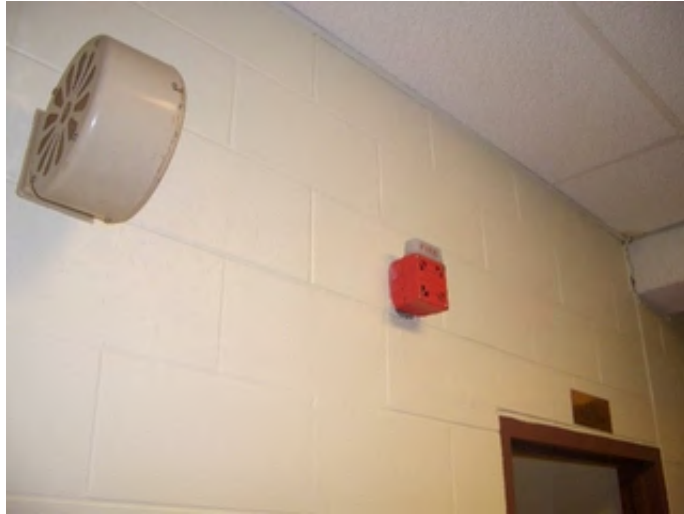
Fire Alarm Horn and Strobe Device

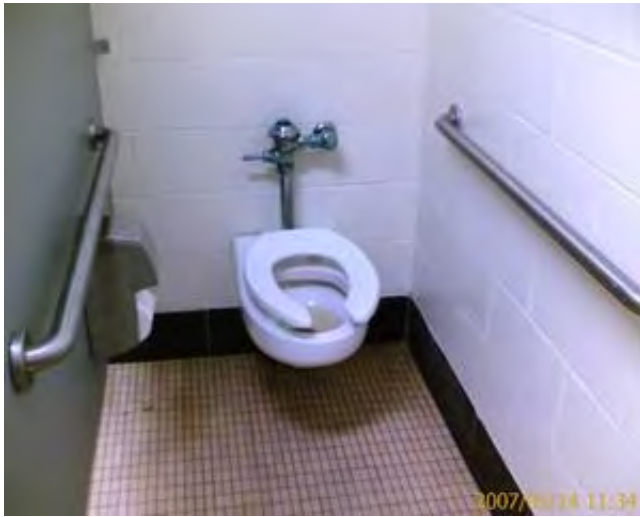
Typical ADA Compliant Restroom

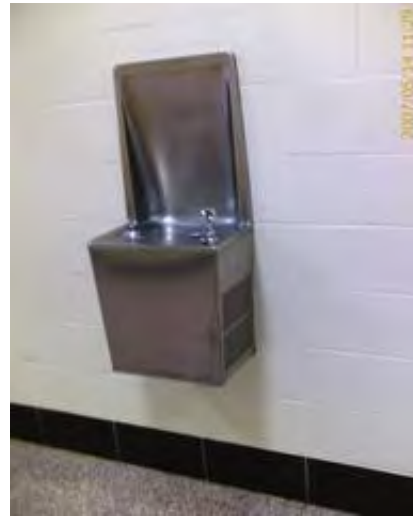
Typical Non ADA Compliant Drinking Fountain

Replace Doors:	\$5,000.00	leaf		5 Required		\$25,000.00	(rework opening and corridor wall to accommodate ADA standards when door opening is set back from edge of corridor and cannot accommodate a wheelchair.)
Other: ADA Mirrors	\$350.00	per unit		14 Required		\$4,900.00	New ADA compliant mirrors.
Other: ADA Shower Replacement	\$3,000.00	per unit		2 Required		\$6,000.00	Shower replacement to comply with ADA requirements.
Other: ADA Shower Units	\$5,000.00	per unit		2 Required		\$10,000.00	New ADA compliant shower.
Other: ADA Soap/Hand Dryer	\$350.00	per unit		14 Required		\$4,900.00	New ADA compliant soap disoenser and hand dryer.
Other: Special Education Restroom	\$25,000.00	allowance		Required		\$25,000.00	Add ADA-compliant Restroom to Special Education Classroom. Costs include 10x12 space with CMU walls, a roll-in ADA shower, ADA toilet, ADA sink, ceiling mounted transfer track, ceramic floor tile, plaster ceiling, new lighting, new mechanical, and a new plumbing system.

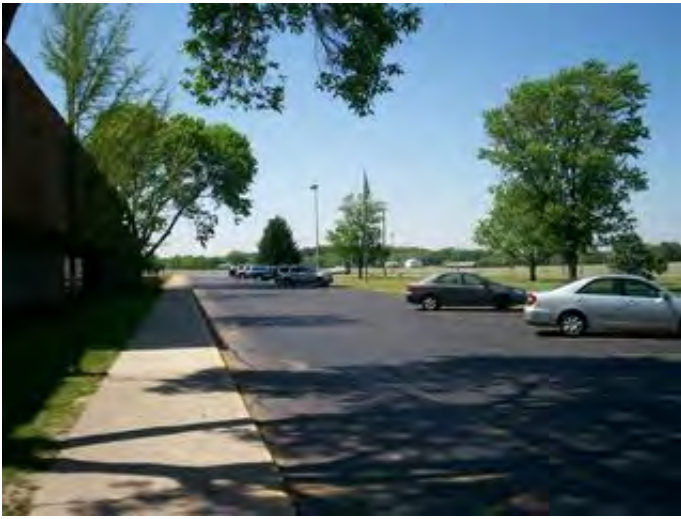
Non-separated Bus Loading and Unloading Zone in Front of School

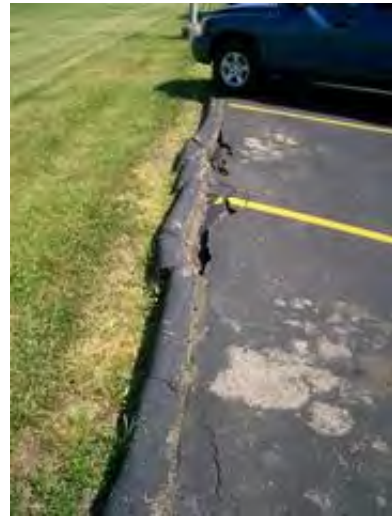
Asphalt Curb in Poor Condition

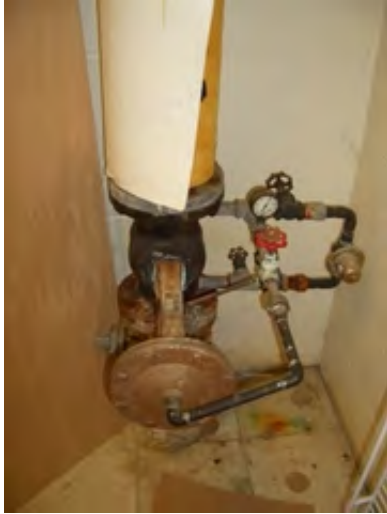
Incoming Water Main

Recommendations: Provide a new city water supply line of adequate capacity to support the existing needs of the facility, as well as a future automated fire suppression system. Funding provided in Item U.

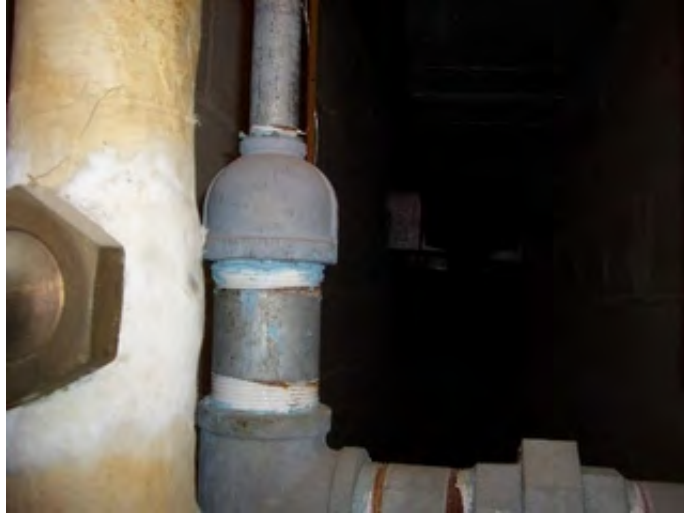
Galvanized Water Piping

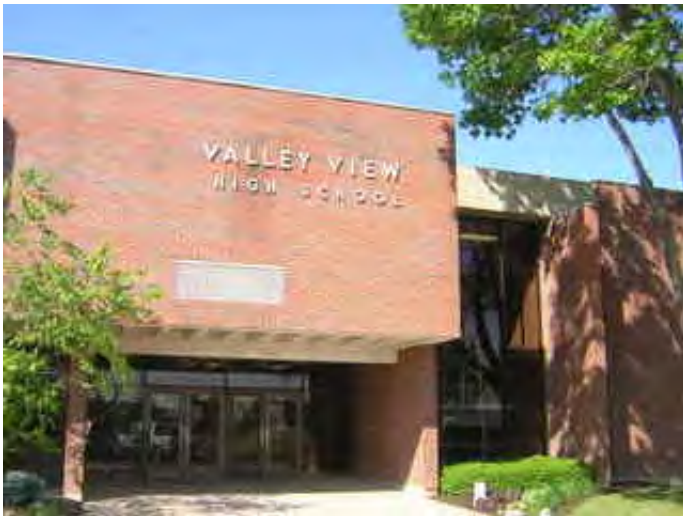
1968 Original Construction Main Entry Doors

Recommendations: Replace all exterior hollow metal doors and frames in the 1968 Original Construction, due to poor condition. Replace all steel overhead doors in the 1968 Original Construction, due to poor condition. POST-ASSESSMENT NOTE Rii 9-24-15 - Delete scope for replacement of two Overhead Doors, as District recently carried this out. POST-ASSESSMENT NOTE Rii 10-1-15 - Per SHP Replace 18 Entrance Doors in Original Construction.

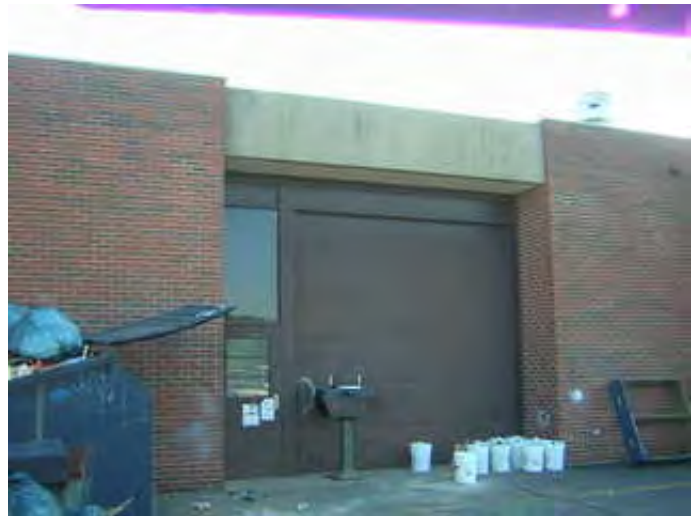
1968 Original Construction HM Door and Steel Overhead Door

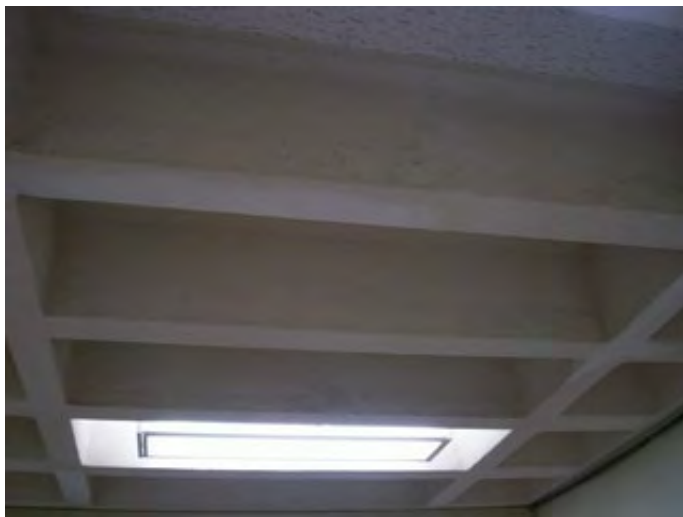
Textured ACM at Cast-in-Place Concrete

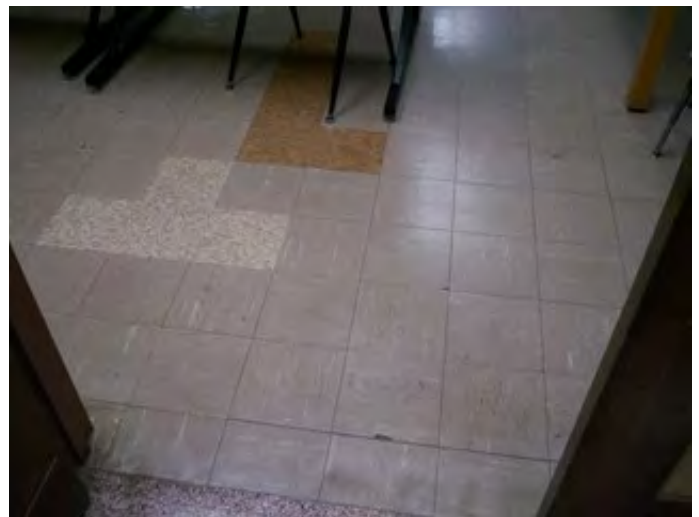
VAT in Classroom

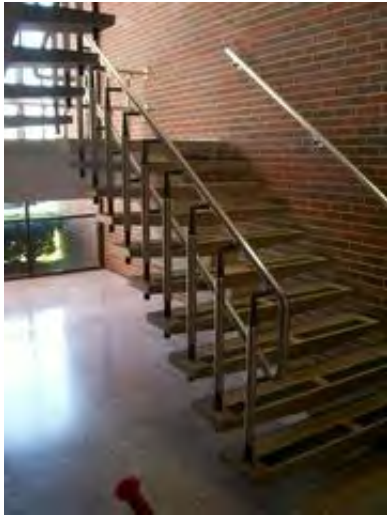
Non Compliant Stair Towers and Railings

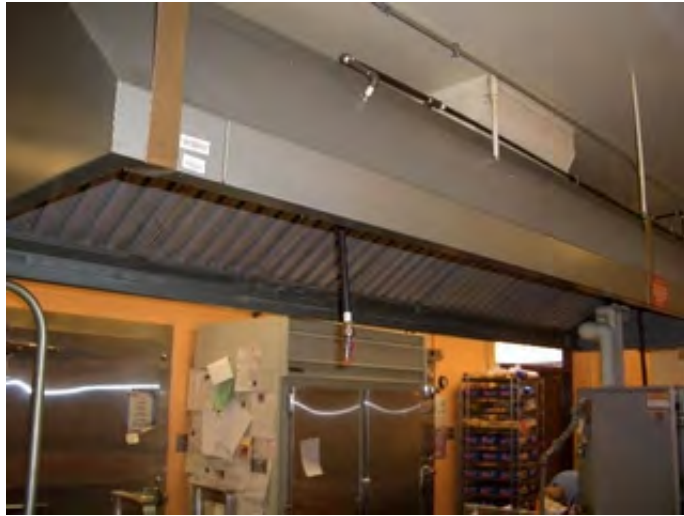
Kitchen Exhaust Hood
