Building Information - Valley View Local (48744) - Valley View Middle School

Program Type	Classroom Facilities Assistance Program (CFAP) - Regular
Setting	Small City
Assessment Name	Valley View Middle with 2016 Costs, 2015 EEA & Scope Adjustments
Assessment Date (on-site; non-EEA)	2015-11-06
Kitchen Type	Full Kitchen
Cost Set:	2016
Building Name	Valley View Middle School
Building IRN	13367
Building Address	64 Comstock Street
Building City	hmhm
Building Zipcode	45327
Building Phone	937-855-4203
Acreage	20.85
Current Grades:	PK, 4-6
Teaching Stations	40
Number of Floors	4
Student Capacity	620
Current Enrollment	472
Enrollment Date	2008-06-09

Valley View Middle School, which is not on the National Register of Historic Buildings, and originally constructed in 1922, is a four story, 87,904 square foot brick school building located in a small town residential setting. The existing facility features a conventionally partitioned design, and does not utilize modular buildings. The structure of the 1922 Original Construction, 1922 Auditorium Fixed Seating Area, and the 1922 Board Offices contains a solid brick masonry bearing wall system type exterior wall construction, with gypsum board p

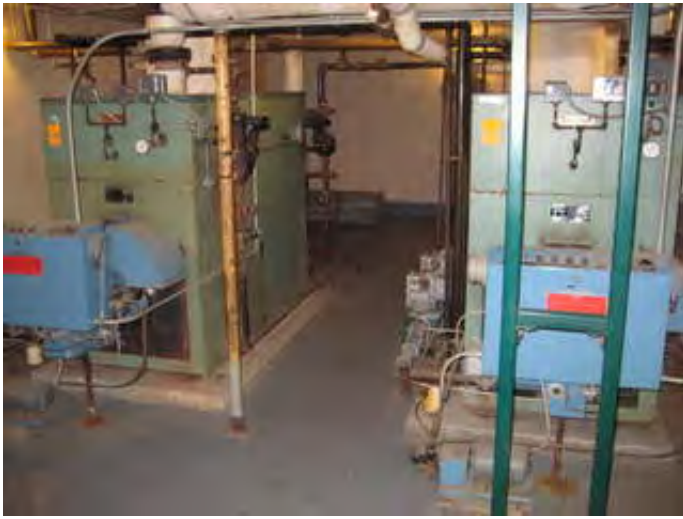
Peerless Steam Boilers

Recommendations: Provide new overall heating, ventilating, and air conditioning system to achieve compliance with Ohio Building Code and Ohio School Design Manual standards. Convert the 1956 and 1962 Additions to a ducted system to facilitate efficient exchange of conditioned air. Replace existing ductwork in the 1922 Original Construction, 1922 Auditorium Fixed Seating Area, 1922 Board Offices, and 1951 Addition to facilitate efficient exchange of conditioned air with pricing included in HVAC system replacement. Provide architectural soffits to accommodate the installation of ductwork, with funding provided in conversion to ducted system replacement.

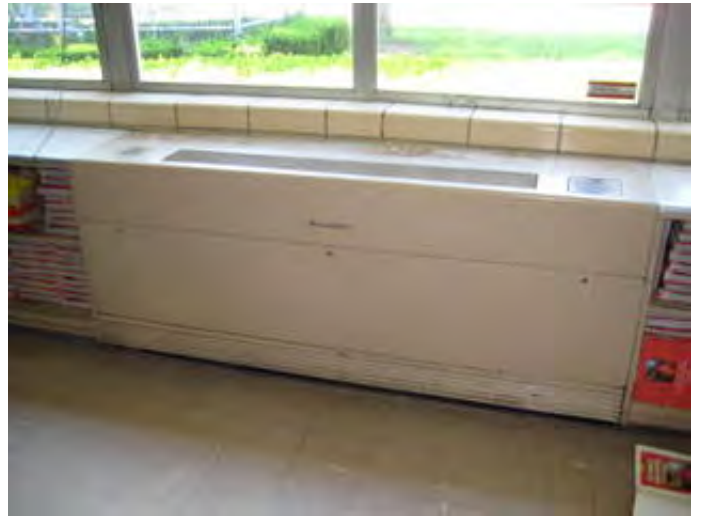
1962 Addition Steam Unit Ventilator

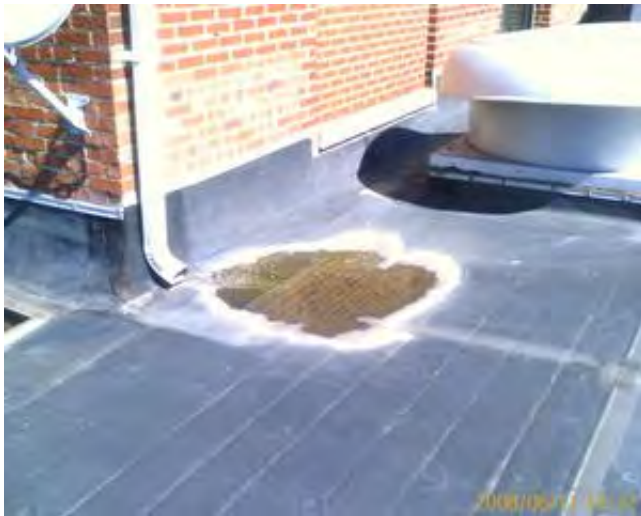
Typical Standing Water Condition

Other: Roof Hatch Replacement	\$2,000.00	per unit						1 Required		\$2,000.00	Roof hatch replacement.
Sum:			\$142,131.00	\$0.00	\$0.00	\$132,931.00	\$0.00	\$9,200.00	\$0.00

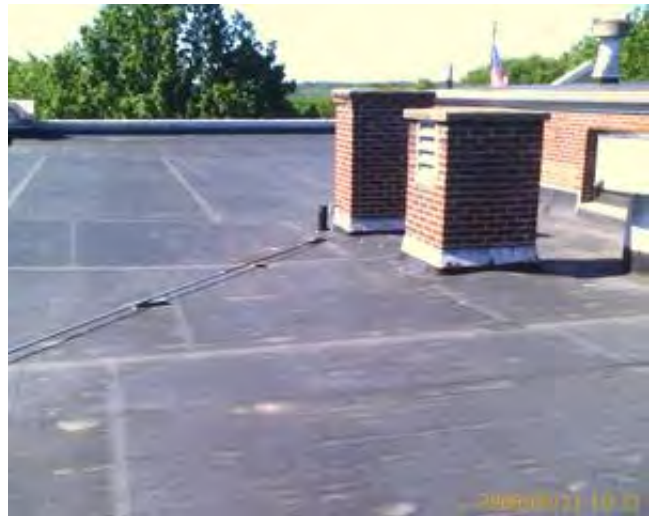
Typical EPDM Roofing Condition

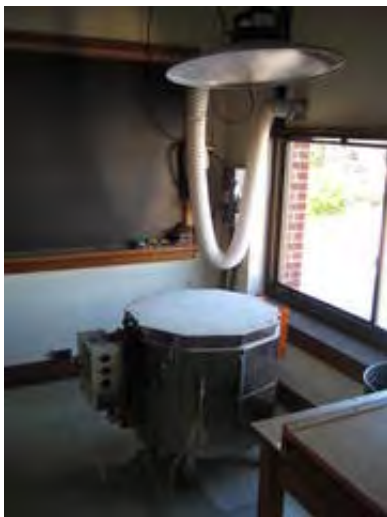
Art Program Kiln Exhaust System

Recommendations: Provide an air conditioning system to meet with Ohio Building Code and Ohio School Design Manual requirements. Pricing included in Item A. Replace the existing general building exhaust system. Replace the existing Art Program kiln ventilation system due to age and condition.

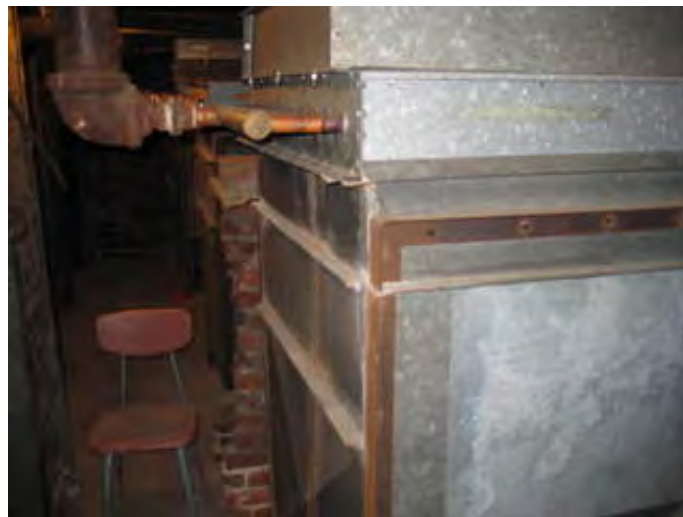
1922 Original Construction Air Handler

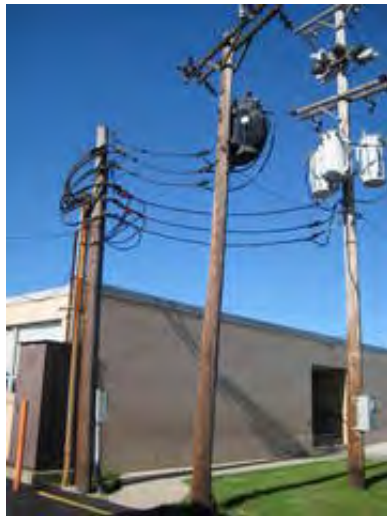
Pole-Mounted Transformers

Recommendations: The entire electrical system requires replacement to meet Ohio School Design Manual guidelines for overall capacity and Classroom capacity due to age, condition, lack of OSDM-required features, and to accommodate the addition of an air conditioning system. Replace the existing emergency generator, with funding included in the electrical system replacement. Provide adequate lightning protection safeguards in the overall facility, including associated grounding system, with funding included in the electrical system replacement. Provide control panel, dimmers, and breakers to support the Stage lighting system, with funding included in the electrical system replacement.

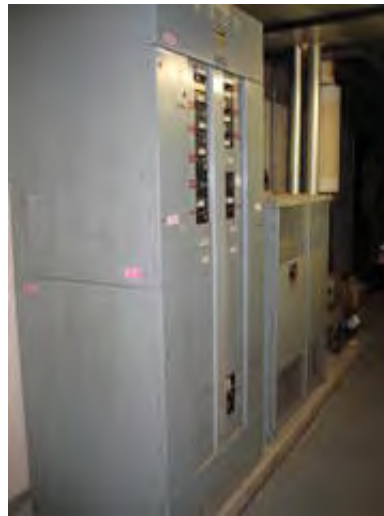
Main Electrical Distribution Panel

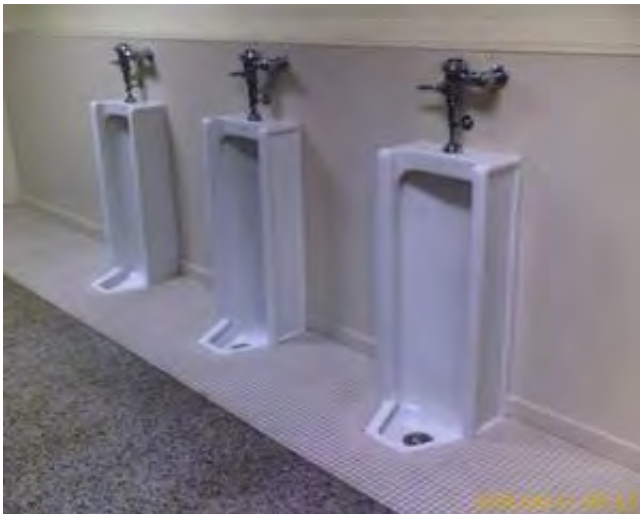
Typical Floor Mounted Urinals

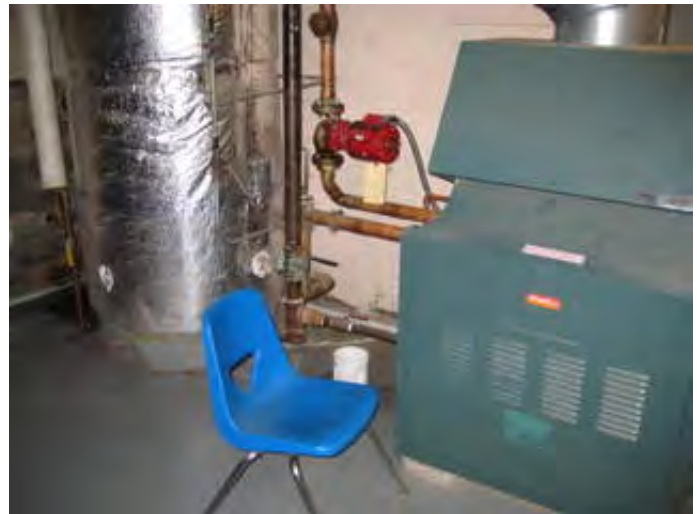
Domestic Hot Water Heater and Storage Tank

HIGH BAY/INDUSTRIAL SPACE - LAB TYPES 5,6,7 - Wash Fountain	\$3,600.00	unit						1 Required	\$3,600.00	
HIGH BAY/INDUSTRIAL SPACE - LAB TYPES 5,6,7 - Natural Gas Connections	\$800.00	each			2 Required			1 Required	\$2,400.00	
HIGH BAY/INDUSTRIAL SPACE - LAB TYPES 5,6,7 - Compressed Air Connections	\$15,000.00	per system			1 Required				\$15,000.00	
Other: Domestic Hot Water Storage Tank	\$3,500.00	per unit			1 Required				\$3,500.00	Replace the domestic 250 gallon hot water storage tank due to age and condition.
Other: Exterior Wall Hydrants	\$2,800.00	per unit			4 Required				\$11,200.00	Provide four (4) additional exterior wall hydrants.
Other: Kitchen Grease Trap	\$5,000.00	per unit			1 Required				\$5,000.00	Provide the Kitchen with a grease trap interceptor.
Other: Kitchen Water Heater	\$5,100.00	per unit			1 Required				\$5,100.00	Replace the Kitchen water booster heater due to age and condition.

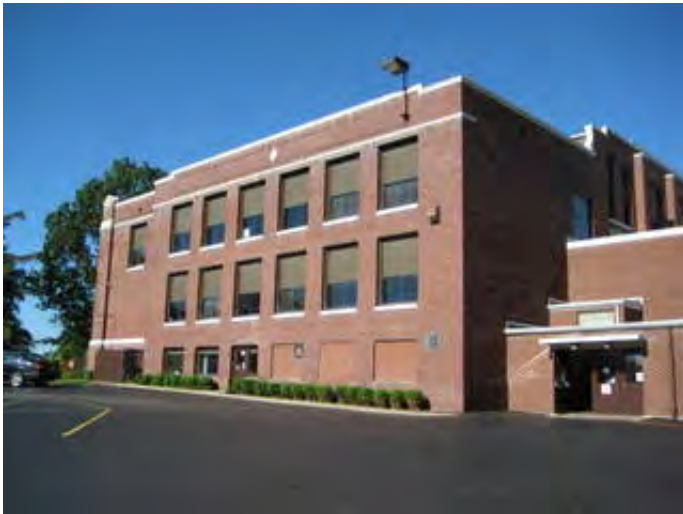
Typical Aluminum Frame Windows

Recommendations: Provide a new insulated window system with integral blinds in the overall facility to meet with Ohio School Design Manual requirements. Replace the existing glass block in the 1956 and 1962 Additions with a new insulated window system with integral blinds to meet with Ohio School Design Manual requirements. Replace window transoms and sidelights in exterior doors of the 1922 Original Construction, 1951 and 1962 Addition to meet with Ohio School Design Manual requirements.

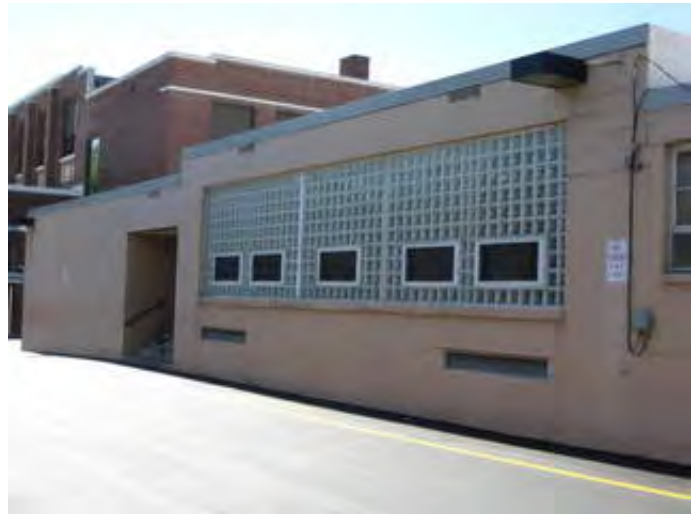
Glass Block Windows

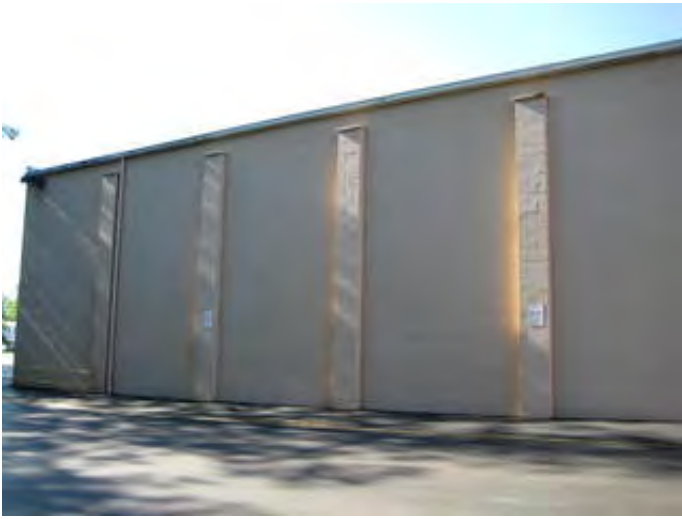
CMU Condition

Other: Replace Steel Lintels	\$150.00	n.ft.				160 Required				\$24,000.00	Replace steel lintels as required in the 1922 Original Construction due to condition.
Other: Scrape and Paint	\$10.00	sq.ft. (Qty)					5,122 Required	5,841 Required	4,593 Required	\$155,560.00	Paint exterior concrete masonry unit walls (after tuckpointing) as required in the 1951, 1956, and 1962 Additions.
Other: Scrape and Paint Canopies	\$10.00	sq.ft. (Qty)					138 Required	165 Required		\$3,030.00	Paint concrete canopies as required in the 1951 and 1956 Additions.
Other: Scrape and Paint Lintels	\$5.00	n.ft.			26 Required	513 Required	113 Required	11 Required	454 Required	\$5,585.00	Scrape and paint steel lintels as required in the overall facility.
Sum:			\$417,270.75	\$10,333.00	\$4,773.00	\$78,501.50	\$75,383.25	\$109,534.00	\$138,746.00

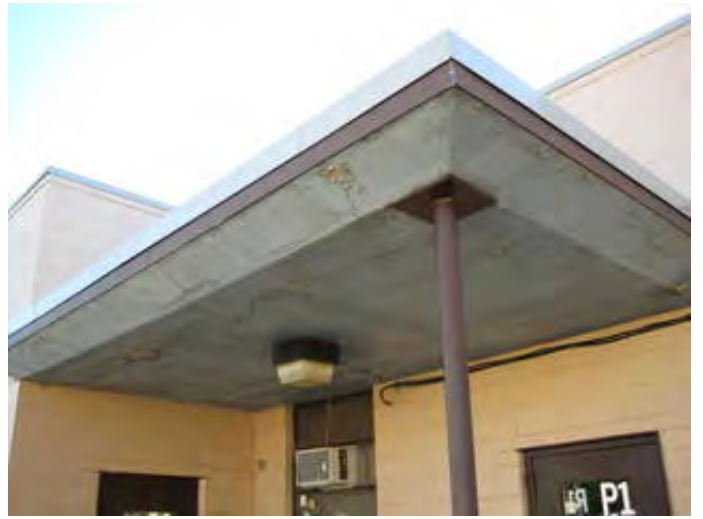
Concrete Canopies

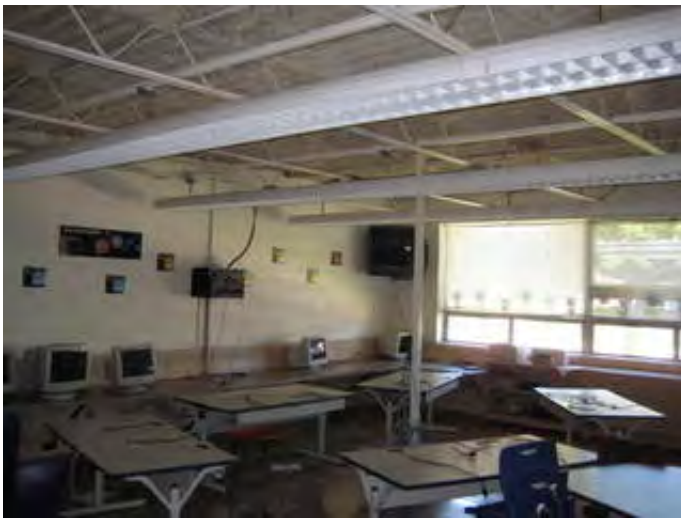
1962 Addition Classroom Fluorescent Light Fixtures

Recommendations: Provide complete replacement of lighting system due to age, condition, inadequate lighting levels, lack of multilevel switching, the utilization of incandescent fixtures, and installation of systems outlined in Items A, C, J, and U.

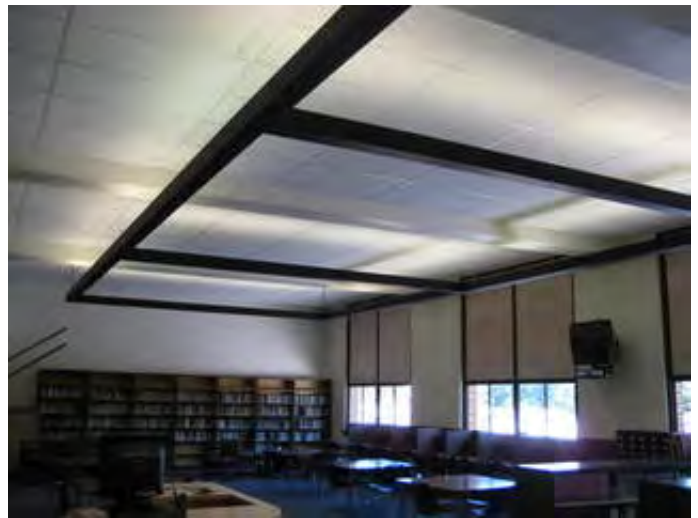
1922 Original Construction Media Center Indirect Fluorescent Light Fixtures

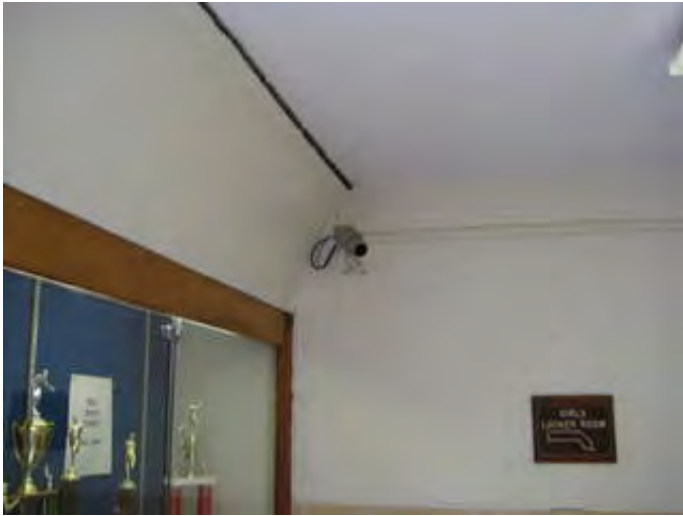
CCTV Camera

Recommendations: Provide complete replacement of security system to meet Ohio School Design Manual guidelines. Provide complete replacement of exterior site lighting system to meet Ohio School Design Manual guidelines. Provide additional playground fencing to meet Ohio School Design Manual guidelines, funding included in complete replacement of security system.

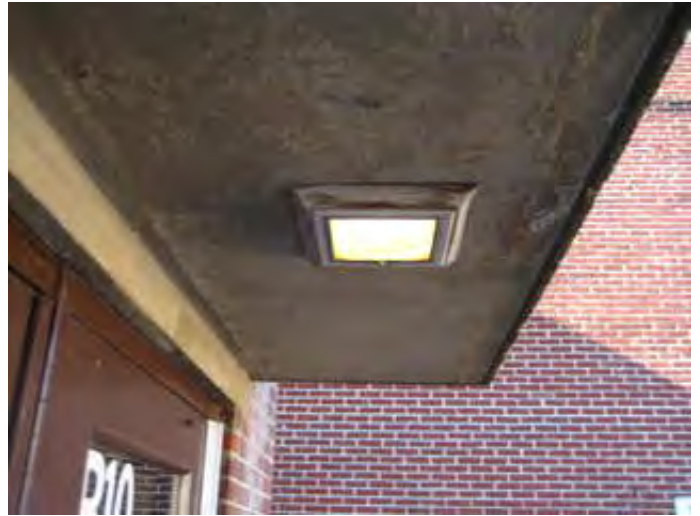
Recessed Entry Light Fixture

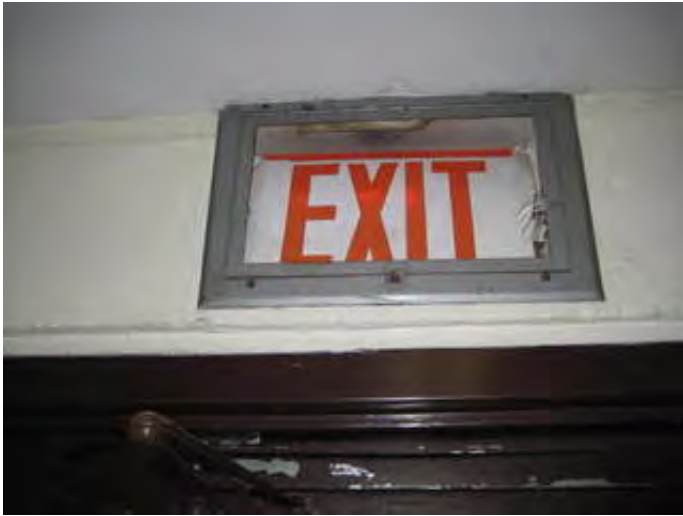
Non-Compliant Non-Illuminated Exit Sign

Recommendations: Provide complete replacement of emergency / egress lighting system to meet Ohio School Design Manual guidelines. Although funding for emergency / egress lighting is not shown for the 1922 Auditorium Fixed Seating Area, work is considered mandatory and funding will be provided via Life Safety Allowance in master planning.

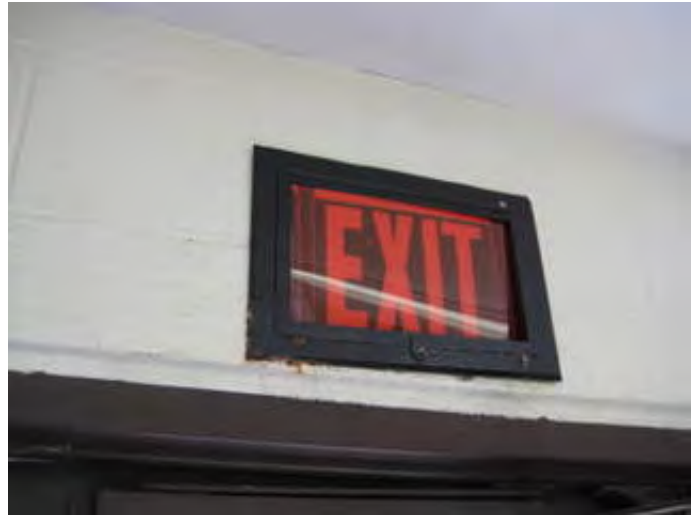
Non-Compliant Exit Sign

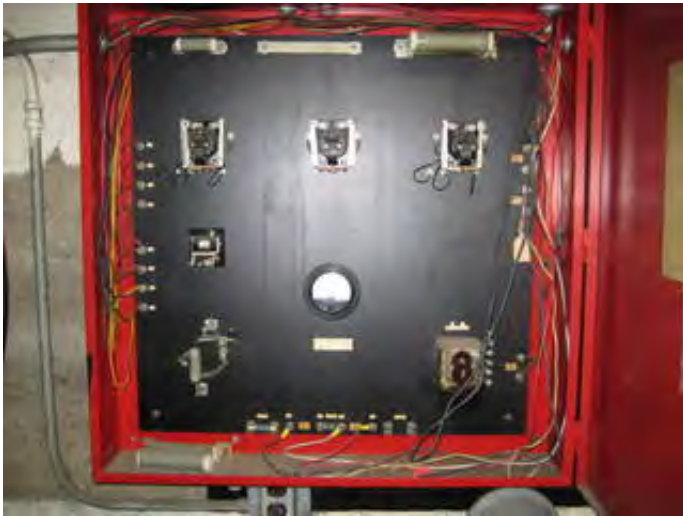
Fire Alarm System Control Panel

Recommendations: Provide complete replacement of fire alarm system to meet OBC, NFPA, and Ohio School Design Manual guidelines. Although funding for fire alarm is not shown for the 1922 Auditorium Fixed Seating Area, work is considered mandatory and funding will be provided via Life Safety Allowance in master planning.

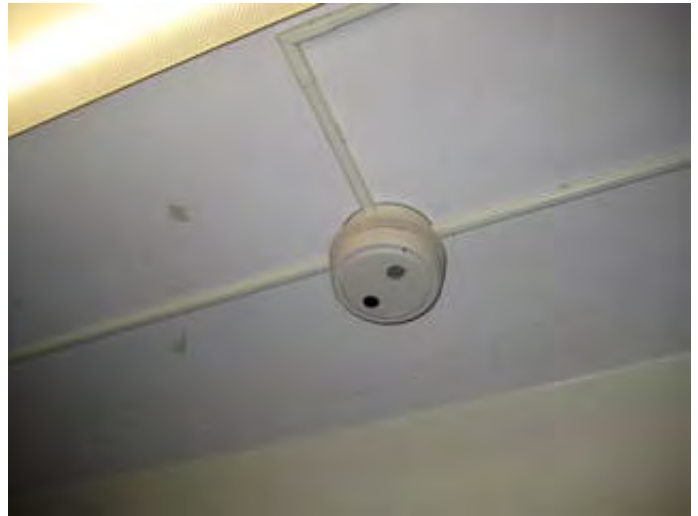
Fire Alarm System Smoke Detection Device

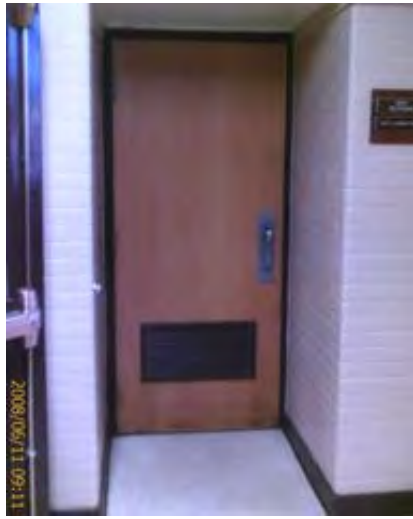
Typical Narrow Recessed Door

ADA Assist Door & Frame:	\$7,500.00	unit				1 Required				\$7,500.00	(openers, electrical, patching, etc)
Replace Doors:	\$1,300.00	leaf				12 Required	11 Required		31 Required	\$70,200.00	(standard 3070 wood door, HM frame, door/light, includes hardware)
Replace Doors:	\$5,000.00	leaf				25 Required		4 Required	19 Required	\$240,000.00	(rework narrow opening to provide 3070 wood door, HM frame, door/light, includes hardware)
Remount Restroom Mirrors to Handicapped Height:	\$285.00	per restroom					9 Required		6 Required	\$4,275.00	
Provide ADA Shower:	\$3,000.00	each					2 Required			\$6,000.00	(includes fixtures, walls, floor drain, and supply line of an existing locker room)
Other: ADA Mirrors	\$285.00	per unit					9 Required		6 Required	\$4,275.00	New ADA mirrors.
Other: ADA Shower	\$3,000.00	per unit					2 Required			\$6,000.00	New ADA shower.
Sum:			\$813,830.80	\$15,637.60	\$503.60	\$412,198.80	\$92,619.20	\$51,776.40	\$241,095.20

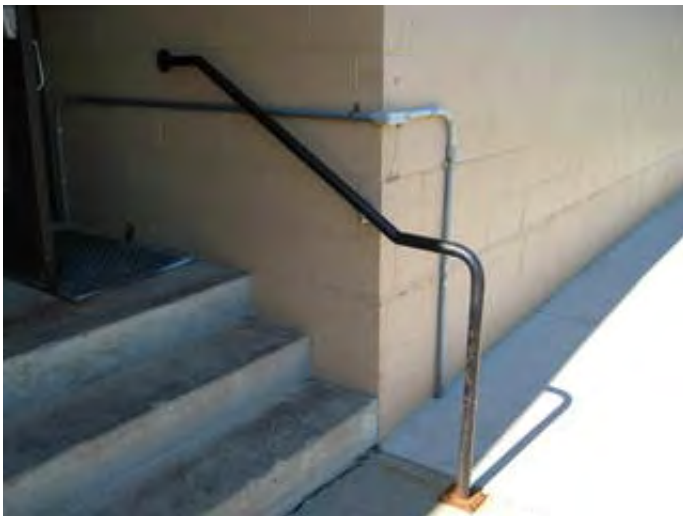
Handrail Condition

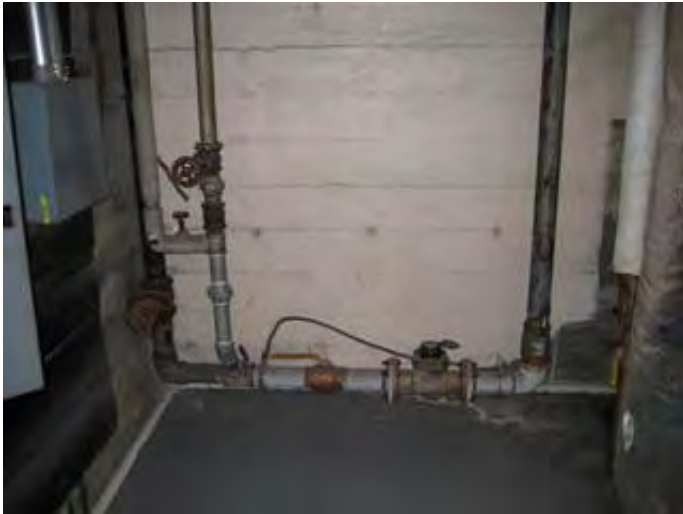
Incoming Domestic Water Service

Recommendations: Provide a new city water supply line of adequate capacity to support the existing needs of the facility, as well as a future automated fire suppression system. Funding provided in Item U.

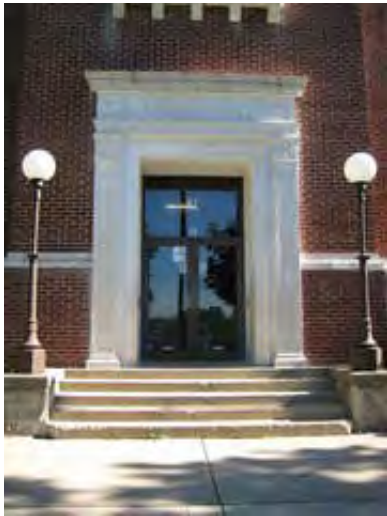
Main Entrance Doors

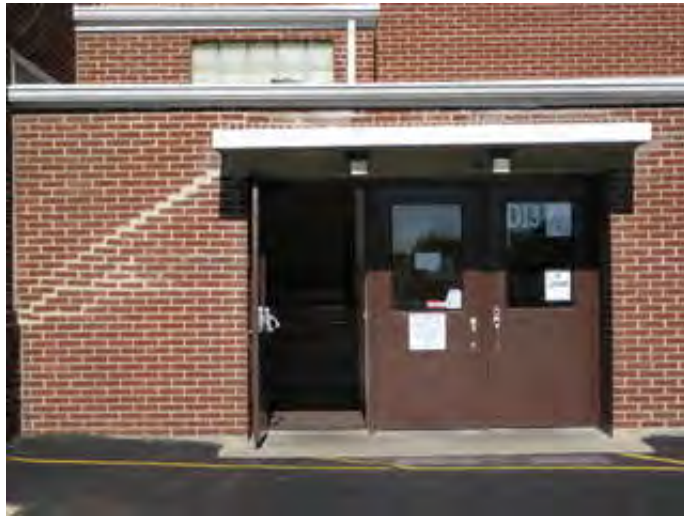
Typical Exterior Doors

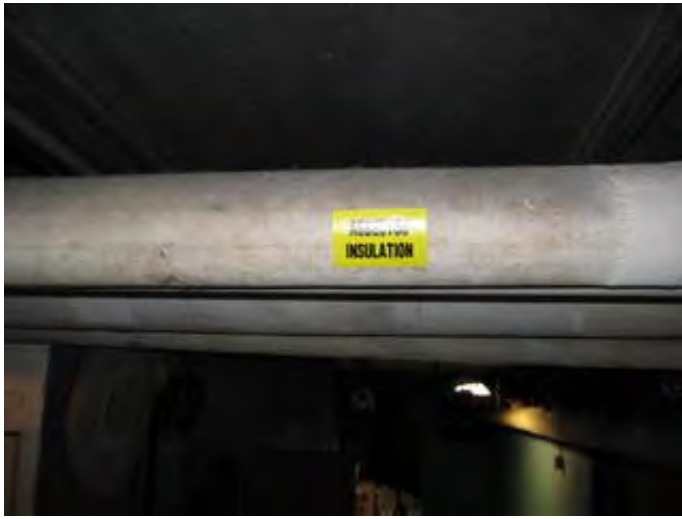
Pipe Insulation

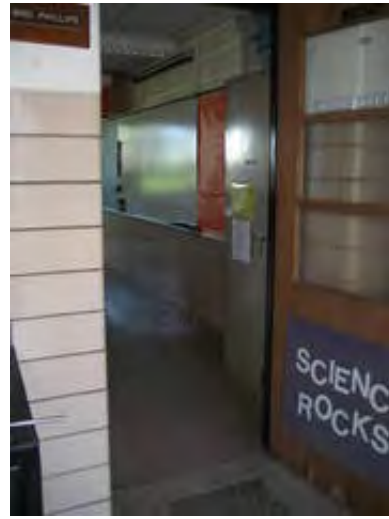
VAT in Classroom

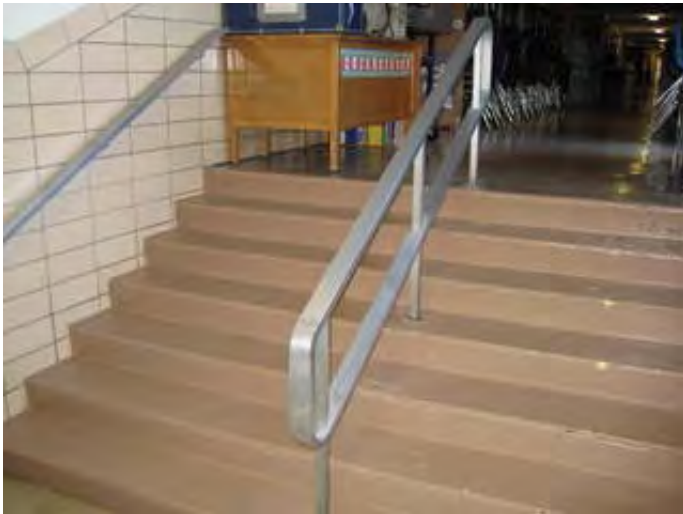
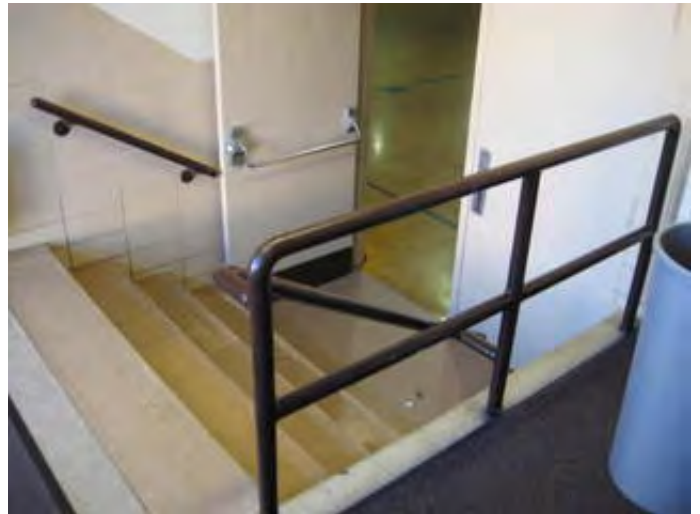
Non-Compliant Stairway and Railing

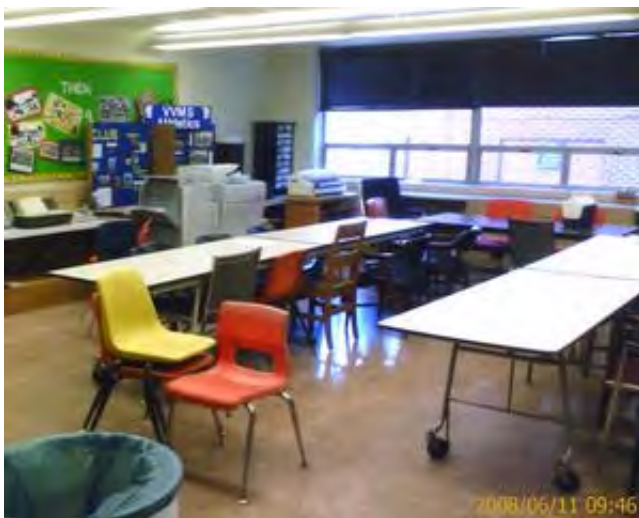
Typical Furniture Condition

Recommendations: Provide for replacement of outdated or inadequate furniture.
