Building Information - Valley View Local (48744) - Farmersville Elementary

Program Type	Classroom Facilities Assistance Program (CFAP) - Regular
Setting	Small City
Assessment Name	Farmersville Elementary with 2016 Costs, 2015 EEA & Related Scope Adjustments
Assessment Date (on-site; non-EEA)	2015-11-06
Kitchen Type	Full Kitchen
Cost Set:	2016
Building Name	Farmersville Elementary
Building IRN	11395
Building Address	202 Jackson Street
Building City	hmhm
Building Zipcode	45325
Building Phone	937-696-2591
Acreage	9.95
Current Grades:	7-8
Teaching Stations	22
Number of Floors	3
Student Capacity	430
Current Enrollment	288
Enrollment Date	2007-07-22
Enrollment Date is the date in which the current enrollment was taken.	
Number of Classrooms	14
Historical Register	NO
Building's Principal	Mrs. Nichole Thomas
Building Type	Middle

Building Construction Information - Valley View Local (48744) - Farmersville Elementary (11395)

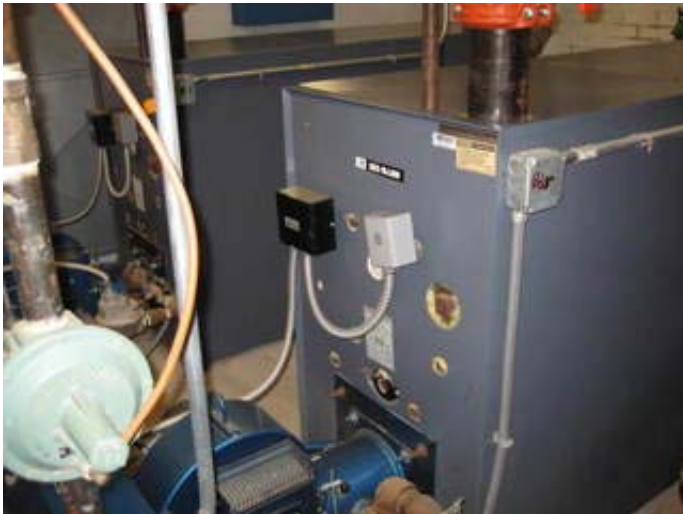
Description: The existing system for the 1923 Original Construction is a natural gas fired hot water boiler type system, installed in 1923, and is in poor condition. The system in the 1923 Auditorium Fixed Seating Area is an extension of that found in the 1923 Original Construction. The existing system for the 1954 Addition is a natural gas fired steam boiler type system, installed in 1954, and is in fair / poor condition. 2-pipe vs. 4-pipe designations are not applicable in this facility, as no central air conditioning is provided. The 1923 Original Construction is equipped with two (2) 78 hot water boilers, manufactured by Weil-McLain, installed in 1994 and in good / fair condition. Heated water is distributed to terminal units in the 1923 Original Construction and 1923 Auditorium Fixed Seating Area consisting of cabinet heaters and an air handler. The terminal equipment was installed in 1923 and is in poor condition. The 1954 Addition is equipped with two LGB steam boilers, manufactured by Weil-McLain, installed in 1996 and in good / fair condition. Steam is distributed to terminal units consisting of unit ventilators, cabinet heaters, and air handlers. The terminal equipment was installed in 1954 and is in fair / poor condition. The system does not comply with the 15 CFM per person fresh air requirements of the Ohio Building Code mechanical code and Ohio School Design Manual. The pneumatic type system temperature controls are original to each addition and are in fair / poor condition. The system does not feature individual temperature controls in all spaces required by the OSDM. The overall system does not feature any central energy recovery systems. The 1923 Original Construction is equipped with louvered interior doors to facilitate Corridor utilization as return air plenums. The 1954 Addition is not equipped with louvered interior doors to facilitate Corridor utilization as return air plenums. The existing systems in the 1923 Original Construction and the 1923 Auditorium Fixed Seating Area are ducted, but the ductwork cannot be integrated into a possible future system due to arrangement, air volume, and routing of existing ductwork. The existing system in the 1954 Addition is not ducted, and floor to structural deck heights will not accommodate the installation of properly sized ductwork for a future Ohio School Design Manual approved system. The overall heating system is evaluated as not being in safe and efficient working order, though long term life expectancy of the existing system is not anticipated. The structure is not equipped with central air conditioning. The site does contain underground fuel tanks that are not currently in use.

Rating: 3 Needs Replacement

1923 Original Construction Hot Water Boilers

Recommendations: Provide new overall heating, ventilating, and air conditioning system to achieve compliance with Ohio Building Code and Ohio School Design Manual standards. Convert the 1954 Addition to a ducted system to facilitate efficient exchange of conditioned air. Replace the existing ductwork in the 1923 Original Construction and the 1923 Auditorium Fixed Seating Area to facilitate efficient exchange of conditioned air with funding provided in conversion to ducted system replacement. Provide architectural soffits in the 1954 Addition to accommodate the installation of ductwork, with funding provided in conversion to ducted system replacement.

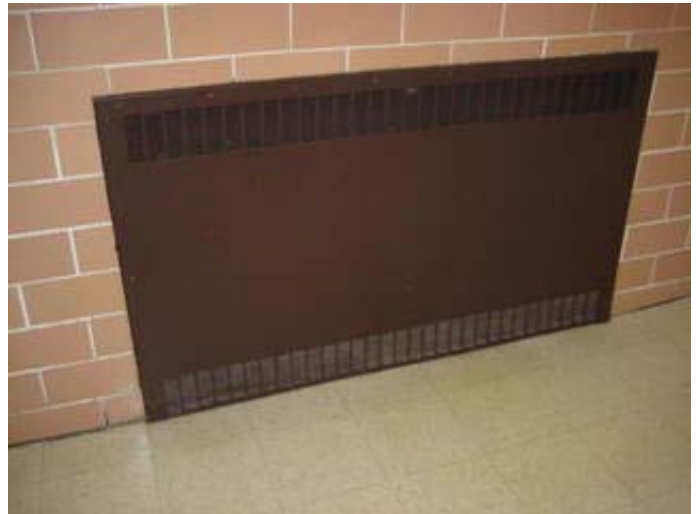
1923 Original Construction Cabinet Heater

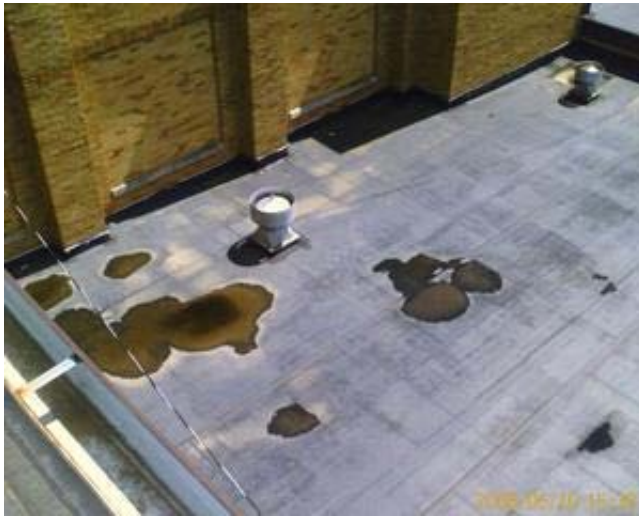
Description: The roof over the 1923 Original Construction and 1923 Auditorium Fixed Seating Area is an EPDM fully adhered membrane system that was installed in 2000 and 2001, and is in good condition. The roof over the 1954 Addition is a combination of asphalt shingles and EPDM fully adhered membrane system that was installed in 1988, and is in fair condition. There are District reports of current leaking. Signs of past leaking were observed during the physical assessment. Access to the 1923 Original Construction and 1923 Auditorium Fixed Seating Area roof was gained by a roof hatch and ladder. Access to the 1954 roof was gained through a second floor window of the 1923 Original Construction. Roof hatch and ladder are in good condition. Fall safety protection cages are not required. There were observations of standing water on the roof. Metal cap flashings and stone copings are in good condition. Roof storm drainage is addressed through a combined system of gutters, downspouts, and wall scuppers, which are properly located, and in good condition. The roof is not equipped with overflow roof drains though they will be required in areas of roof replacement in the 1954 Addition. Overflow roof drains are not required in the 1923 Original Construction and 1923 Auditorium Fixed Seating Area. No problems requiring attention were encountered with any roof penetrations. There are covered walkways attached to this structure connecting main building with modular classrooms. Covered walkway structure type is steel columns and wood joist with metal standing seam roof, all of which are in good condition.

Rating: 3 Needs Replacement

Typical EPDM Roofing Condition

Recommendations: The roof over the overall facility requires replacement to meet Ohio School Design Manual guidelines for age of system and due to condition. To facilitate the school's compliance with OBC provide new overflow roof drains in areas of roof replacement in the 1954 Addition.

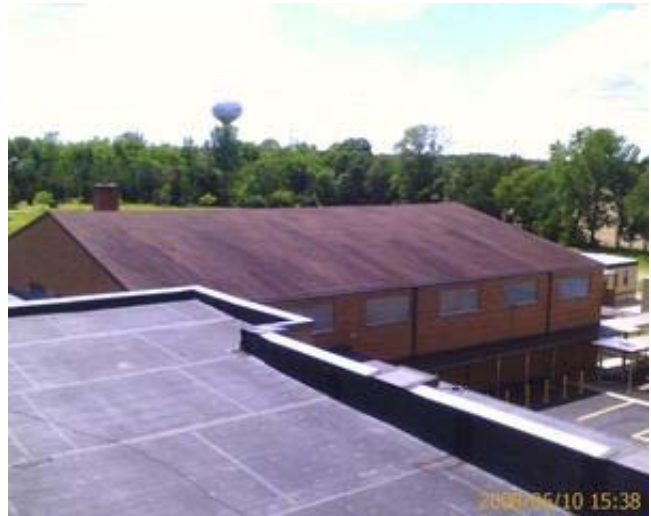
Typical Asphalt Shingle Roof

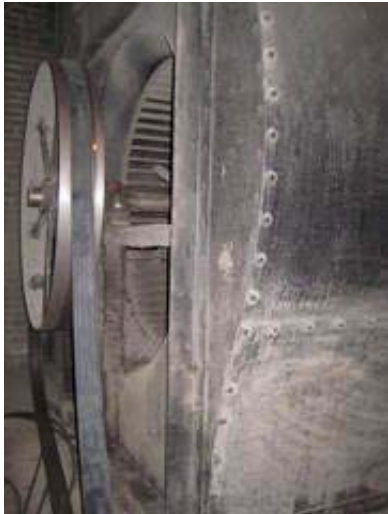
Description: The overall facility is not equipped with a central air conditioning system. Window units are provided in the School Administrative Offices, Computer Lab, Teacher's Lounge, and Clinic locations. The ventilation system in the 1923 Original Construction and 1923 Auditorium Fixed Seating Area consists of an air handler, installed in 1923 and in poor condition, providing fresh air to Classrooms, and air handlers, installed in 1923 and in fair / poor condition, providing fresh air to other miscellaneous spaces such as the Gymnasium and Media Center. The ventilation system in the 1954 Addition consists of unit ventilators, installed in 1954 and in fair condition, providing fresh air to Classrooms and other miscellaneous spaces such as the Cafeteria. Relief air venting is provided by an air handler, a central relief fan, and louvered interior doors in the 1923 Original Construction and 1923 Auditorium Fixed Seating Area and unit ventilators and transfer grilles to Corridors in the 1954 Addition. The ventilation system does not meet the Ohio Building Code 15 CFM per occupant fresh air requirement. The overall system is not compliant with Ohio Building Code and Ohio School Design Manual requirements. Dust collection systems are not required in this facility. Exhaust systems for Restrooms, Kitchen, Gymnasium, Storage Rooms, and Custodial Closets are inadequately placed, and in fair condition. The Art program is not equipped with a kiln.

Rating: 2 Needs Repair

1923 Original Construction Air Handler / Central Relief Fan

Recommendations: Provide an air conditioning system to meet with Ohio Building Code and Ohio School Design Manual requirements. Pricing included in Item A. Replace the existing general building exhaust system. Pricing for the Art Program kiln and associated ventilation system is included in Item J.

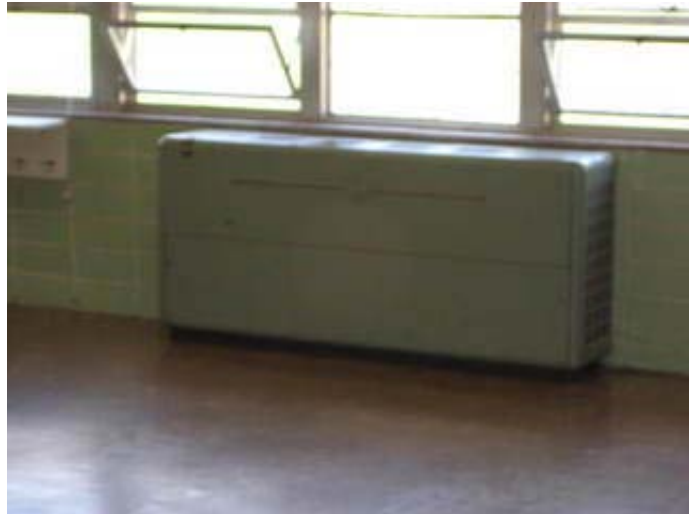
1954 Addition Steam Unit Ventilator

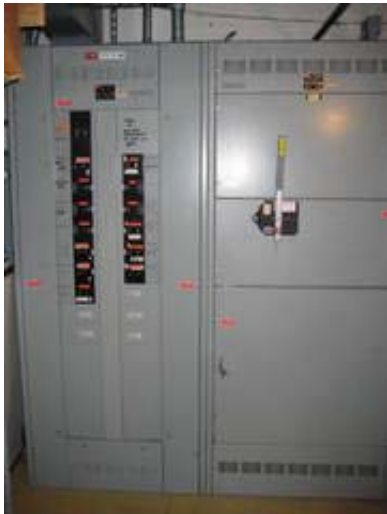
Description: The electrical systems provided to the 1923 Original Construction are two (2) 120/208 volts, 800 amp, 3 phase and 4 wire systems installed in 1984, and in fair condition. The systems in the 1923 Auditorium Fixed Seating Area and 1954 Addition are an extension of that found in the 1923 Original Construction. Power is provided to the school by a single utility owned, pad-mounted transformer located outside of the Boiler Room in the 1923 Original Construction, and in good / fair condition. The panel system in the 1923 Original Construction, installed in 1984, is in fair condition, and can be expanded to add additional capacity. The panel system in the 1954 Addition, installed in 1954, is in poor condition, and cannot be expanded to add additional capacity. The Classrooms are not equipped with adequate electrical outlets. The typical Classroom contains five (5) general purpose outlets, zero (0) dedicated outlets for each Classroom computer, and one (1) dedicated outlet for each Classroom television. Some Classrooms are equipped with as many as six (6) general purpose outlets, while others are equipped with as few as three (3) general purpose outlets. There are not any spaces that have no electrical outlets. The Corridors are not equipped with adequate electrical outlets for servicing. GFI protected exterior outlets are not provided around the perimeter of the building. The facility is equipped with an unsuitable emergency generator. Adequate lightning protection safeguards are not provided. Stage lighting power system including control panel, breakers, and dimmers is inadequately provided, in fair condition and does not meet OSDM requirements. The overall electrical system does not meet Ohio School Design Manual requirements in supporting the current needs of the school, and will be inadequate to meet the facility's future needs.

Rating: 3 Needs Replacement

Main Electrical Distribution Panel

Recommendations: The entire electrical system requires replacement to meet Ohio School Design Manual guidelines for overall capacity and Classroom capacity due to age, condition, lack of OSDM-required features, and to accommodate the addition of an air conditioning system. Provide an emergency generator, with funding included in the electrical system replacement. Provide adequate lightning protection safeguards in the overall facility, including associated grounding system, with funding included in the electrical system replacement. Provide control panel, dimmers, and breakers to support the Stage lighting system, with funding included in the electrical system replacement.

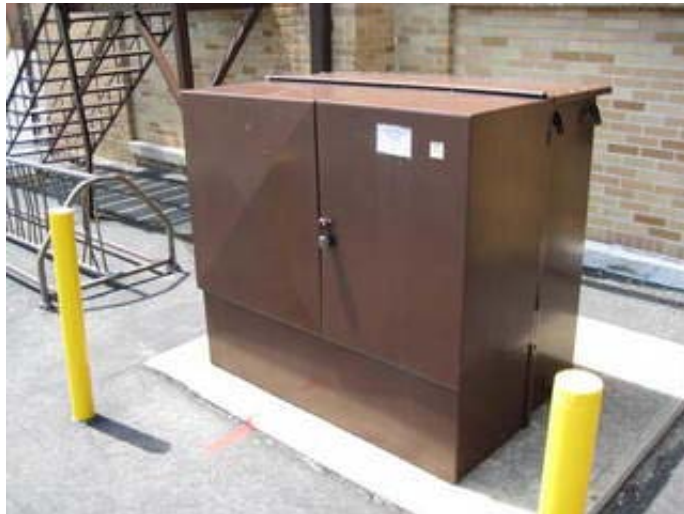
Pad Mounted Transformer

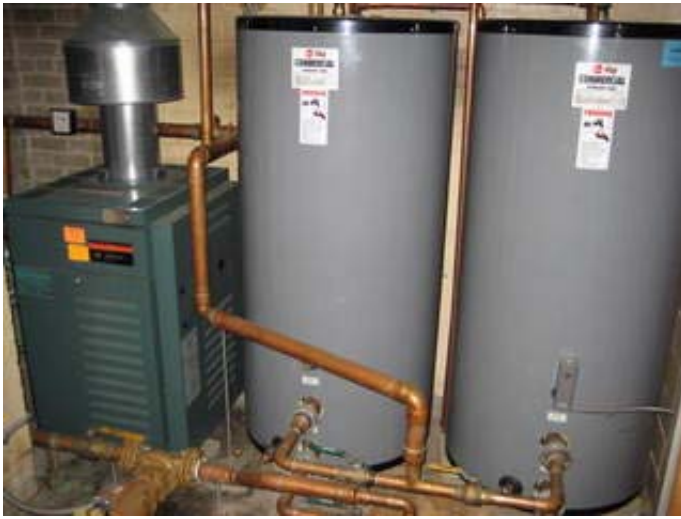
Description: The service entrances in the 1923 Original Construction and 1954 Addition are not equipped with reduced pressure backflow preventers. Water treatment systems are provided in the 1923 Original Construction and 1954 Addition and are in fair condition. The domestic water supply piping in the overall facility is galvanized and copper, is original to each addition, and is in fair condition. The waste piping in the overall facility is cast iron / PVC, is original to each addition, and is in fair / poor condition. The 1955 Addition is equipped with a State 'Censible' 40 gallon natural gas water heater, installed in 1991, and in fair / poor condition. The 1923 Original Construction is equipped with one (1) natural gas water heater in good condition, and installed in 2003, with two (2) separate 115 gallon storage tanks in good condition and installed in 2003. The school contains (2) Large Group Restrooms for boys, (2) Large Group Restrooms for girls, (1) Locker Room Restroom for boys, and (2) Restrooms for staff. Boys' Large Group Restrooms contain (1) ADA and (7) non-ADA (1 wall and 7 floor) mounted flush valve toilets, (13) non-ADA (10 wall and 3 floor) mounted flush valve urinals, as well as (6) non-ADA (3 countertop and 3 wall mounted) lavatories. Girls' Large Group Restrooms contain (14) non-ADA floor mounted flush valve toilets, as well as (6) non-ADA (3 multiple user and 3 wall mounted) lavatories. Boys' Locker Room Restroom contains (1) non-ADA floor mounted flush valve toilet, (1) non-ADA wall mounted flush valve urinal (1) non-ADA wall mounted lavatory, as well as (4) non-ADA showers. Staff Restrooms contain (2) ADA and (3) non-ADA floor mounted (4 tank type and 1 flush valve) toilets, as well as (3) non-ADA wall mounted lavatories. Condition of fixtures is good. The facility is equipped with (5) non-ADA and (4) ADA compliant electric water coolers, in good condition. Special Education Classroom is not equipped with the required Restroom facilities. Kitchen is not equipped with the required Restroom facilities. Health Clinic is equipped with the required Restroom facility, and is in good condition. Kindergarten / Pre-K Classrooms are not equipped with the required Restroom facilities. Kitchen fixtures consist of (2) single and (1) 3-well sinks, as well as (1) dishwasher and (1) garbage disposal unit, which are in fair condition. The school meets the OBC requirements for fixtures. ADA requirements are not met for fixtures and drinking fountains (see Item O). Custodial Closets are properly located and are adequately provided with required service sinks, which are in good condition. Science Classroom / Lab utility sinks, gas connections, compressed air connections, and safety shower / eyewash are not provided, but are not required due to existing grade configuration. The Kitchen is not equipped with a grease interceptor. The Kitchen is provided the required 140 degree hot water supply via a Hatco type water heater, which is in poor condition. Adequate exterior wall hydrants are not provided.

Rating: 3 Needs Replacement

1923 Original Construction Domestic Hot Water Heater and Storage Tanks

Recommendations: Replace galvanized water supply piping in the overall facility with copper piping due to age and condition. Replace sanitary waste piping in the overall facility due to age and condition. Provide two (2) reduced pressure back flow preventers for the 1923 Original Construction and 1954 Addition. Replace both water treatment systems in the overall facility due to age and condition. Replace the 1954 Addition State 'Censible' 40 gallon domestic hot water heater due to age and condition. Due to condition and OSFC standards, replace (4) faucets and valves, (4) toilets, (3) urinals, and (3) lavatories. See Item O for replacement of fixtures related to ADA requirements. See Item J for provisions on Kitchen related equipment. Provide the Kitchen with a grease trap interceptor. Replace the Kitchen water booster heater due to age and condition. Provide five (5) additional exterior wall hydrants.

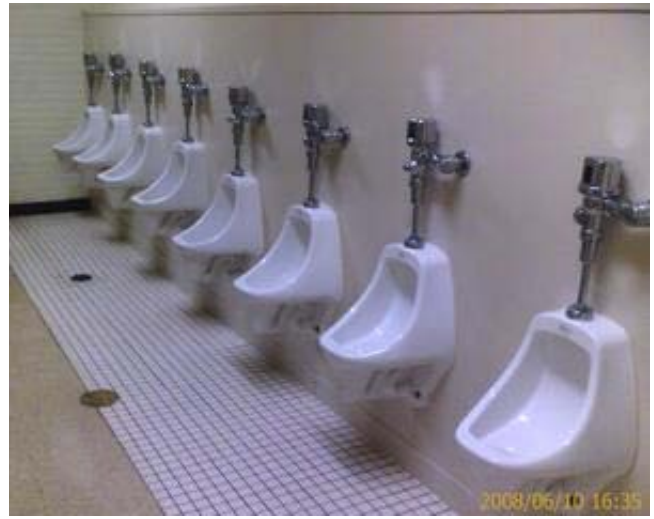
Typical Plumbing Fixture Condition

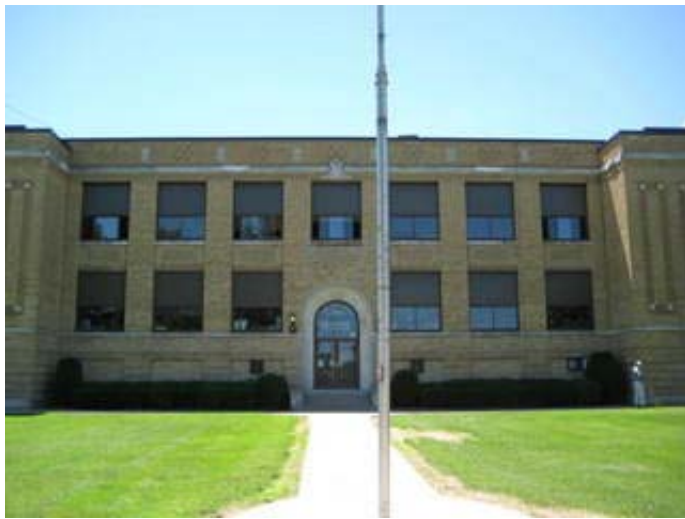
Description: The 1923 Original Construction is equipped with non-thermally broken aluminum frame windows with single glazed non-insulated glazing type window system, which was installed in 1982, and is in fair condition. Window system seals are in fair condition, with minimal air infiltration being experienced. Window system hardware is in fair condition. The window system features surface mounted blinds, which are in fair condition. The window system is not equipped with insect screens on operable windows. The 1955 Addition is equipped with non-thermally broken aluminum frame windows with single glazed non-insulated glazing type window system, which was installed in 1955, and is in poor condition. Window system seals are in poor condition, with frequent air and water infiltration being experienced. Window system hardware is in poor condition. The window system features surface mounted blinds, which are in fair condition or no blinds. The window system is not equipped with insect screens on operable windows. The 1923 Auditorium Fixed Seating Area is not equipped with a window system. This facility is not equipped with any curtain wall systems. There are glass block windows in the 1955 Addition, in good to fair condition. The exterior doors in the 1923 Original Construction are equipped with non-thermally broken aluminum frame sidelights and transoms with single glazed non-insulated glazing, in good condition. The exterior doors in the 1955 Addition are equipped with non-thermally broken hollow metal frame sidelights and transoms with single glazed non-insulated glazing, in fair condition. The school does not contain skylights. There is not a Greenhouse associated with this school.

Rating: 3 Needs Replacement

Typical Aluminum Frame Windows

Recommendations: Provide a new insulated window system with integral blinds to meet with Ohio School Design Manual requirements. Replace the existing glass block in the 1955 Addition with a new insulated window system with integral blinds to meet with Ohio School Design Manual requirements. Replace window transoms and sidelights in exterior doors of the 1923 Original Construction and 1954 Addition to meet with Ohio School Design Manual requirements.

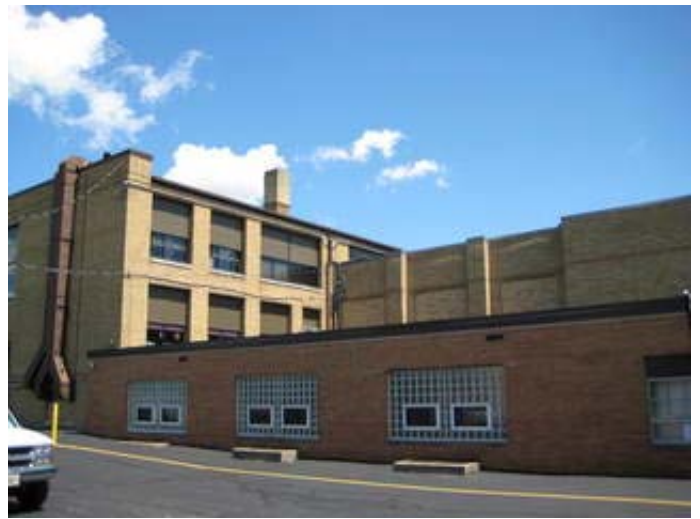
Glass Block Windows

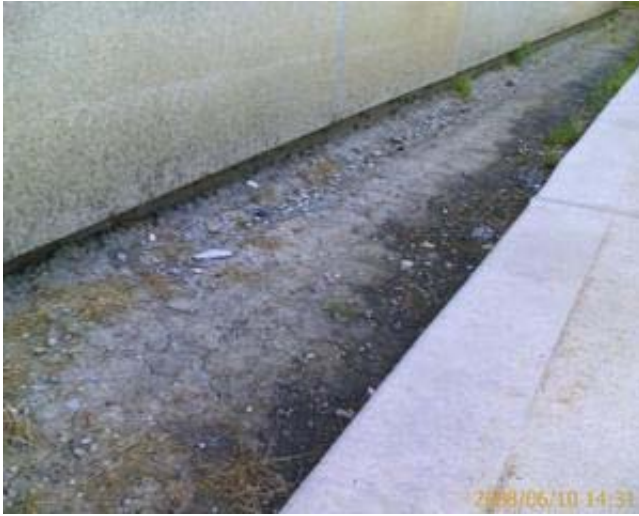
Description: The 1923 Original Construction and 1923 Auditorium Fixed Seating Area are equipped with a combination of cast-in-place concrete and brick masonry foundation walls on concrete footings, which displayed no locations of significant differential settlement, cracking, or leaking, and are in good condition. The 1954 Addition is equipped with cast-in-place concrete foundation walls on concrete footings, which displayed no locations of significant differential settlement, cracking, or leaking, and are in good condition. The District reports that there has been no past leaking. No grading or site drainage deficiencies were noted around the perimeter of the structure that are contributing or could contribute to foundation / wall structural deterioration.

Typical Cast-in-Place Concrete Foundation Wall

Recommendations: Existing conditions require no renovation or replacement at the present time.

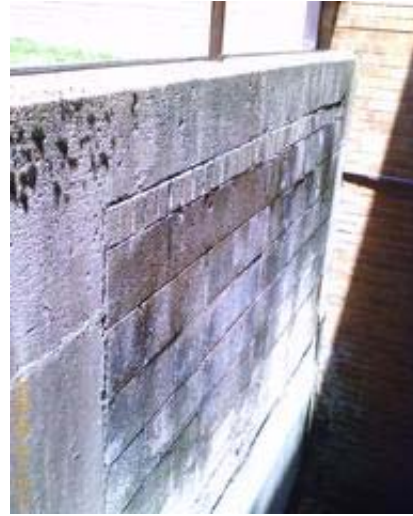
Typical Masonry Foundation Wall

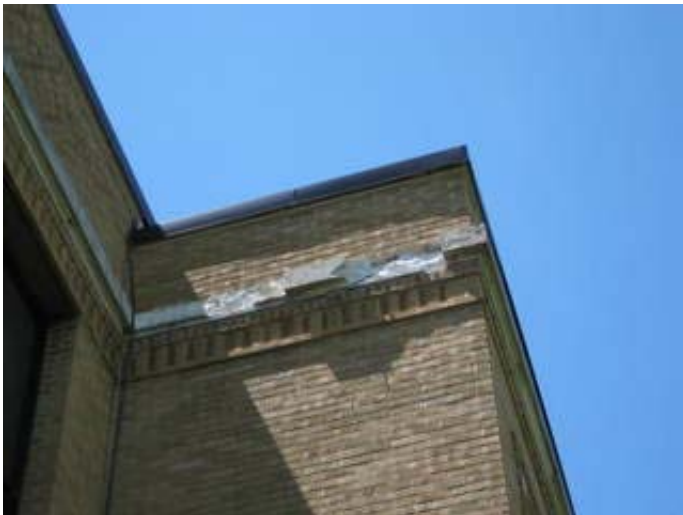
Description: The overall facility has a brick veneer on a masonry bearing wall system, which displayed locations of deterioration, and is in fair to poor condition. The school does not contain control joints, and none are needed as there is no indication of exterior masonry cracking or separation. Control joints are not provided at lintel locations at doors and windows. The school does not contain expansion joints, and none are needed as there is no indication of exterior masonry cracking or separation. The exterior masonry has been partially cleaned and sealed in recent years, and shows evidence of mortar deterioration throughout the overall facility. Architectural exterior accent materials consist of stone, which is in poor condition. Interior walls are concrete masonry units, glazed block, gypsum board partitions, brick, and masonry with plaster and are in fair condition. Interior masonry appears to have been adequately spaced, and does not require control joints. The window sills are stone and an element of the aluminum window system, and are in fair to poor condition. The exterior lintels are steel, and are rusting in fair to poor condition. Chimneys are in fair condition requiring cleaning, sealing and tuckpointing. Canopies over entrances are corrugated aluminum type construction, in good condition, and metal deck with aluminum trim, in poor condition. Exterior soffits are plaster and are in poor condition.

Rating: 2 Needs Repair

Stone Accent Condition

Recommendations: Provide tuckpointing in all areas of mortar deterioration as required through the overall facility, including chimney and stone sills. Provide masonry cleaning and sealing as required through the overall facility, including chimney and stone sills. Scrape and paint steel lintels as required in the 1923 Original Construction and 1954 Addition. Replace stone sills and stone banding as required. Replace entry canopies at the Gymnasium entrances, due to age and condition. Repair exterior plaster soffits as required in the 1923 Original Construction and 1954 Addition.

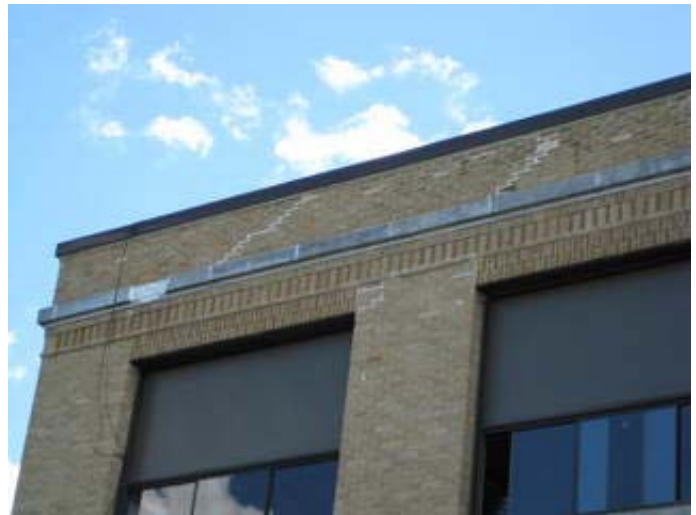
Masonry Condition

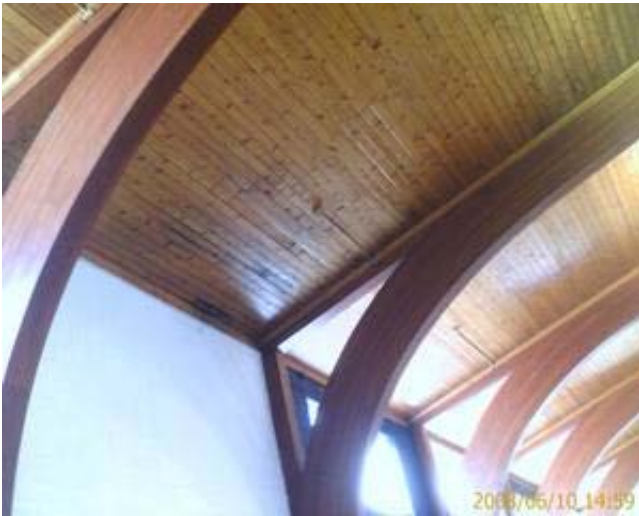
Description: The floor construction of the base floor of the 1923 Original Construction and 1954 Addition is concrete slab-on-grade type construction, and is in good condition. There is no base floor for the 1923 Auditorium Fixed Seating Area due to Auditorium being located on a portion of the second floor of the 1923 Original Construction. There is no crawl space. The floor construction of the intermediate floors of the overall facility is cast-in-place concrete on masonry load bearing walls and is in good condition. Ceiling to structural deck spaces are sufficient to accommodate HVAC, electrical, and plumbing scopes of work in required renovations. The roof construction of the 1923 Original Construction and 1923 Auditorium Fixed Seating Area is wood plank on wood joist type construction, which is in good condition, and is provided with an adequate fire separation. The roof construction of the 1954 Addition is a combination of wood deck on wood laminated beam type construction, located in the Gymnasium area, which is in good condition, but is not provided with an adequate fire separation, and a precast concrete plank with concrete topping type construction, and is in good condition.

Typical Gymnasium Roof Structure

Recommendations: Provisions for fire protection of wood roof deck in the Gymnasium Area of the 1954 Addition are provided under Item U.

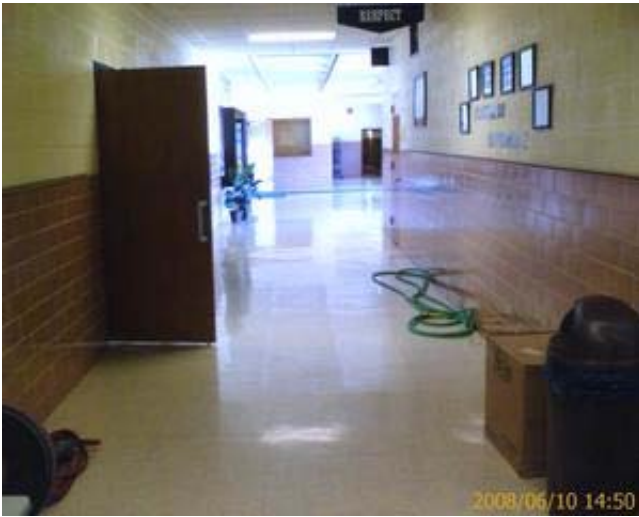
Description: The overall facility features conventionally partitioned Classrooms with a combination of VAT, VCT and carpet type flooring, acoustic ceiling panel type ceilings, as well as a combination of painted brick, painted CMU, glazed block, and painted plaster type wall finishes, and they are in fair condition. The 1923 Original Construction has Corridors with terrazzo and sealed concrete type flooring, acoustic ceiling panel type ceilings, as well as painted plaster type wall finishes, and they are in good condition. There are no Corridors in the 1923 Auditorium Fixed Seating Area. The 1954 Addition has Corridors with VCT type flooring, acoustic ceiling panel type ceilings, as well as a combination of painted CMU and glazed block type wall finishes, and they are in good condition. The overall facility has Restrooms with terrazzo type flooring, painted plaster type ceilings, as well as glazed block and painted CMU type wall finishes, and they are in good condition. Toilet partitions are metal, and are under contract for replacement. Classroom casework in the 1923 Original Construction is wood type construction with plastic laminate tops, is inadequately provided, and in fair condition. Classroom casework in the 1954 Addition is not provided. Classrooms are provided with adequate chalkboards and tackboards, which are in good condition. The lockers / Classroom storage cubbies, located in the Classrooms are adequately provided, and in poor condition. The Art program is not equipped with a kiln. The facility is equipped with wood louvered interior doors that are flush and recessed mounted without proper ADA hardware and clearances, and in poor condition. The Gymnasium space has wood type flooring which has been sanded down for refinishing over the years but is not at an advanced stage of useful lifecycle, exposed wood deck type ceilings, as well as painted CMU type wall finishes, and they are in good condition. Gymnasium telescoping stands are wood type construction in good condition. Gymnasium basketball backboards are fixed type, and are in good condition. The Media Center, located in the 1923 Original Construction, has carpet type flooring, acoustic ceiling panel type ceilings, as well as plaster type wall finishes, and they are in good condition. Student Dining, located in the 1955 Addition, has VCT type flooring, acoustic ceiling panel type ceilings, as well as painted CMU and glazed block type wall finishes, and they are in good condition. OSDM-required fixed equipment for Stage is inadequately provided, and in fair condition. The existing Kitchen is full service, is undersized based on current enrollment, and the existing Kitchen equipment, (no installation date was available at time of assessment), is in good condition. The Kitchen hood is in good to fair condition, and is equipped with the required UL 300 compliant wet chemical fire suppression system. The required 6" overhang on all three exposed sides of the cooking equipment is provided by the hood. Kitchen hood exhaust ductwork is of proper construction and is installed as required by the OSDM and OBMC. Walk-in coolers / freezers are located within the Student Dining space, and are in good condition.

Rating: 3 Needs Replacement

Typical Corridor Finishes

Recommendations: Provide complete replacement of finishes and casework due to installation of systems outlined in Items A, C, D, E, I, K, L, M, N, T, and U. Funding for replacement of interior doors is provided in Item O, including doors here noted as being in poor condition. Due to life span and condition provide new Gymnasium flooring. Overall replacement of toilet partitions was under contract at time of assessment. Provide a new kiln and kiln heat removal hood for the Art program. Provide gypsum board, tape, mud, and paint for the replacement of drywall removal funded in Item T. Provide for the replacement of hard plaster in the 1923 Original Construction and 1923 Auditorium Fixed Seating Area due to work in Item T.

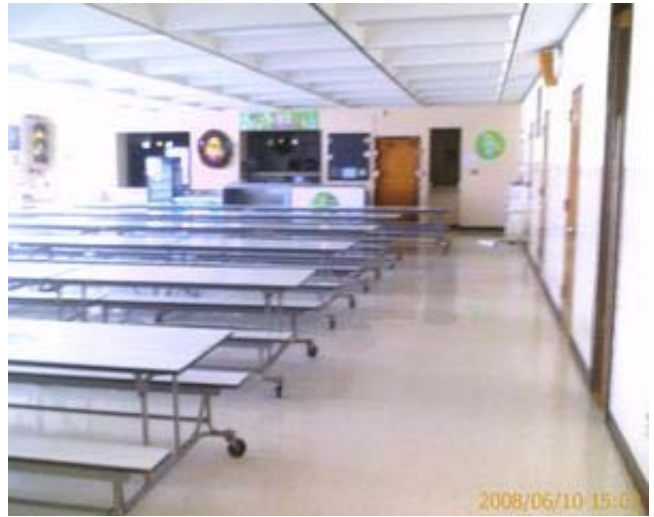
Typical Student Dining Finishes

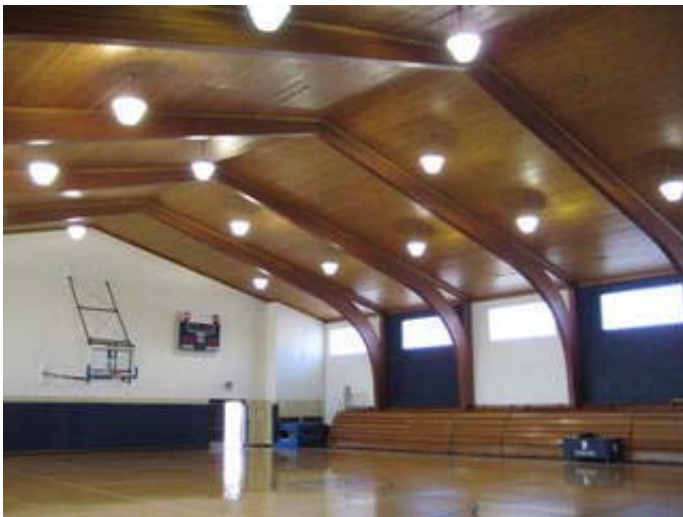
Description: The typical Classrooms in the 1923 Original Construction are equipped with T-8 2x4 lay-in direct fluorescent fixtures with single level switching. Classroom fixtures are in fair condition, providing an average illumination of 34 FC, which is less than the 50 FC recommended by the OSDM. The typical Classrooms in the 1954 Addition are equipped with T-8 2x4 lay-in direct fluorescent fixtures with single level switching. Classroom fixtures are in fair condition, providing an average illumination of 40 FC, which is less than the 50 FC recommended by the OSDM. The typical Corridors in the 1923 Original Construction are equipped with T-8 2x4 lay-in direct fluorescent fixtures with single level switching. Corridor fixtures are in fair condition, providing an average illumination of 12 FC, which is less than the 20 FC recommended by the OSDM. The typical Corridors in the 1954 Addition are equipped with T-8 2x4 lay-in direct fluorescent fixtures with single level switching. Corridor fixtures are in fair condition, providing an average illumination of 22 FC, thus complying with the 20 FC recommended by the OSDM. The Gymnasium spaces are equipped with pendant metal halide type lighting, in good condition, providing an average illumination of 53 FC, thus complying with the 50 FC recommended by the OSDM. The Media Center is equipped with T-8 2x4 lay-in direct fluorescent fixture type lighting in fair condition, providing an average illumination of 52 FC, thus complying with the 50 FC recommended by the OSDM. The Student Dining spaces are equipped with T-8 1x4 surface mount inside recessed coffers fluorescent fixture type lighting with single level switching. Student Dining fixtures are in fair condition, providing an average illumination of 46 FC, which is less than the 50 FC recommended by the OSDM. The Kitchen spaces are equipped with T-8 2x4 lay-in direct fluorescent fixture type lighting with single level switching. Kitchen fixtures are in fair condition, providing an average illumination of 67 FC, which is less than the 75-80 FC recommended by the OSDM. The Service Areas in the overall facility are equipped with incandescent and T-8 1x4 suspended and surface mount fluorescent fixture type lighting in fair / poor condition, providing inadequate illumination. The typical Administrative spaces in the overall facility are equipped with T-8 2x4 lay-in direct fluorescent fixture type lighting in fair condition, providing adequate illumination based on OSDM requirements. The overall lighting systems of the facility are not compliant with Ohio School Design Manual requirements due to age, condition, inadequate lighting levels, lack of multi-level switching, and the utilization of incandescent fixtures.

Rating: 3 Needs Replacement

Gymnasium Metal Halide Light Fixtures

Recommendations: Provide complete replacement of lighting system due to age, condition, inadequate lighting levels, lack of multilevel switching, the utilization of incandescent fixtures, and installation of systems outlined in Items A, C, J and U.

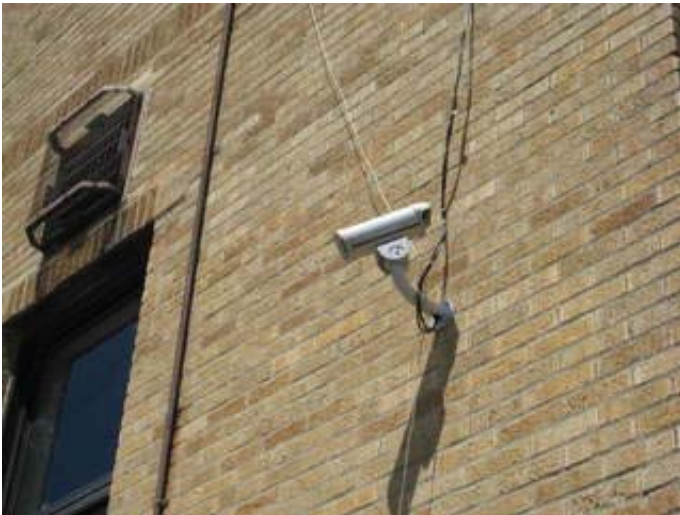
Description: The overall facility contains a CCTV camera type security system in fair condition. Motion detectors are not provided in main entries, central gathering areas, offices, main Corridors, and spaces where 6 or more computers are located. Exterior doors are not equipped with door contacts. An automatic visitor control system is not provided. Compliant color CCTV cameras are inadequately provided at main entry areas, parking lots, central gathering areas, and main Corridors. CCTV is monitored in Administrative Area with the use of the Principal's computer. A compliant computer controlled access control system integrating alarms and video signals, with appropriate UPS backup, is not provided. The system is not equipped with card / biometric readers. The security system is not adequately provided throughout, and the system is not compliant with Ohio School Design Manual guidelines. Existing playground fencing is not compliant with Ohio School Design Manual guidelines. The exterior site lighting system is equipped with surface mounted HID high pressure sodium and metal halide entry lights in fair / poor condition. Pedestrian walkways are not illuminated. Parking areas are illuminated by pole mounted HID metal halide / mercury vapor fixtures in fair condition. Bus pick-up / drop off areas are not illuminated. The exterior site lighting system provides inadequate coverage.

Rating: 3 Needs Replacement

Security System CCTV Camera

Recommendations: Provide complete replacement of security system to meet Ohio School Design Manual guidelines. Provide complete replacement of exterior site lighting system to meet Ohio School Design Manual guidelines. Provide additional playground fencing to meet Ohio School Design Manual guidelines, funding included in complete replacement of security system.

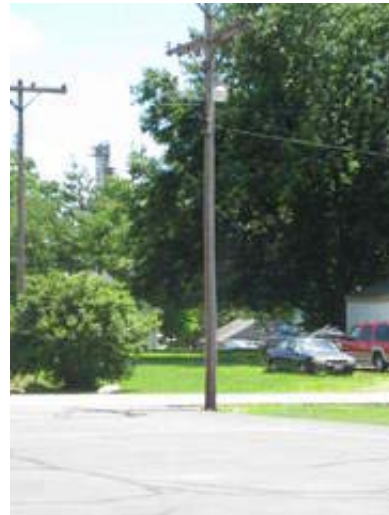
Pole-Mounted HID High Pressure Sodium / Mercury Vapor Light Fixture

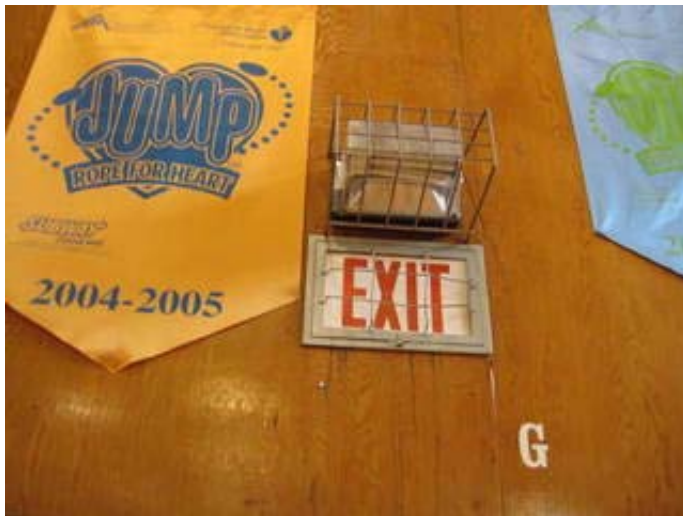
Rating: 3 Needs Replacement

Non-Compliant Non-Illuminated Exit Sign

Recommendations: Provide complete replacement of emergency / egress lighting system to meet Ohio School Design Manual guidelines. Although funding for emergency / egress lighting is not shown for the 1923 Auditorium Fixed Seating Area, work is considered mandatory and funding will be provided via Life Safety Allowance in master planning.

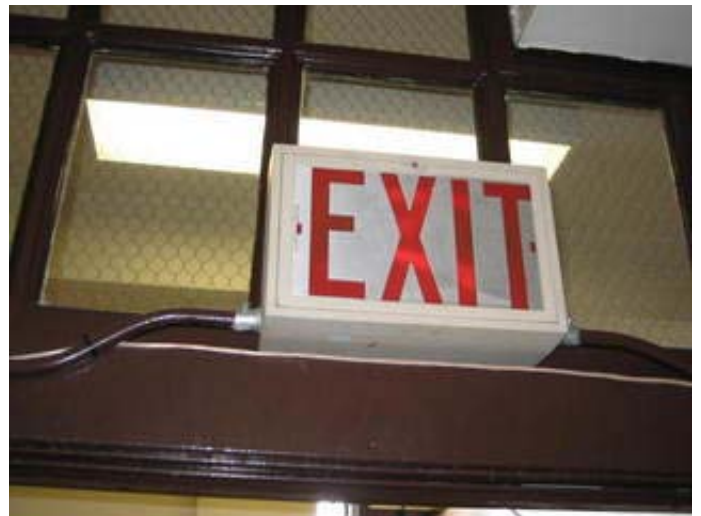
Non-Compliant Lighted Exit Sign

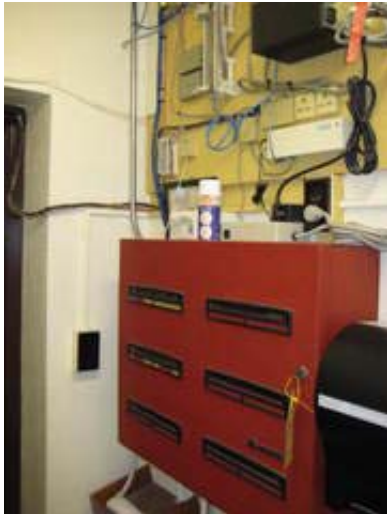
Rating: 3 Needs Replacement

Fire Alarm Control Panel

Recommendations: Provide complete replacement of fire alarm system to meet OBC, NFPA, and Ohio School Design Manual guidelines. Although funding for fire alarm is not shown for the 1923 Auditorium Fixed Seating Area, work is considered mandatory and funding will be provided via Life Safety Allowance in master planning.

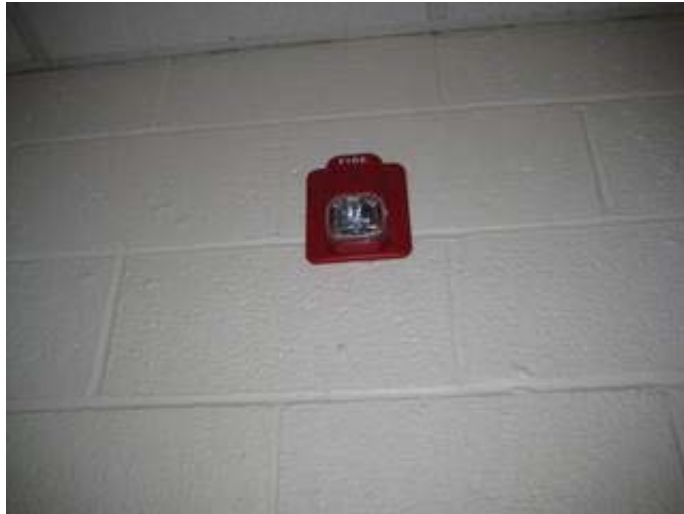
Fire Alarm Horn and Strobe Indicating Device

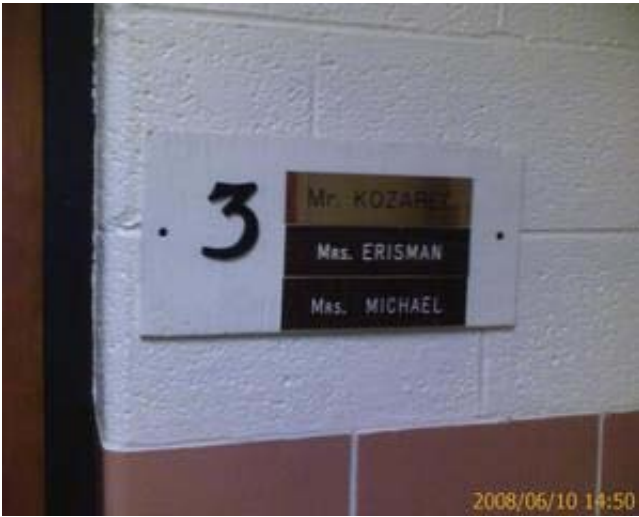
Typical Signage

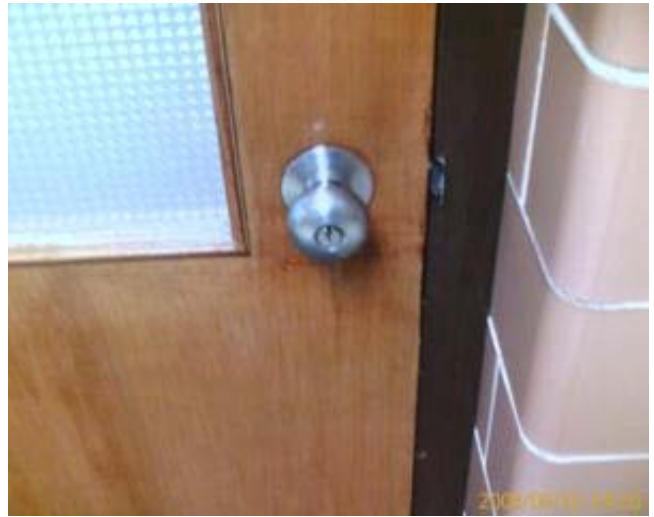
Typical Door Hardware

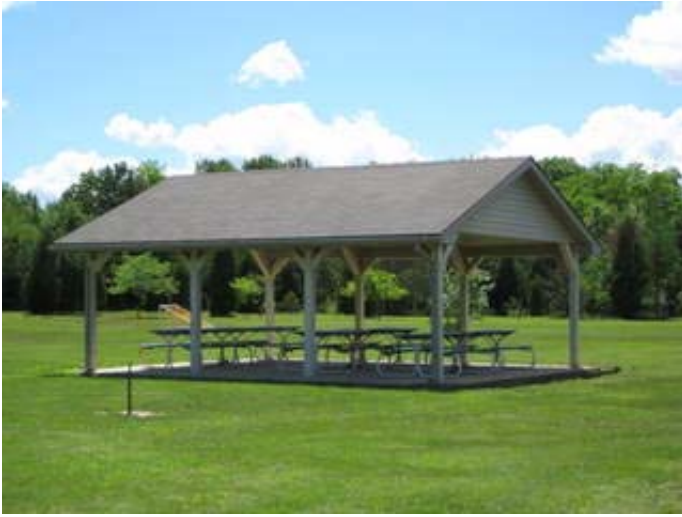
Outdoor Shelter and Picnic Tables

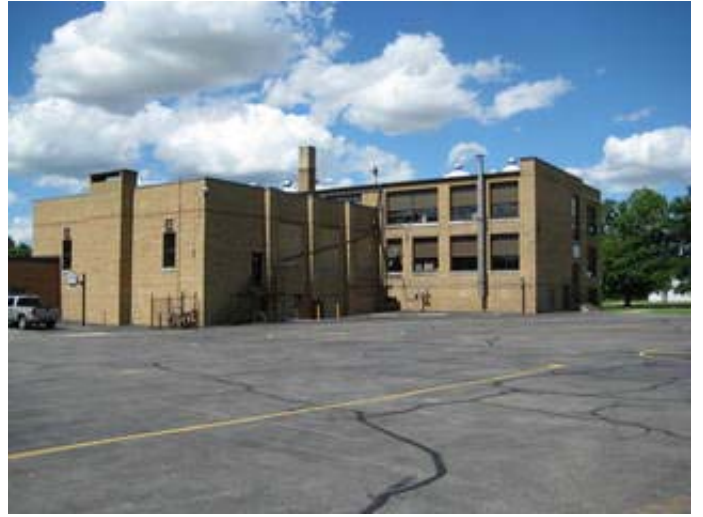
Asphalt Pavement Condition

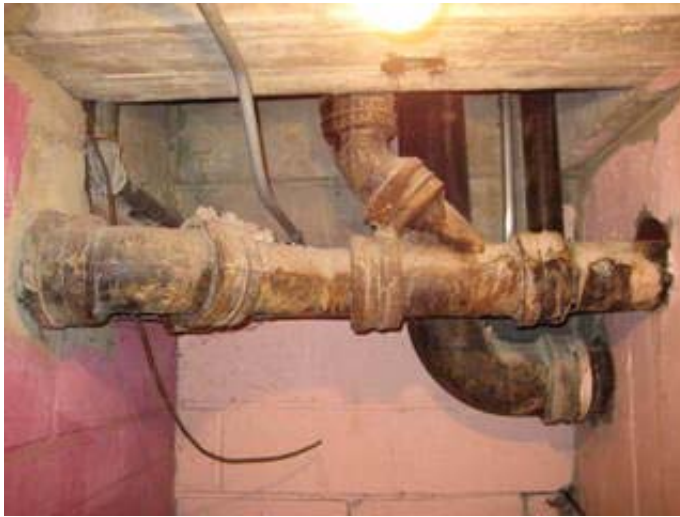
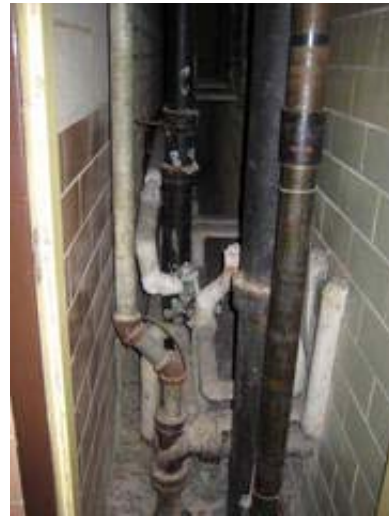
Sanitary Waste Piping

Recommendations: Existing conditions require no renovation or replacement at the present time.

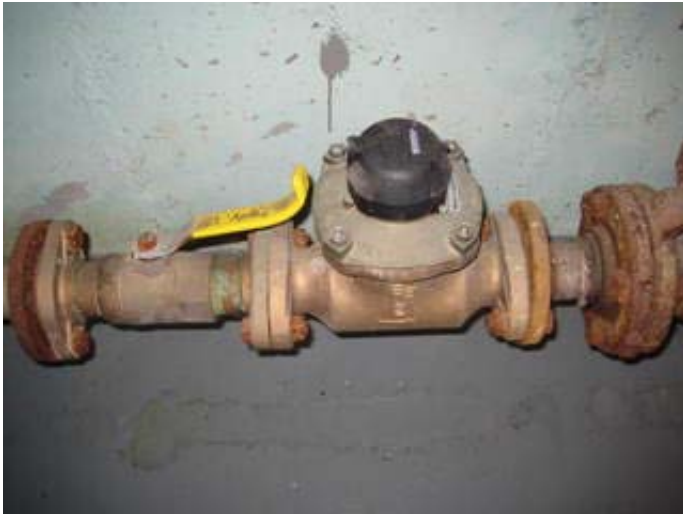
1954 Addition Incoming Domestic Water Meter

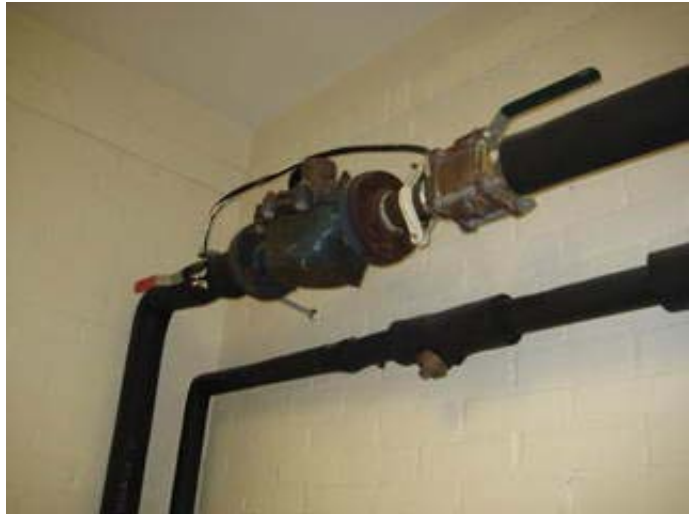
1923 Original Construction Incoming Domestic Water Service

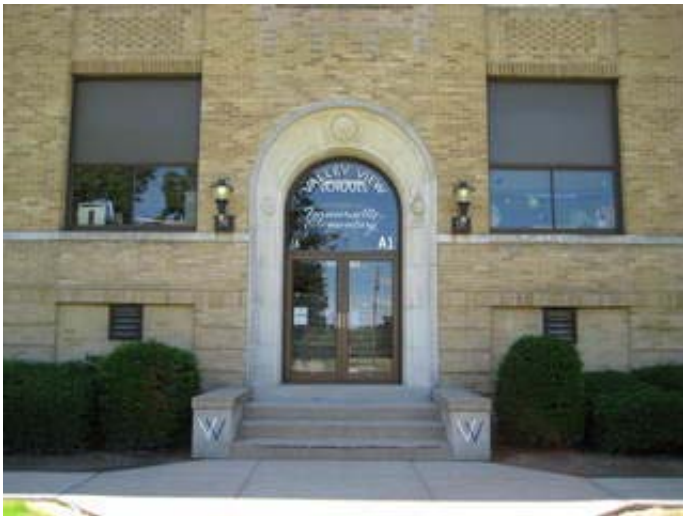
Main Entrance Doors

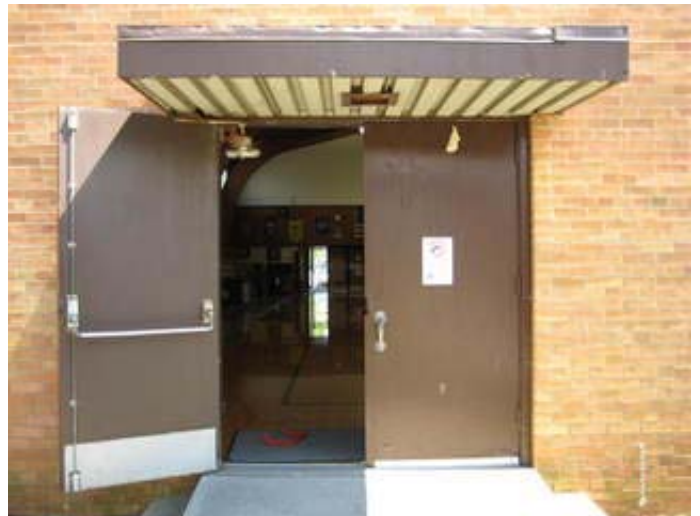
Typical Exterior Doors

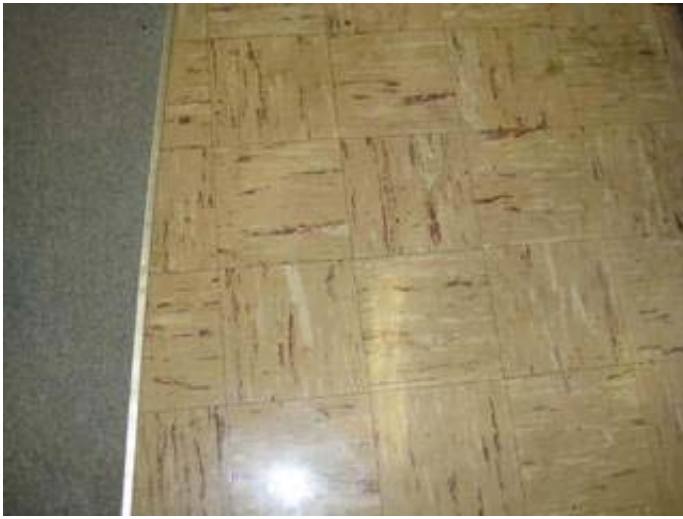
Floor Tiles

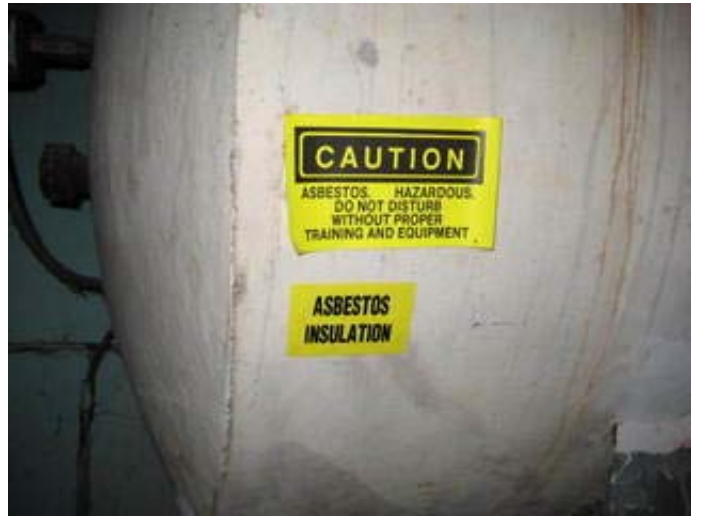
Storage Tank

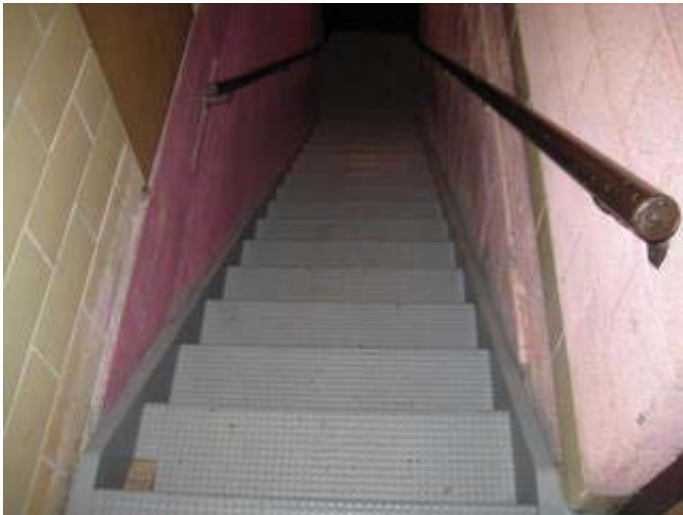
Non-Compliant Stairway and Railing

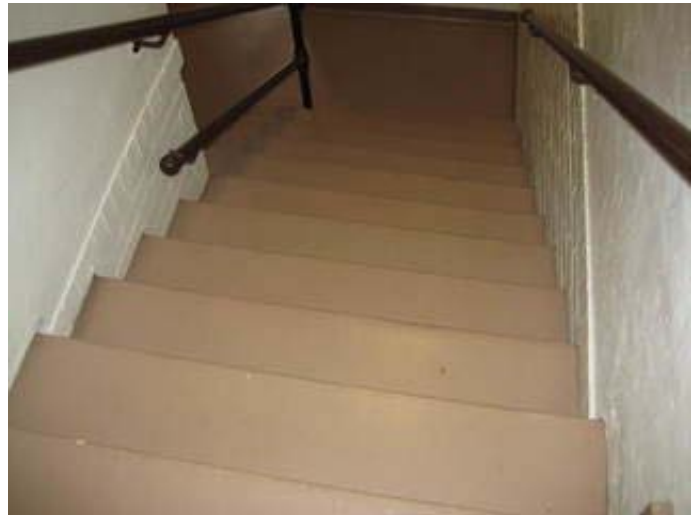
Non-Compliant Stairway and Railing

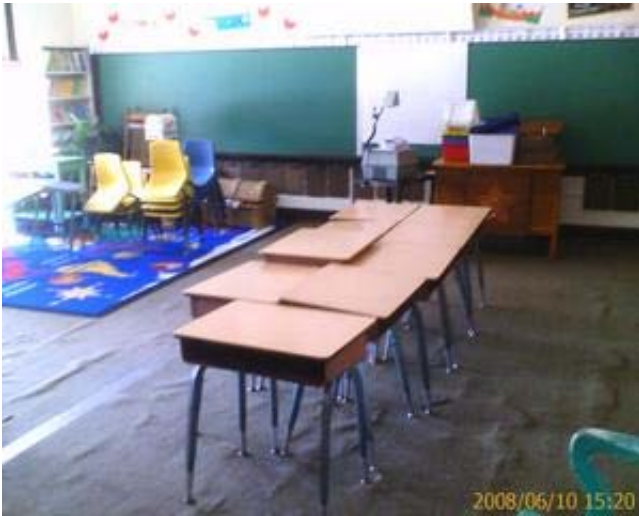
Typical Classroom Loose Furniture
