Building Information - Valley View Local (48744) - Farmersville Elementary

Program Type	Classroom Facilities Assistance Program (CFAP) - Regular
Setting	Small City
Assessment Name	Farmersville Elementary with 2016 Costs, 2015 EEA & Related Scope Adjustments
Assessment Date (on-site; non-EEA)	2015-11-06
Kitchen Type	Full Kitchen
Cost Set:	2016
Building Name	Farmersville Elementary
Building IRN	11395
Building Address	202 Jackson Street
Building City	hmhm
Building Zipcode	45325
Building Phone	937-696-2591
Acreage	9.95
Current Grades:	7-8
Teaching Stations	22
Number of Floors	3
Student Capacity	430
Current Enrollment	288
Enrollment Date	2007-07-22
Enrollment Date is the date in which the current enrollment was taken.	
Number of Classrooms	14
Historical Register	NO
Building's Principal	Mrs. Nichole Thomas
Building Type	Middle

Building Construction Information - Valley View Local (48744) - Farmersville Elementary (11395)

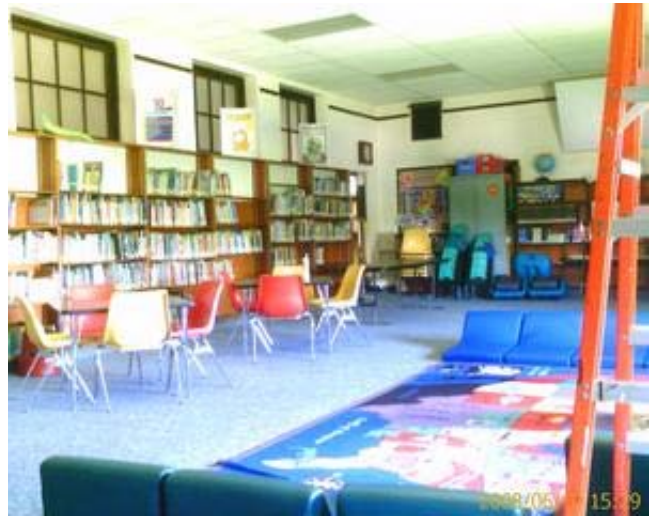
Typical Media Center Loose Furniture

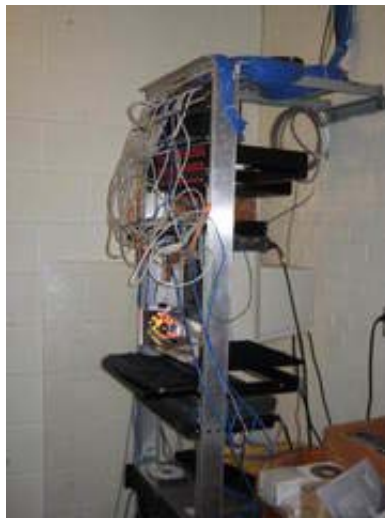
Data Rack

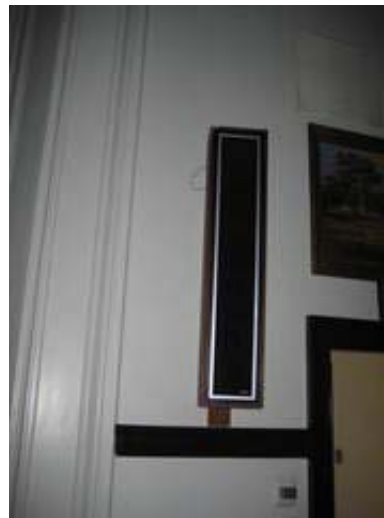
Specialized Stage Sound Equipment
