Building Information - Valley View Local (48744) - Germantown Elementary School

Building Construction Information - Valley View Local (48744) - Germantown Elementary School (13359)

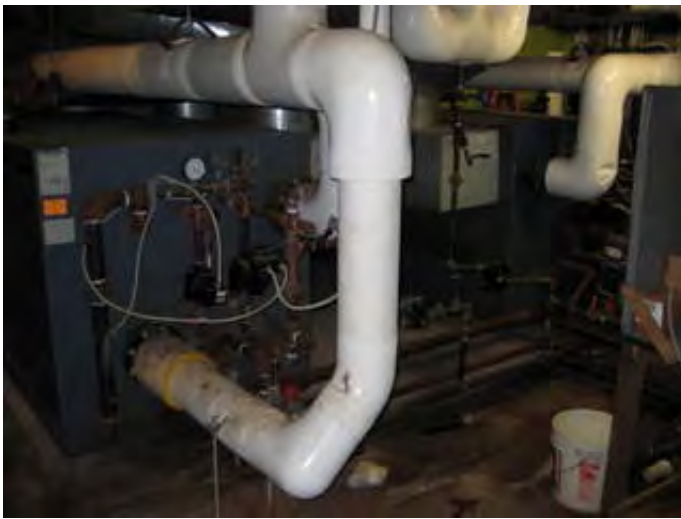
Description: The existing system for the 1948 Original Construction is a natural gas fired steam boiler type system, installed in 1948, and is in fair / poor condition. The system in the 1954 Addition is an extension of that found in the 1948 Original Construction. 2-pipe vs. 4-pipe designations are not applicable in this facility, as no central air conditioning is provided. The two (2) stream boilers, manufactured by Weil-McLain, were installed in 1991 and are in fair condition. Steam is distributed to terminal units consisting of unit ventilators in the 1954 Addition and cabinet heaters, unit heaters, air handlers, and radiators in the 1948 Original Construction. The terminal equipment is original to each addition and is in fair / poor condition. The system does not comply with the 15 CFM per person fresh air requirements of the Ohio Building Code mechanical code and Ohio School Design Manual. The pneumatic type system temperature controls are original to each addition and are in poor condition. The system does not feature individual temperature controls in all spaces required by the OSDM. The overall system does not feature any central energy recovery systems. The facility is not equipped with louvered interior doors to facilitate Corridor utilization as return air plenums. The existing system in the 1948 Original Construction is partially ducted, but the ductwork cannot be integrated into a possible future system due to arrangement, air volume, and routing of existing ductwork. The existing system in the 1954 Addition is not ducted, but floor to structural deck heights will accommodate the installation of properly sized ductwork for a future Ohio School Design Manual approved system. The overall heating system is evaluated as not being in safe and efficient working order, though long term life expectancy of the existing system is not anticipated. The structure is not equipped with central air conditioning. The site does contain underground fuel tanks that are not currently in use.

Rating: 3 Needs Replacement

Natural Gas Fired Steam Boilers

Recommendations: Provide new overall heating, ventilating, and air conditioning system to achieve compliance with Ohio Building Code and Ohio School Design Manual standards. Convert the 1954 Addition to a ducted system to facilitate efficient exchange of conditioned air. Replace existing ductwork in the 1948 Original Construction to facilitate efficient exchange of conditioned air with pricing included in HVAC system replacement.

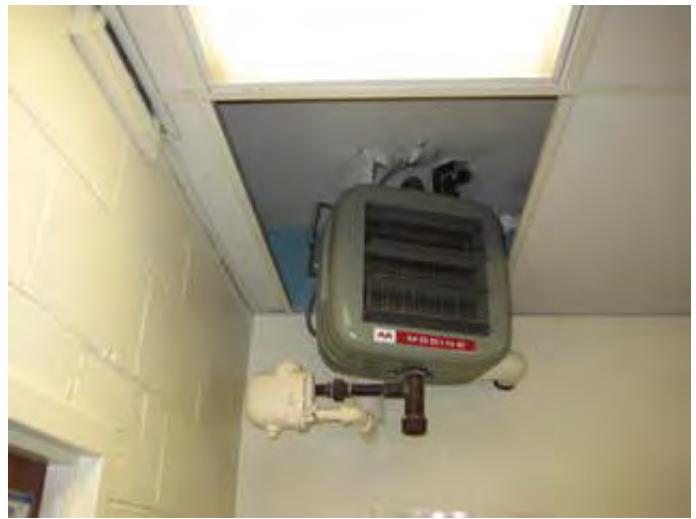
Steam Unit Heater

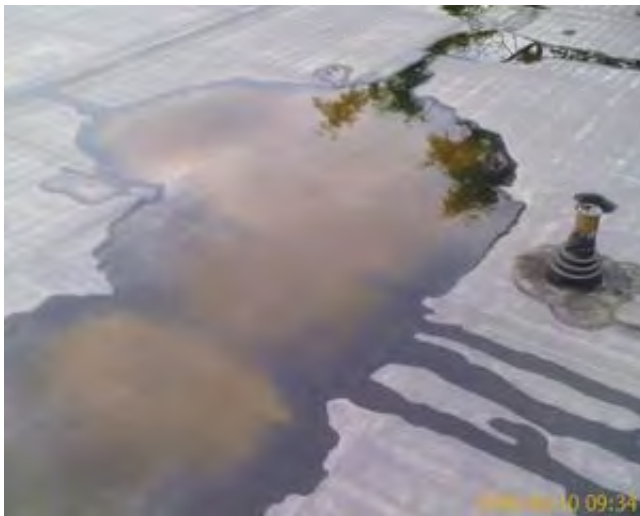
Description: The roof over the overall facility is an EPDM fully adhered membrane system that was installed in 1988, and is in fair condition. There are District reports of current leaking. Signs of past leaking were observed during the physical assessment. Access to the roof was gained by roof hatch and ladder that are in fair condition. Fall safety protection cages are not required. There were observations of standing water on the roof. Metal cap flashings and stone copings are in good condition. Roof storm drainage is addressed through a system of roof drains, which are properly located, and in good condition. The roof is not equipped with overflow roof drains though they will be required in areas of roof replacement. No problems requiring attention were encountered with any roof penetrations. There are covered walkways attached to this structure connecting Germantown Elementary with Valley View Middle School. Covered walkway structure type is metal standing seam roof on steel frame which is in good condition.

Rating: 3 Needs Replacement

Typical Standing Water Condition

Recommendations: The roof over the overall facility requires replacement to meet Ohio School Design Manual guidelines for age of system and due to condition. To facilitate the school's compliance with OBC provide new overflow roof drains in areas of roof replacement in the overall facility.

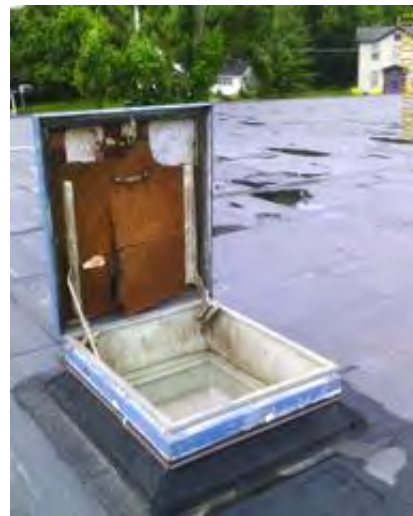
Typical Roof Hatch Condition

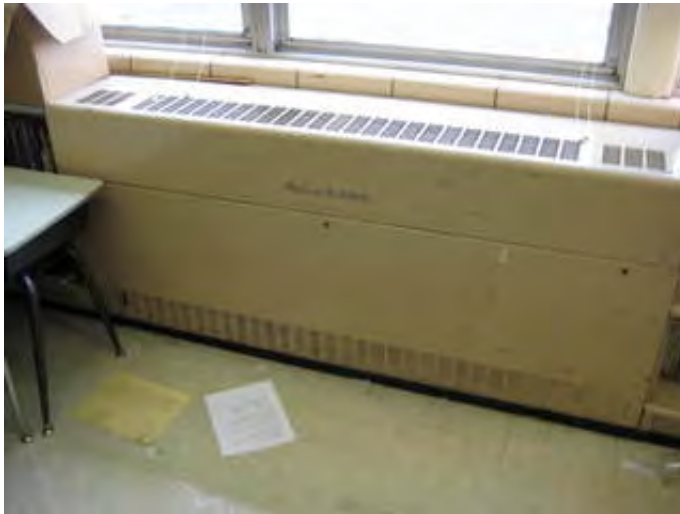
Description: The overall facility is not equipped with a central air conditioning system. Window units are provided in the Staff Lounge and School Administrative Office locations. The ventilation system in the overall facility consists of air handlers in the 1948 Original Construction and unit ventilators in the 1954 Addition, original to each addition and in fair / poor condition, providing fresh air to Classrooms and other miscellaneous spaces such as the Media Center. Relief air venting is provided by transfer grilles to Corridors, unit ventilators in the 1954 Addition and central relief fans. The ventilation system does not meet the Ohio Building Code 15 CFM per occupant fresh air requirement. The overall system is not compliant with Ohio Building Code and Ohio School Design Manual requirements. Dust collection systems are not required in this facility. Exhaust systems for Restrooms, Storage Rooms, and Custodial Closets are inadequately placed, and in fair condition. The Art program is equipped with a kiln, and the existing kiln ventilation system is inadequate.

Rating: 2 Needs Repair

1954 Addition Unit Ventilator

Recommendations: Provide an air conditioning system to meet with Ohio Building Code and Ohio School Design Manual requirements. Pricing included in Item A. Replace the existing general building exhaust system. Replace the existing Art Program kiln ventilation system due to age and condition.

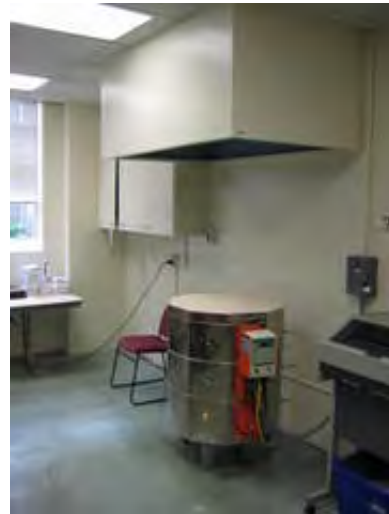
Art Program Kiln and Exhaust System

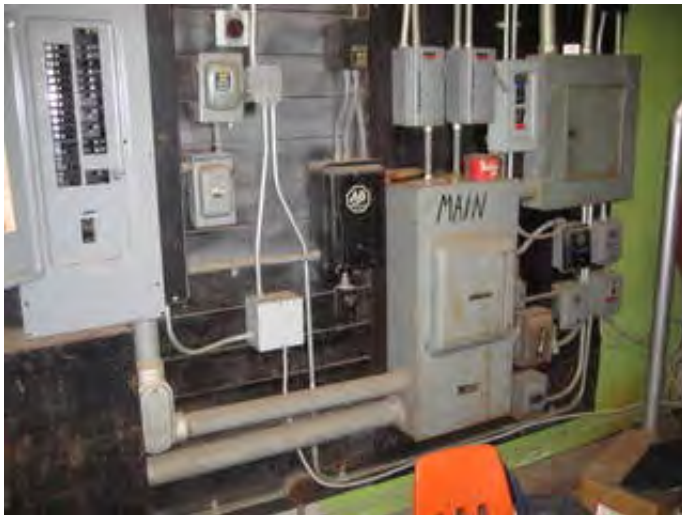
Description: The electrical system provided to the overall facility is a 230 volts, 400 amp, 1 phase and 3 wire system installed in 1948, and is in poor condition. The system in the overall facility is an extension of that found in the adjacent Middle School. Power is provided to the school by multiple utility owned, pole-mounted transformers located at the adjacent Middle School, and in good / fair condition. The panel system, installed in 1948, is in poor condition, and cannot be expanded to add additional capacity. The Classrooms are not equipped with adequate electrical outlets. The typical Classroom contains four (4) general purpose outlets, zero (0) dedicated outlets for each Classroom computer, and one (1) dedicated outlet for each Classroom television. Some Classrooms are equipped with as many as five (5) general purpose outlets, while others are equipped with as few as three (3) general purpose outlets. There are not any spaces that have no electrical outlets. The Corridors are not equipped with adequate electrical outlets for servicing. GFI protected exterior outlets are not provided around the perimeter of the building. The facility is not equipped with an emergency generator. Adequate lightning protection safeguards are not provided. The facility is not equipped with a Stage. The overall electrical system does not meet Ohio School Design Manual requirements in supporting the current needs of the school, and will be inadequate to meet the facility's future needs.

Rating: 3 Needs Replacement

Main Electrical Distribution Panel

Recommendations: The entire electrical system requires replacement to meet Ohio School Design Manual guidelines for overall capacity and Classroom capacity due to age, condition, lack of OSDM-required features, and to accommodate the addition of an air conditioning system. Provide an emergency generator, with funding included in the electrical system replacement. Provide adequate lightning protection safeguards in the overall facility, including associated grounding system, with funding included in the electrical system replacement.

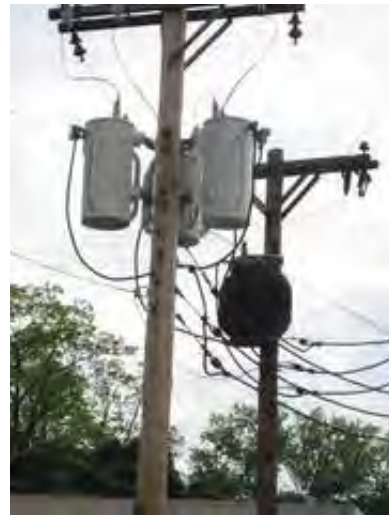
Pole Mounted Transformers

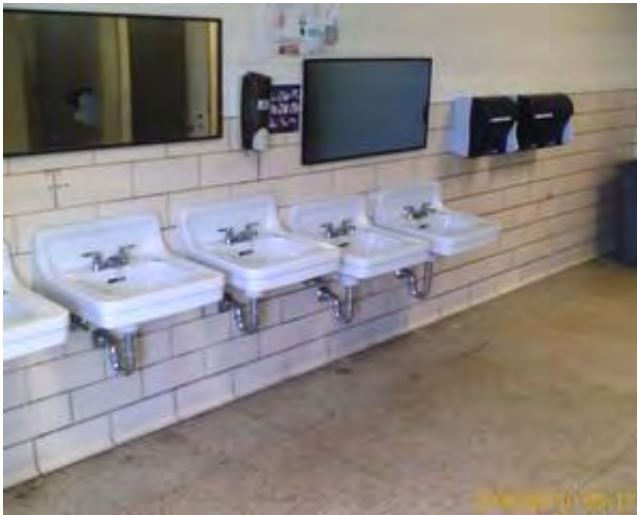
Description: The service entrance is not equipped with a reduced pressure backflow preventer. A water treatment system is provided for the steam boilers and is in poor condition. The domestic water supply piping in the overall facility is 85% galvanized and 15% copper, is original to each addition, and is in fair condition. The waste piping in the overall facility is cast iron / PVC, is original to each addition, and is in fair condition. The facility is equipped with a State 'Sensible' type 40 gallon natural gas water heater, installed in 1991, and in fair condition. The school contains (2) Large Group Restrooms for boys, (2) Large Group Restrooms for girls, and (2) Restrooms for staff. Boys' Large Group Restrooms contain (9) non-ADA floor mounted flush valve toilets, (12) non-ADA wall mounted flush valve urinals, as well as (7) non-ADA wall mounted lavatories. Girls' Large Group Restrooms contain (15) non-ADA floor mounted flush valve toilets, as well as (7) non-ADA wall mounted lavatories. Staff Restrooms contain (2) non-ADA floor mounted flush valve toilets, as well as (2) non-ADA wall mounted lavatories. Condition of fixtures is good. The facility is equipped with (4) ADA and (2) non-ADA electric water coolers, in fair condition. Special Education Classroom is not equipped with the required Restroom facilities. Health Clinic is not equipped with the required Restroom facilities. Kindergarten Classrooms are not equipped with the required Restroom facilities. The facility is not equipped with a Kitchen. The Middle School in the adjacent building serves as the Kitchen and Cafeteria. The school meets the OBC requirements for fixtures except for drinking fountains. ADA requirements are not met for fixtures and drinking fountains (see Item O). Custodial Closets are properly located and are adequately provided with required service sinks, which are in good condition. Science Classroom / Lab utility sinks, gas connections, compressed air connections, and safety shower / eyewash are not provided, but are not required due to existing grade configuration. Adequate exterior wall hydrants are not provided.

Rating: 3 Needs Replacement

Typical Fixture Condition

Recommendations: Replace galvanized water supply piping in the overall facility with copper piping due to age and condition. Replace sanitary waste piping in the overall facility due to age and condition. Provide reduced pressure back flow preventer. Replace water treatment system due to age and condition. Replace the domestic hot water heater due to age and condition. To facilitate the school's compliance with OBC and OSFC requirements provide (3) new electric water coolers. See Item O for replacement of fixtures related to ADA requirements. Provide five (5) additional exterior wall hydrants.

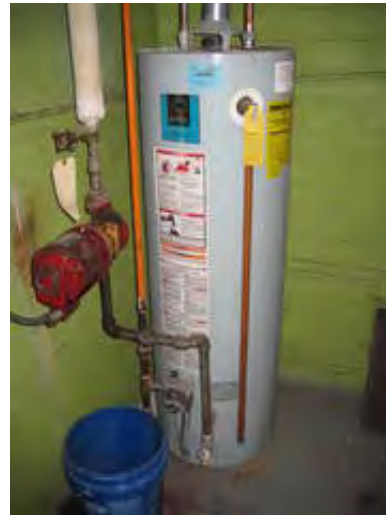
Natural Gas Fired 40 Gallon Domestic Water Heater

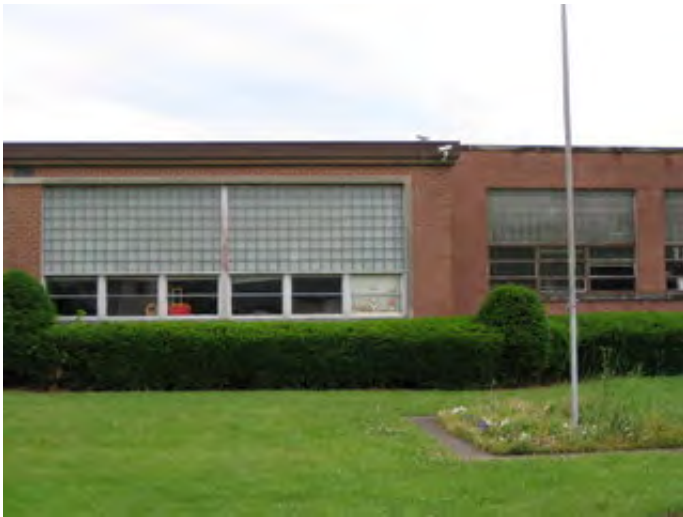
Description: The 1948 Original Construction is equipped with non-thermally broken steel frame windows with single glazed non-insulated glazing type window system, which was installed in 1948, and is in poor condition. Window system seals are in poor condition, with frequent air and water infiltration being experienced. Window system hardware is in poor condition. The window system features surface mounted blinds, which are in fair to poor condition. The window system is not equipped with insect screens on operable windows. The 1954 Addition is equipped with non-thermally broken aluminum frame windows with single glazed non-insulated glazing type window system, which was installed in 1954, and is in poor condition. Window system seals are in poor condition, with frequent air and water infiltration being experienced. Window system hardware is in poor condition. The window system features surface mounted blinds, which are in fair to poor condition. The window system is not equipped with insect screens on operable windows. This facility is not equipped with any curtain wall systems. There are glass block windows in the overall facility, in poor condition. The exterior doors in the 1954 Addition are equipped with non-thermally broken hollow metal frame sidelights and transoms with single glazed non-insulated glazing, in poor condition. The school does not contain skylights. There is not a Greenhouse associated with this school.

Rating: 3 Needs Replacement

Typical Aluminum Frame Windows with Glass Block

Recommendations: Provide a new insulated window system with integral blinds in the overall facility to meet with Ohio School Design Manual requirements. Replace the existing glass block in the overall facility with a new insulated window system with integral blinds to meet with Ohio School Design Manual requirements. Replace window transoms and sidelights in exterior doors of the 1954 Addition to meet with Ohio School Design Manual requirements. Provide security screens for all lower level windows.

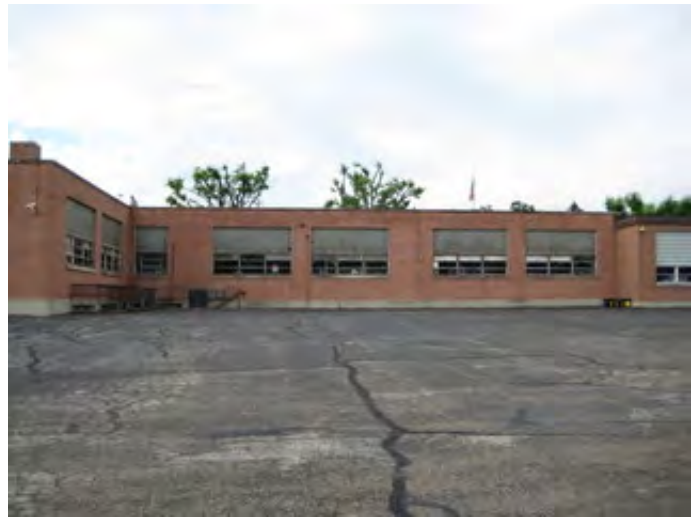
Typical Steel Frame Windows with Glass Block

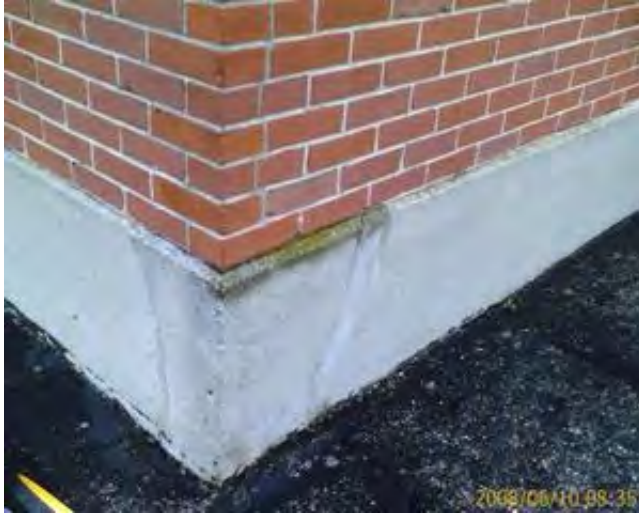
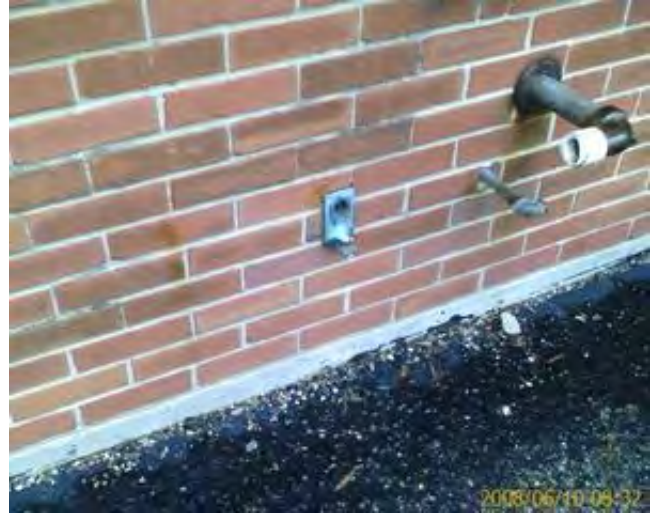
Description: The overall facility is equipped with cast-in-place concrete foundation walls on concrete footings, which displayed no locations of significant differential settlement, cracking, or leaking, and are in good condition. The District reports that there has been no past leaking. No grading or site drainage deficiencies were noted around the perimeter of the structure that are contributing or could contribute to foundation / wall structural deterioration.

Typical Cast-in-Place Concrete Foundation Wall

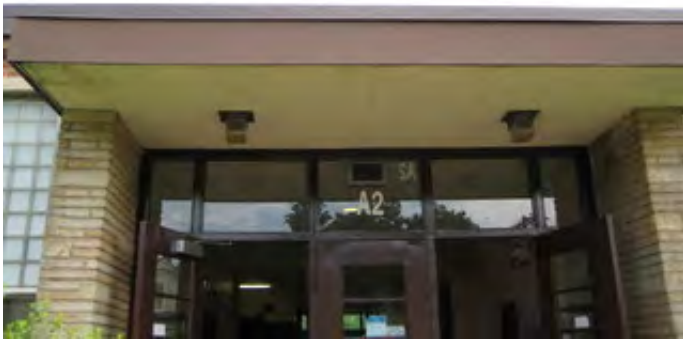
Plaster Soffit

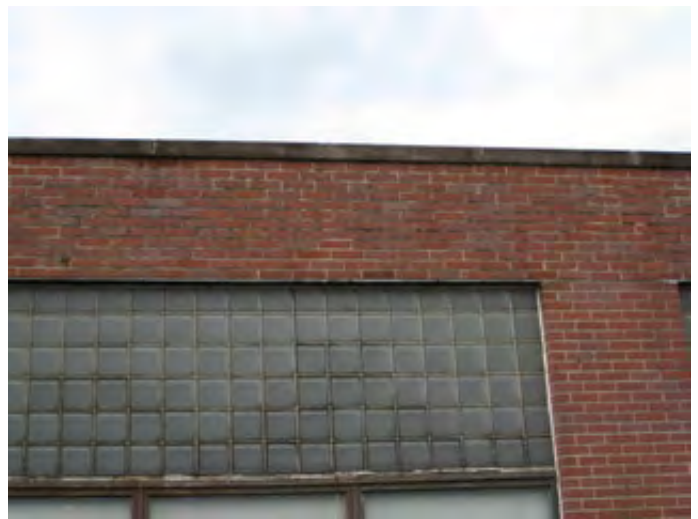
Description: The overall facility has a brick veneer on a masonry bearing wall system, which displayed minimal locations of deterioration, and is in good to fair condition. The exterior masonry appears to have appropriately spaced and adequately caulked control joints. Control joints are not provided at lintel locations at doors and windows. The school does not contain expansion joints, and none are needed as there is no indication of exterior masonry cracking or separation. The exterior masonry has been partially cleaned and sealed in recent years, and shows evidence of mortar deterioration on the north facade of the overall facility. Architectural exterior accent material consists of stone, which is in good to fair condition. Interior walls are concrete masonry units, glazed block, and masonry with plaster and are in fair condition. Interior masonry appears to have adequately spaced and caulked control joints in fair condition. The window sills are stone, and are in fair condition. The exterior lintels are steel, and are rusting in fair to poor condition. Window wells on the north facade have chainlink security fencing, in poor condition. Chimneys are in fair condition requiring cleaning, sealing, and tuckpointing. Canopies over entrances are concrete type construction, and are in fair to poor condition. Exterior soffits are plaster type, and are in fair to poor condition. Walkways to adjacent buildings consist of a steel frame with corrugated aluminum siding, and are in fair to poor condition.

Rating: 2 Needs Repair

Brick Veneer Condition

Recommendations: Provide tuckpointing in all areas of mortar deterioration as required through the overall facility. Pricing to include chimney and stone sills. Provide masonry cleaning and sealing as required through the overall facility. Pricing to include chimney and stone sills. Scrape and paint steel lintels as required through the overall facility. Repair exterior plaster soffits as required through the overall facility. Patch and repair concrete canopies as required in the 1948 Original Construction. Replace corrugated aluminum at covered walkways. Replace security fencing at windows wells with security screens at the first floor windows as required through the overall facility. Funding provided in Item F.

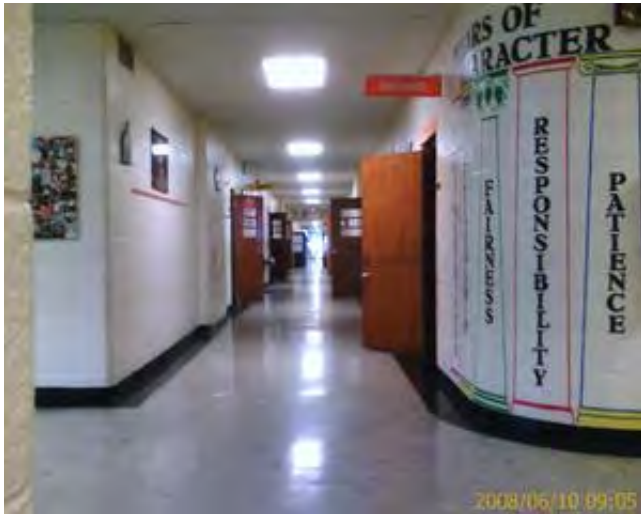
Description: The overall facility features conventionally partitioned Classrooms with a combination of VCT, VAT, and carpet flooring, acoustical ceiling panel ceilings in the 1948 Original Construction and acoustical plaster ceilings in the 1954 Addition, as well as a combination of painted CMU and glazed block type wall finishes, and they are in good condition. The 1948 Original Construction has Corridors with a combination of sealed concrete and VAT type flooring, acoustical ceiling panel type ceilings, as well as a combination of painted plaster and painted CMU type wall finishes, and they are in good condition. The 1954 Addition has Corridors with VCT type flooring, acoustical plaster ceilings, as well as painted CMU type wall finishes, and they are in good condition. The overall facility has Restrooms with terrazzo type flooring, acoustical ceiling panel type ceilings, as well as a combination of glazed block and painted CMU type wall finishes, and they are in good condition. Toilet partitions are marble / stone and wood, and are in fair condition. No casework is provided in the Classrooms. Classrooms are provided adequate chalkboards, markerboards, and tackboards, in addition to a shared smartboard, all of which are in good condition. The lockers / Classroom storage cubbies, located in the Classrooms, are inadequately provided, and in poor condition. The Art program is equipped with a kiln in good condition, and existing kiln ventilation is inadequate. The overall facility is equipped with a combination of wood louvered and non-louvered interior doors that are mostly flush mounted without proper ADA hardware and clearances, and in poor condition. Gymnasium space is not provided in this facility. Physical Education program is provided in Valley View Middle School. The Media Center, located in the 1948 Original Construction, has carpet type flooring, acoustic ceiling tile type ceilings, as well as painted plaster type wall finishes, and they are in fair condition. Student Dining space is not provided in this facility. Student Dining services are provided in Valley View Middle School. No Kitchen is provided in this facility. Food service needs are provided in Valley View Middle School.

Rating: 3 Needs Replacement

Typical Corridor Condition

Recommendations: Provide complete replacement of finishes and casework due to installation of systems outlined in Items A, C, D, E, I, K, L, M, N, T, U. Funding for replacement of interior doors is provided in Item O, including doors here noted as being in poor condition. Heat removal hood for the Art program kiln is addressed under Item C. Provide for masonry infill of old ventilation grilles. Funding for the replacement of ceiling and floor materials due to work in Item T is included in the complete replacement of finishes.

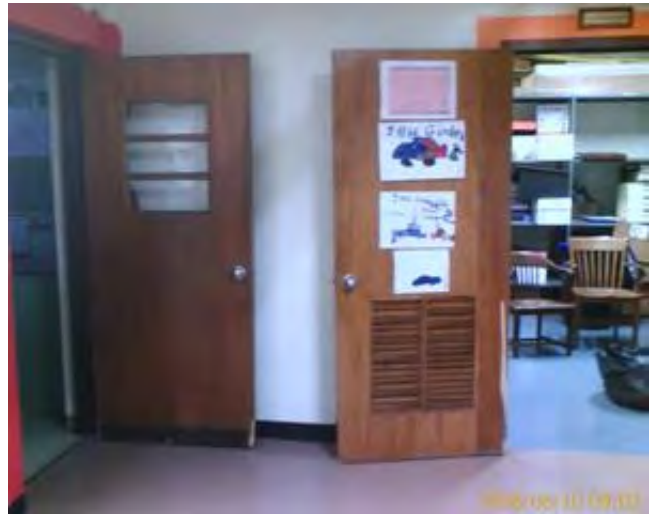
Typical Door Condition

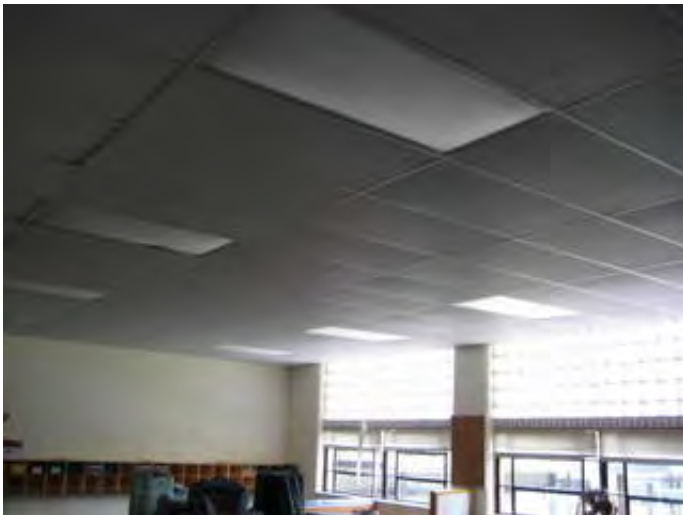
Description: The typical Classrooms in the 1948 Original Construction are equipped with T-8 2x4 lay-in direct fluorescent fixtures with single level switching. Classroom fixtures are in fair condition, providing an average illumination of 33 FC, which is less than the 50 FC recommended by the OSDM. The typical Classrooms in the 1954 Addition are equipped with T-8 1x4 surface mount fluorescent fixtures with single level switching. Classroom fixtures are in fair / poor condition, providing an average illumination of 46 FC, which is less than the 50 FC recommended by the OSDM. The typical Corridors in the 1948 Original Construction are equipped with T-8 2x4 lay-in direct fluorescent fixtures with single level switching. Corridor fixtures are in fair condition, providing an average illumination of 15 FC, which is less than the 20 FC recommended by the OSDM. The typical Corridors in the 1954 Addition are equipped with T-8 1x4 surface mount fluorescent fixtures with single level switching. Corridor fixtures are in fair / poor condition, providing an average illumination of 21 FC, thus complying with the 20 FC recommended by the OSDM. The facility is not equipped with Gymnasium spaces. The Media Center is equipped with T-8 1x4 surface mount fluorescent fixture type lighting in fair / poor condition, providing an average illumination of 44 FC, which is less than the 50 FC recommended by the OSDM. The facility is not equipped with Student Dining spaces. The facility is not equipped with Kitchen spaces. The Service Areas in the overall facility are equipped with incandescent and T-8 suspended fluorescent fixture type lighting in poor condition, providing inadequate illumination. The typical Administrative spaces in the overall facility are equipped with T-8 1x4 surface mount fluorescent fixture type lighting in fair condition, providing adequate illumination based on OSDM requirements. The overall lighting systems of the facility are not compliant with Ohio School Design Manual requirements due to age, condition, inadequate lighting levels, lack of multi-level switching, and the utilization of incandescent fixtures.

Rating: 3 Needs Replacement

1948 Original Construction Classroom Fluorescent Light Fixtures

Recommendations: Provide complete replacement of lighting system due to age, condition, inadequate lighting levels, lack of multilevel switching, the utilization of incandescent fixtures, and installation of systems outlined in Items A, C, J, and U.

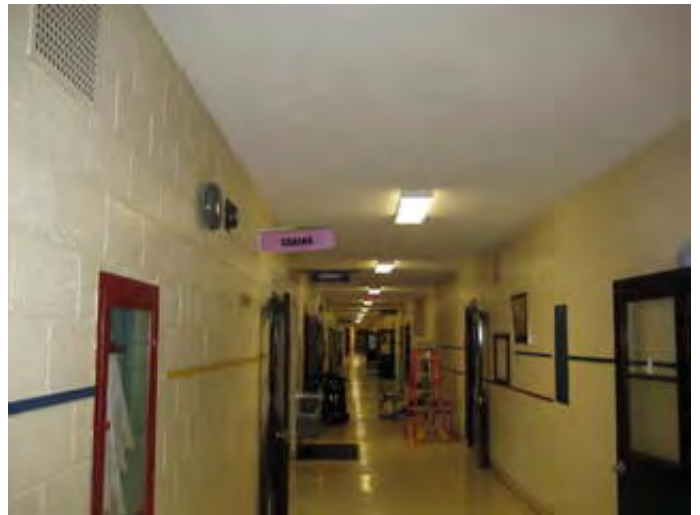
1954 Addition Corridor Fluorescent Light Fixtures

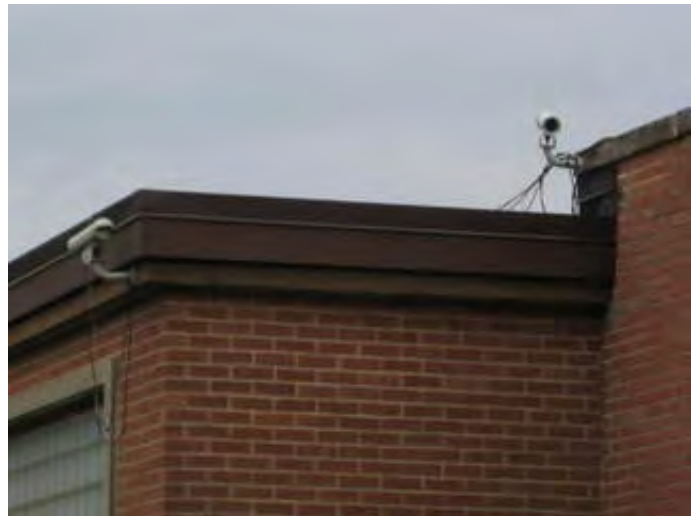
CCTV Cameras

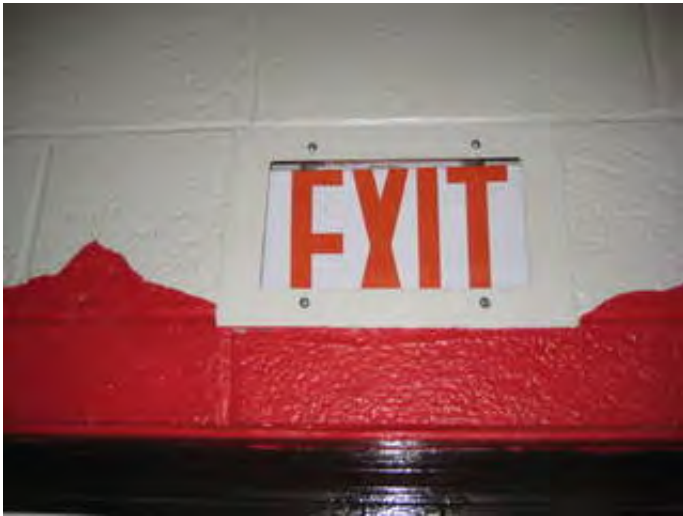
Description: The overall facility is equipped with an emergency egress lighting system consisting of non compliant incandescent, plastic construction, and non illuminated and OSDM compliant red lettered exit signs and emergency floodlighting. The system is in fair / poor condition, and is not provided with appropriate battery backup or emergency generator on separate circuits. The system is not adequately provided throughout, and does not meet Ohio School Design Manual and Ohio Building Code requirements.

Rating: 3 Needs Replacement

Non-Compliant Non-Illuminated Exit Sign

Recommendations: Provide complete replacement of emergency / egress lighting system to meet Ohio School Design Manual guidelines.

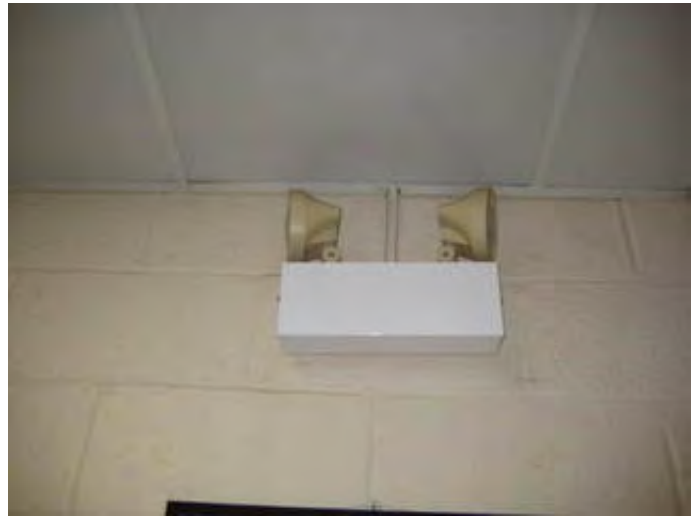
Emergency Egress Light Fixture

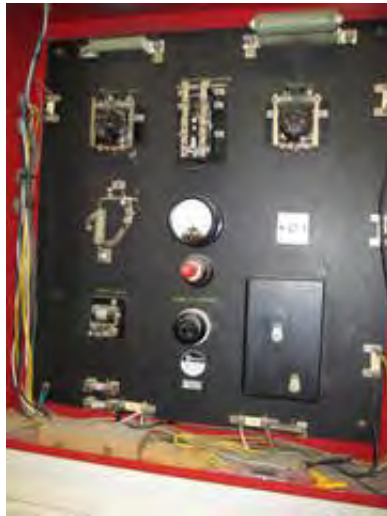
Fire Alarm Control Panel

Recommendations: Provide complete replacement of fire alarm system to meet OBC, NFPA, and Ohio School Design Manual guidelines.

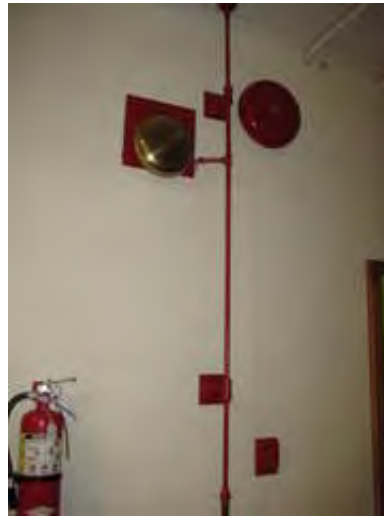
Fire Alarm Bell and Manual Pull Station

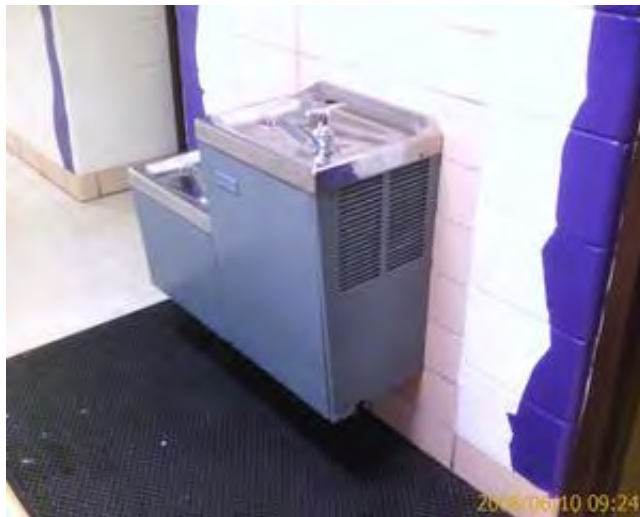
Typical Electric Water Cooler to be Replaced

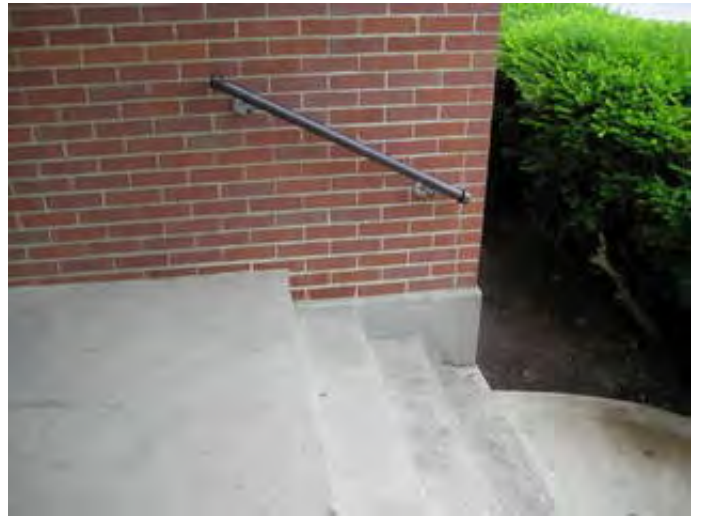
Non-Compliant Handrail

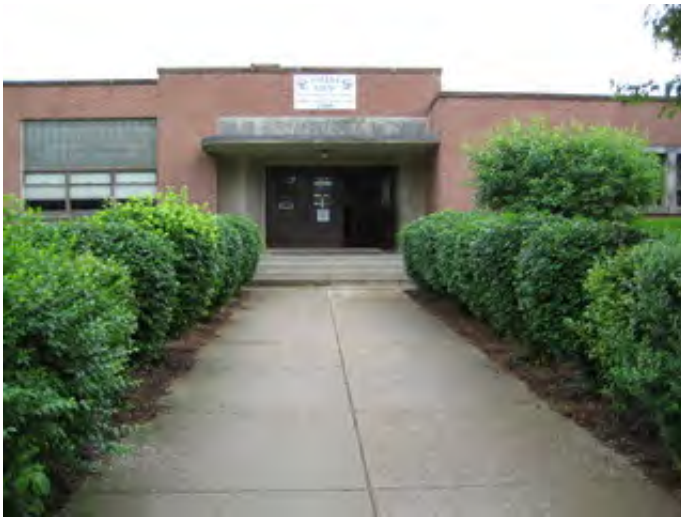
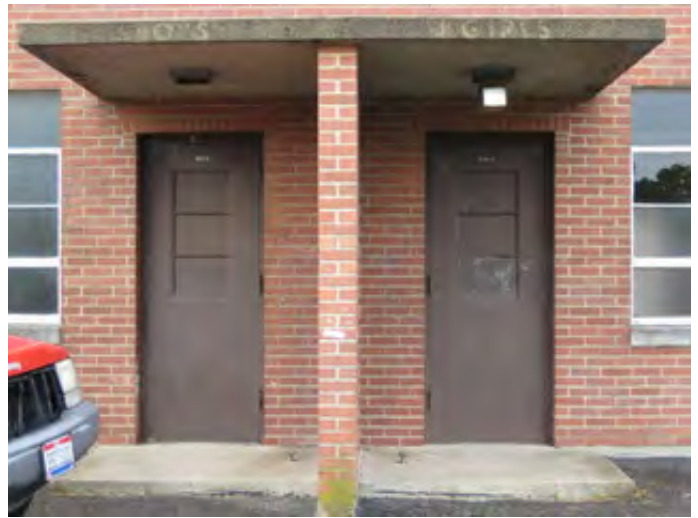
Main Entrance Doors

Typical Exterior Doors

Recommendations: Replace all exterior doors to comply with Ohio Building Code, ADA, and Ohio School Design Manual guidelines. POST-ASSESSMENT NOTE: Rii 4-8-16 Scope added to replace one Fire Door per EEHA.

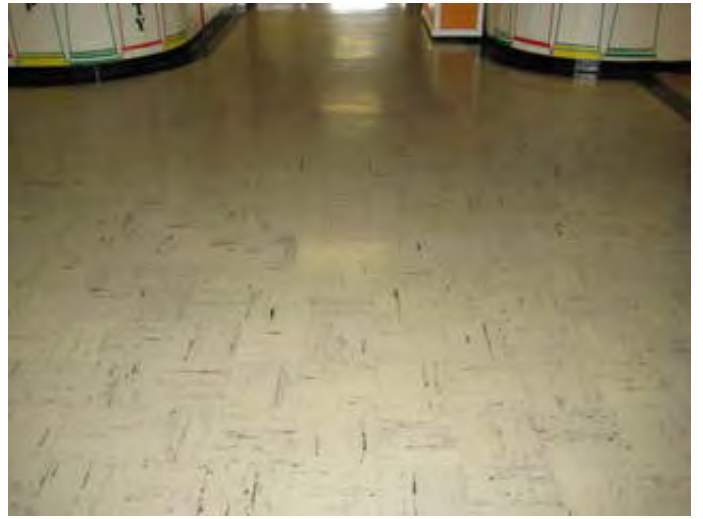
VAT in Classroom

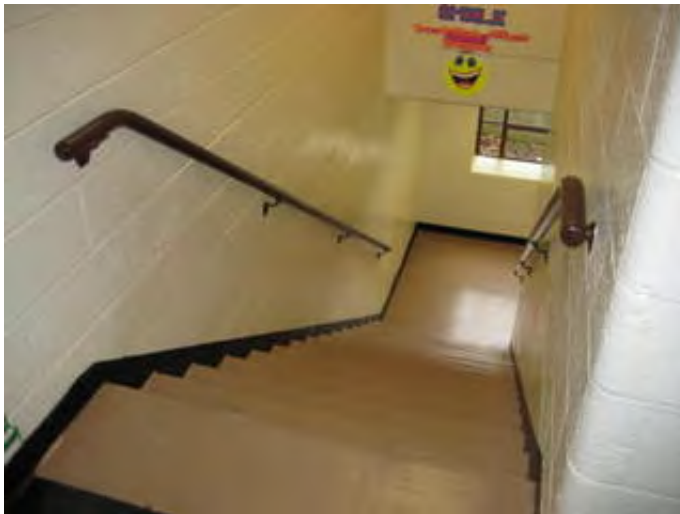
Non-Compliant Stairway and Railings

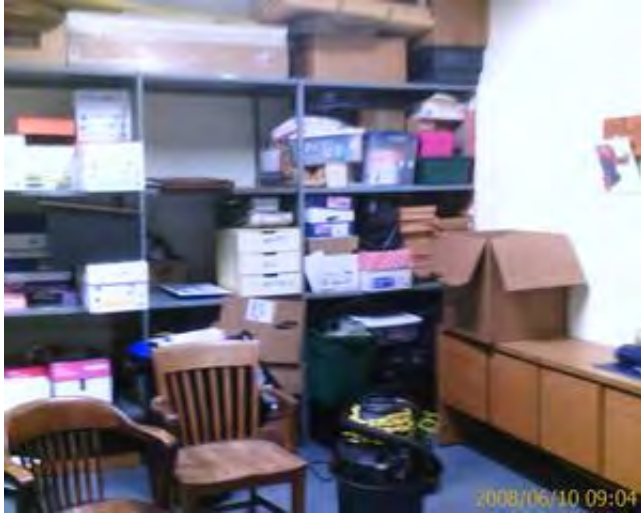
Typical Furniture Condition
