Building Information - Valley View Local (48744) - Valley View High

GENERAL DESCRIPTION

Valley View High School, which is not on the National Register of Historic Buildings, and originally constructed in 1968, is a 2 story, 96,535 square foot brick school building located in a rural agricultural setting. The existing facility features a conventionally partitioned design, and does utilize a modular building. The structure of the overall facility is a brick veneer on a masonry bearing wall system type exterior wall construction, with concrete masonry unit and demountable partition type wall construction in the interior. The ground floor system consists of concrete slab on grade. The Intermediate floor consists of a cast-in-place concrete system. The roof structure is a combination of metal deck, tectum, wood deck and cast in place concrete on steel joist. The roofing system of the overall facility is EPDM fully adhered membrane, installed in 1995, 1996, 1997, 1998, and 2000. The ventilation system in the 1968 Original Construction is inadequate to meet the needs of the users. The ventilation system in the 2000 Addition is adequate to meet the needs of the users. The Classrooms are

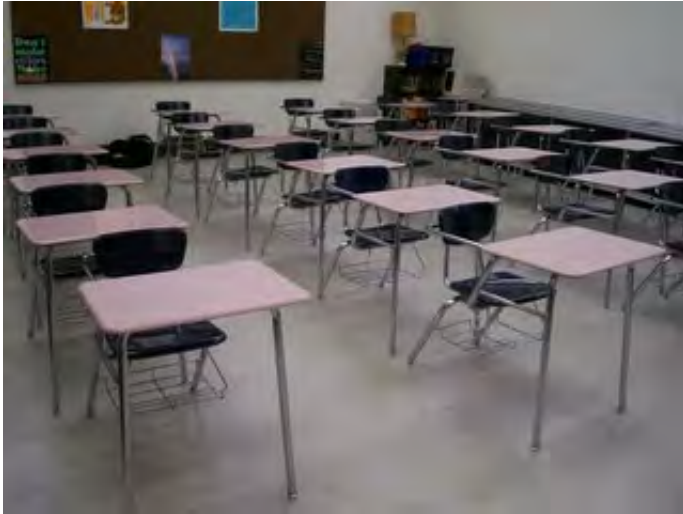
Typical Student Desk and Chair

Recommendations: Provide for replacement of outdated or inadequate furniture. POST-ASSESSMENT NOTE Rii 9-24-15 - Amended rating of 6 to rating of 3 to provide additional appropriate funding. Coordinated with CEFPI 6.17

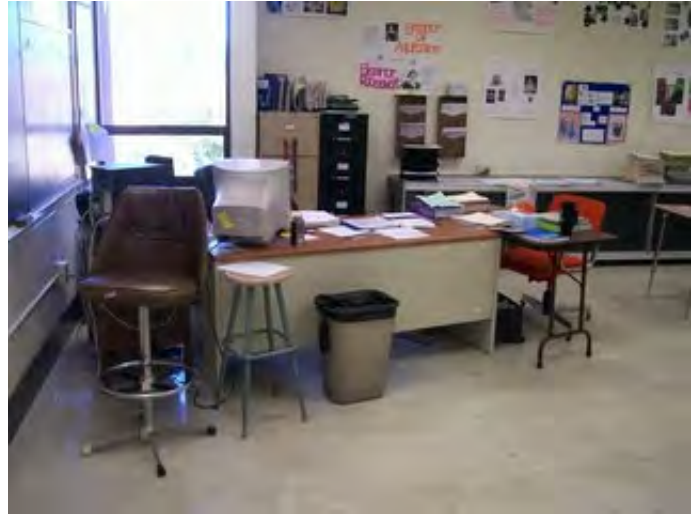
Typical Teacher Desk and Chair
